## Volvo Car USA LLC

## Technical Journal

| Technical Journal Title<br><b>Noise From Engine During Idling</b> | | Ref. No.<br><b>TJ 37844.1.0</b> | |
| Function Description<br><b>Crankcase ventilation</b> | | Page<br><b>Page 1 of 3</b> | |

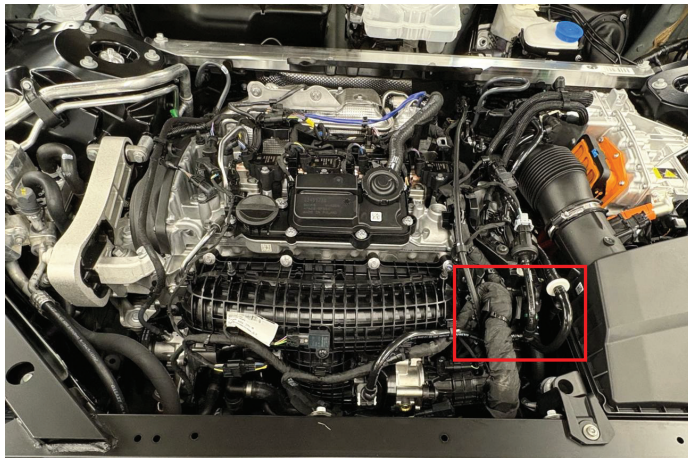
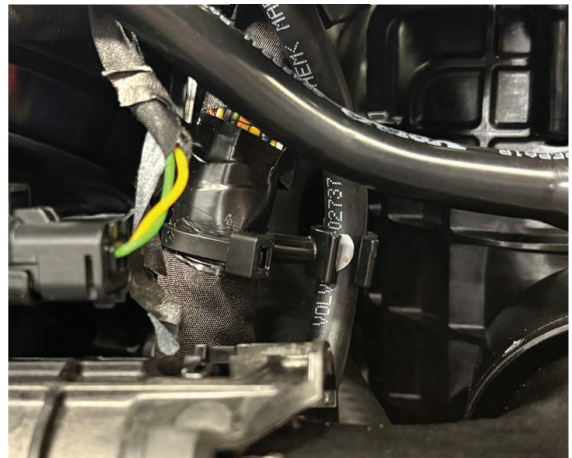
TJ\_37844

If a noise from the engine occurs during idling, refer to the attached sound file for reference and comparison; see attachment [TJ\\_37844\\_1.MOV](#).

If the noise corresponds to the attached sound file, make sure that the fresh air hose is not squeezed or kinked; see attachment [TJ\\_37844\\_2.MOV](#).

For location and correct clip positions, see attachment TJ\_37844\_1.pdf.
