# Technical Journal

## Electric System Temporarily Limited Message

| REF NO:<br><b>TJ 37515.1.0</b> | ISSUING DEPARTMENT:<br><b>Technical Service</b> | CAR MARKET:<br><b>United States and Canada</b> | |

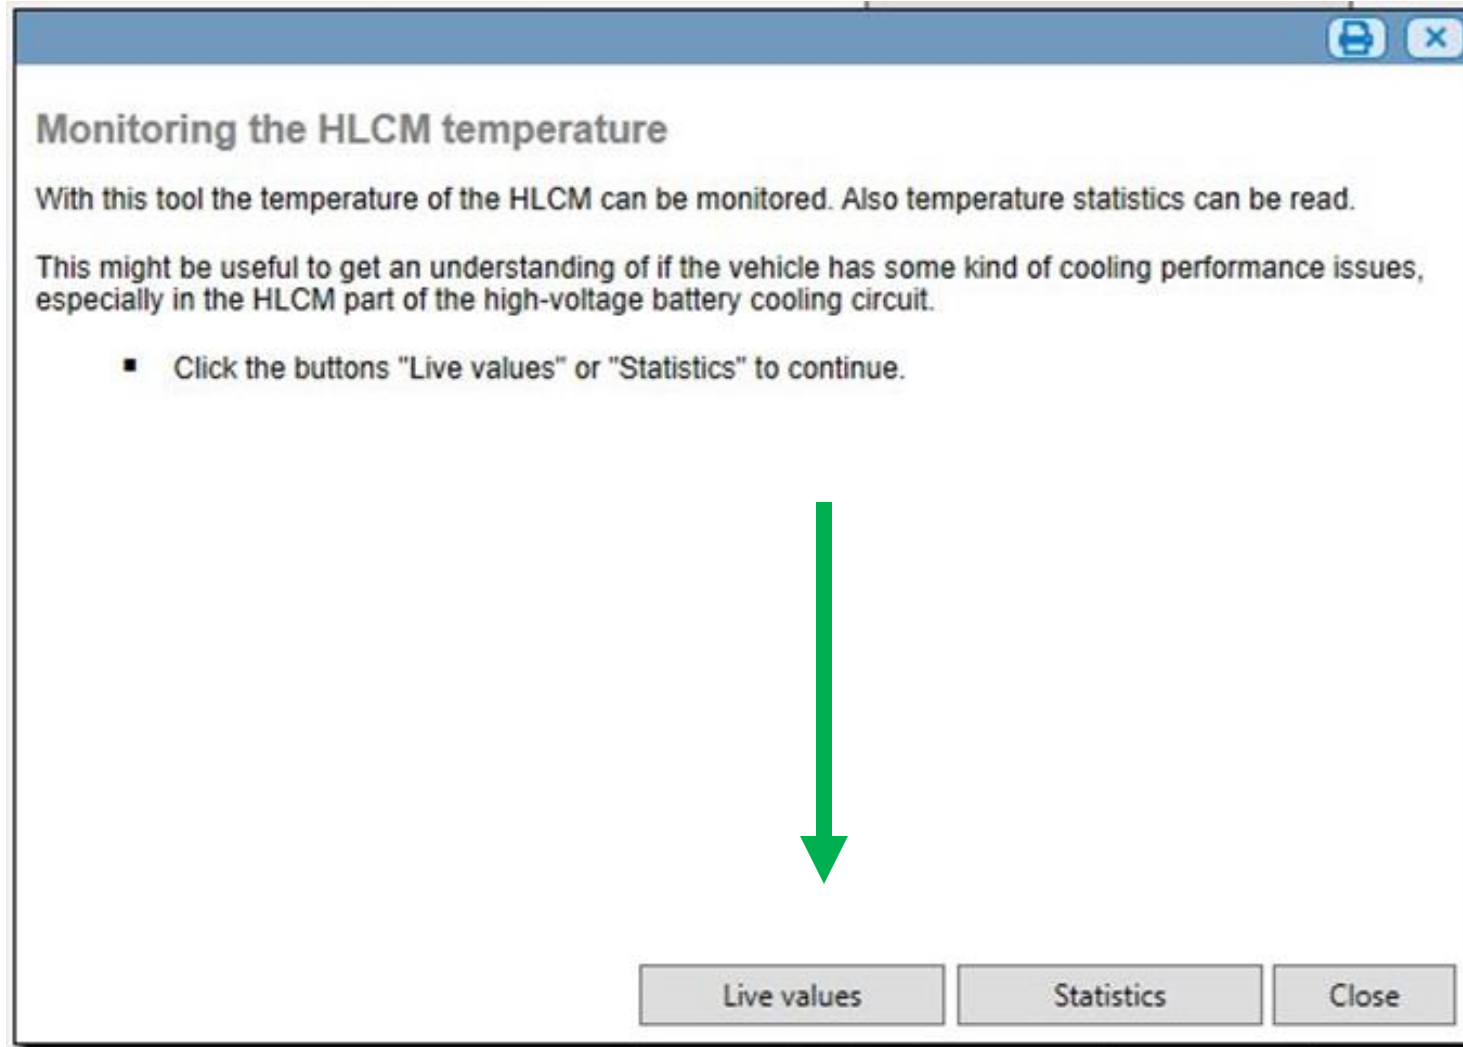
1. With a driver in the driver's seat, activate the rear window defroster, all seat heating, and the steering wheel heat.
2. Run the diagnostic sequence for HLCM temperature monitoring. See page 2 of the attachment TJ\_37515\_1.pdf.
3. Click the button "Live values" and observe the temperatures. See page 3 of the attachment TJ\_37515\_1.pdf.

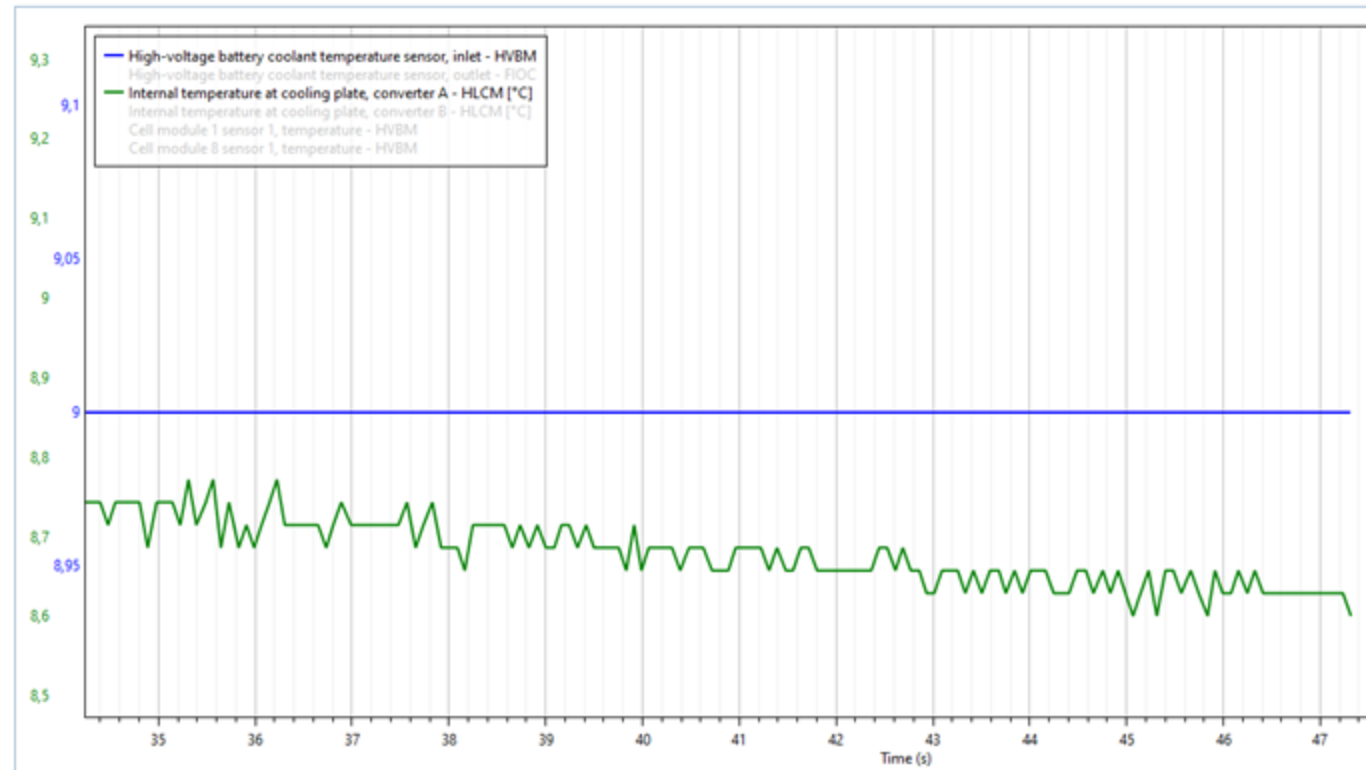
- 3.1. The HLCM cooling plate temperature and the HV battery coolant inlet temperature are about the same. See page 3.1 of the attachment TJ\_37515\_1.pdf

No further action required. The HLCM cooling system is not blocked. Continue the fault tracing according to VIDA.

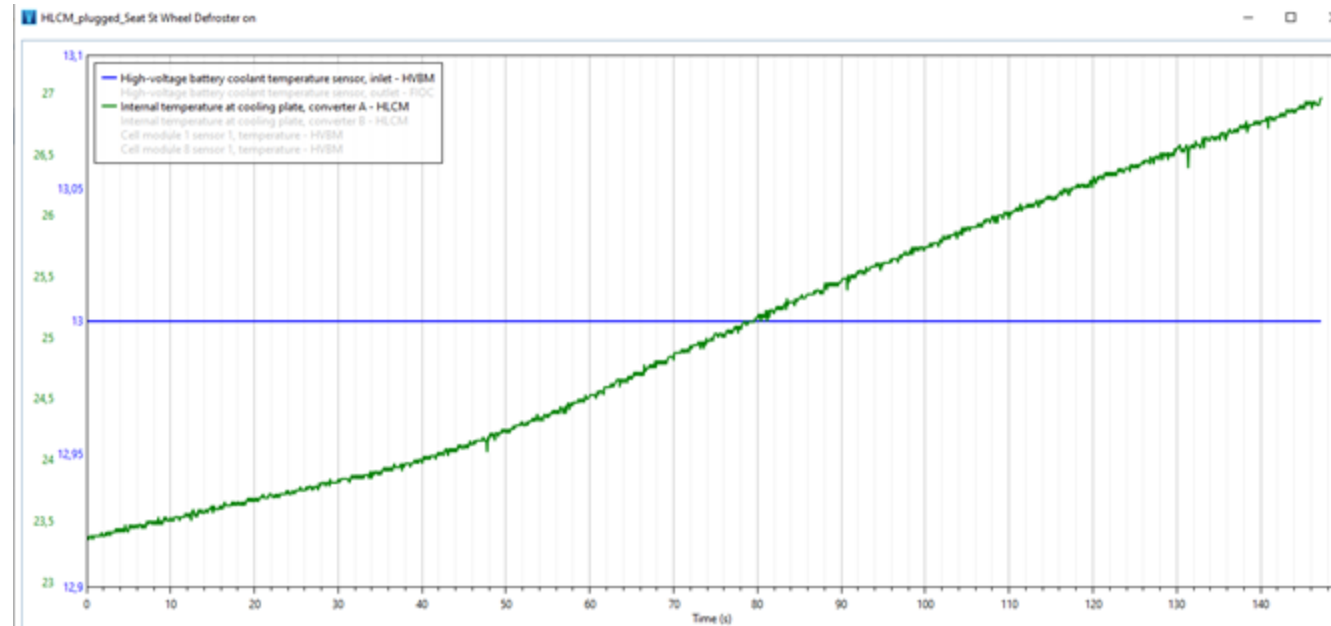
- 3.2. The HLCM cooling plate temperature is increasing significantly faster compared to the HV battery coolant inlet temperature. See page 3.2 of the attachment TJ\_37515\_1.pdf.

4. Check the function of the HV battery coolant pump by monitoring the requested speed vs the actual speed. The two speeds shall be the same. See page 4 of the attachment TJ\_37515\_1.pdf.
5. If the pump is working properly, the HLCM cooling problems are likely caused by blocked coolant flow in the HLCM coolant ports. Both the inlet and/or the outlet can be blocked. If the coolant ports are blocked, the plugs can be removed, and the HLCM reinstalled. It is not necessary to replace the HLCM for this issue. See page 5 of the attachment TJ\_37515\_1.pdf.
