# Technical Journal

**Wind Noise from Side Window**

| REF NO:<br><b>TJ 37421.4.0</b> | ISSUING DEPARTMENT:<br><b>Technical Service</b> | CAR MARKET:<br><b>United States and Canada</b> | |

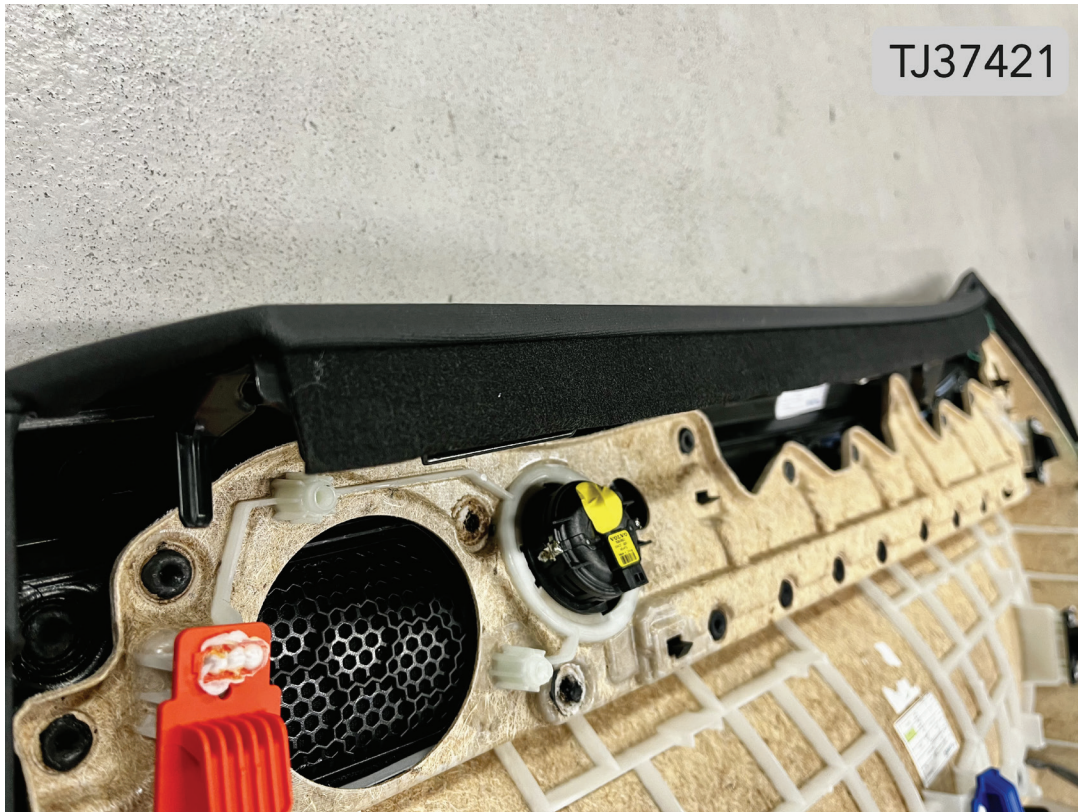
3. Apply tape to door panel (see attachment TJ37421\_1.JPG). Cut the tape to following dimensions: 690 mm long and 25 mm wide, ensuring it covers the entire panel lip.
4. Apply tape to the weatherstrip (see attachment TJ37421\_2.JPG and for location, see attachment TJ37421\_3.jpg). Cut the tape: 300 mm long and 12.5 mm wide. Apply with 2 layers. The tape should start approximately 300 mm from rear end (B pillar) and only cover the middle portion of the seal, not the entire moulding.

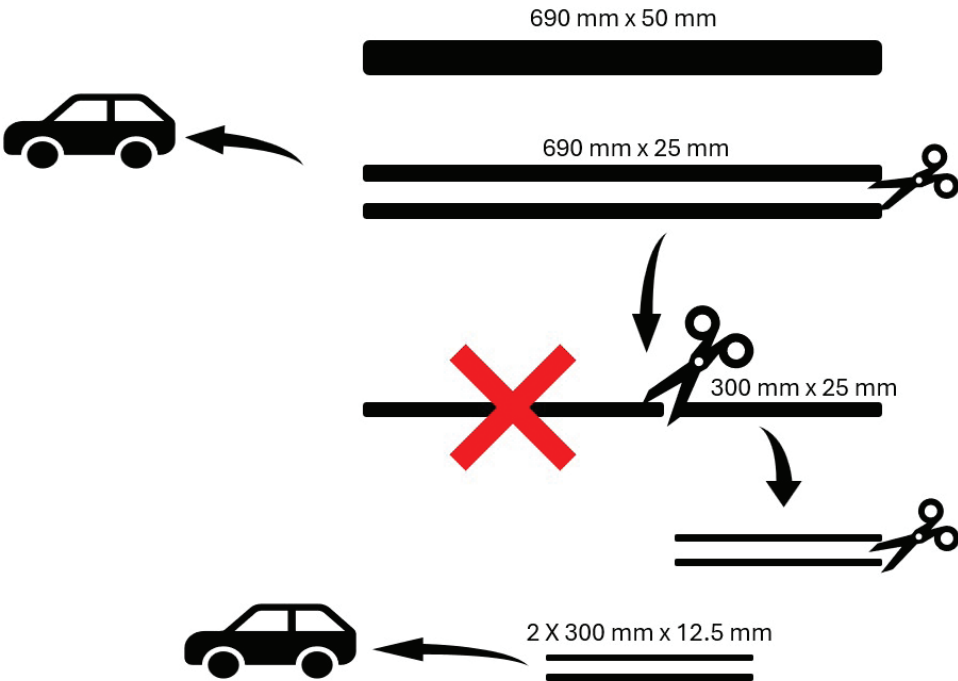
TJ37421

Details for cutting (see attachment TJ37421\_4.jpg):

- a) Cut 690 mm of the tape.
- b) Cut this piece in half so you have 2 lengths of 690 mm x 25 mm, one tape should be applied for action 3.
- c) Cut the tape to dimension 300 mm long and 25 mm wide.
- d) Then cut the tape in half, so both pieces are 300 mm long and 12.5 mm wide for action 4.

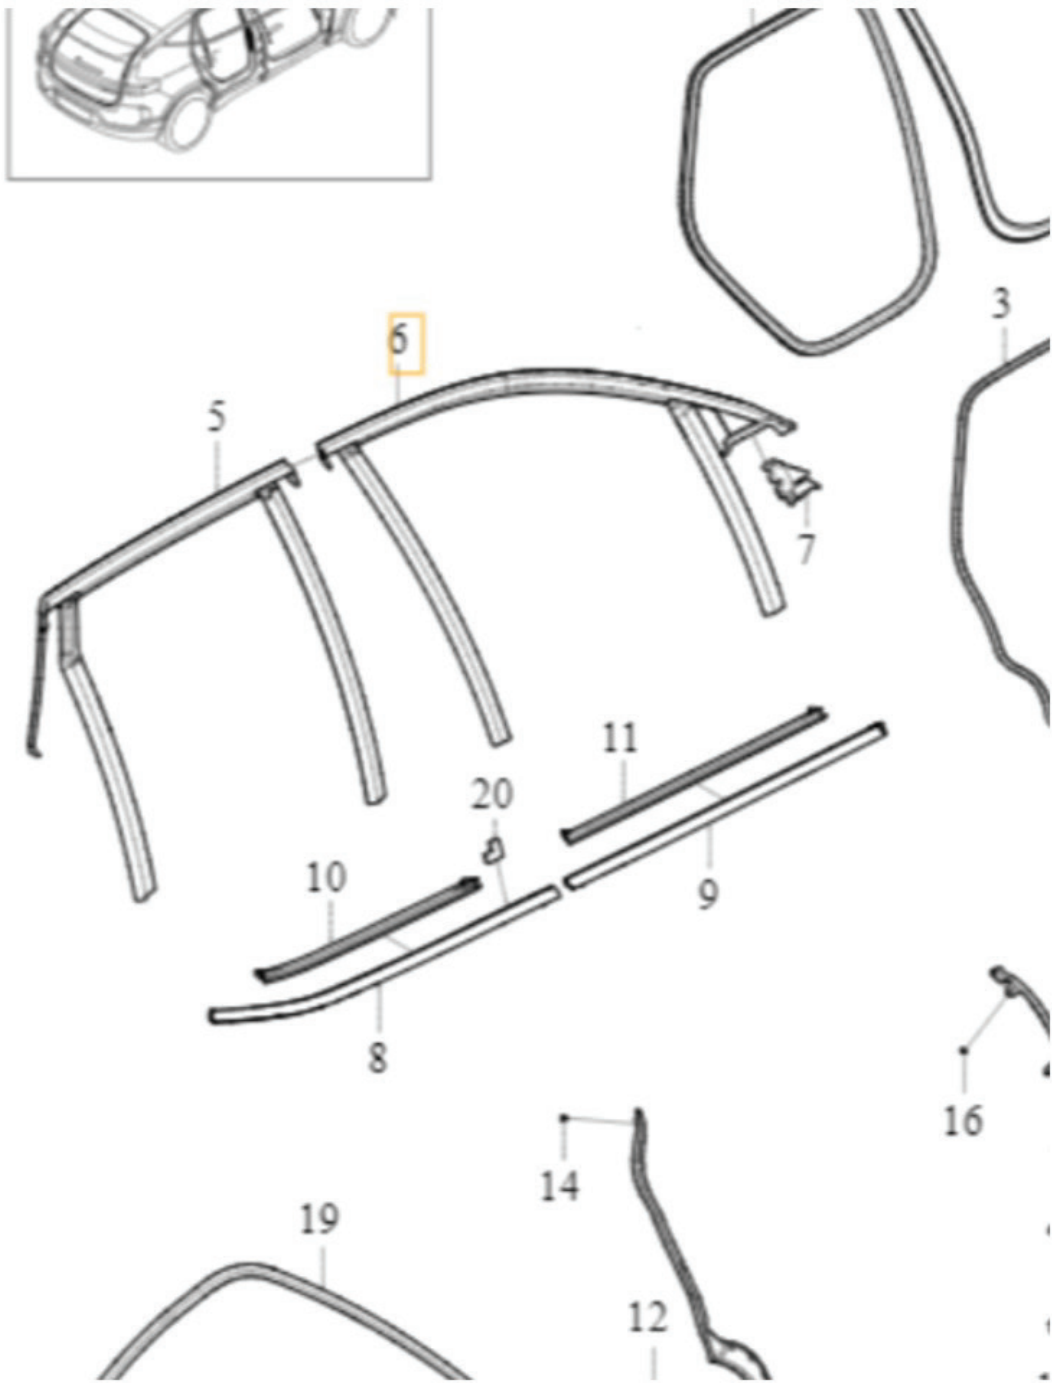
TJ37421

1. Check the calibration of the window. Recalibrate if needed. This can be checked by following reference VCC-524977-1.
2. Inspect the trim moulding (see attachment TJ37421\_5.jpg). The pressure from the original window calibration can permanently deform or damage the material, replace needed.
