# Technical Journal

**ICUP Black Map in DIM**

| REF NO:<br><b>TJ 37516.3.0</b> | ISSUING DEPARTMENT:<br><b>Technical Service</b> | CAR MARKET:<br><b>United States and Canada</b> | |

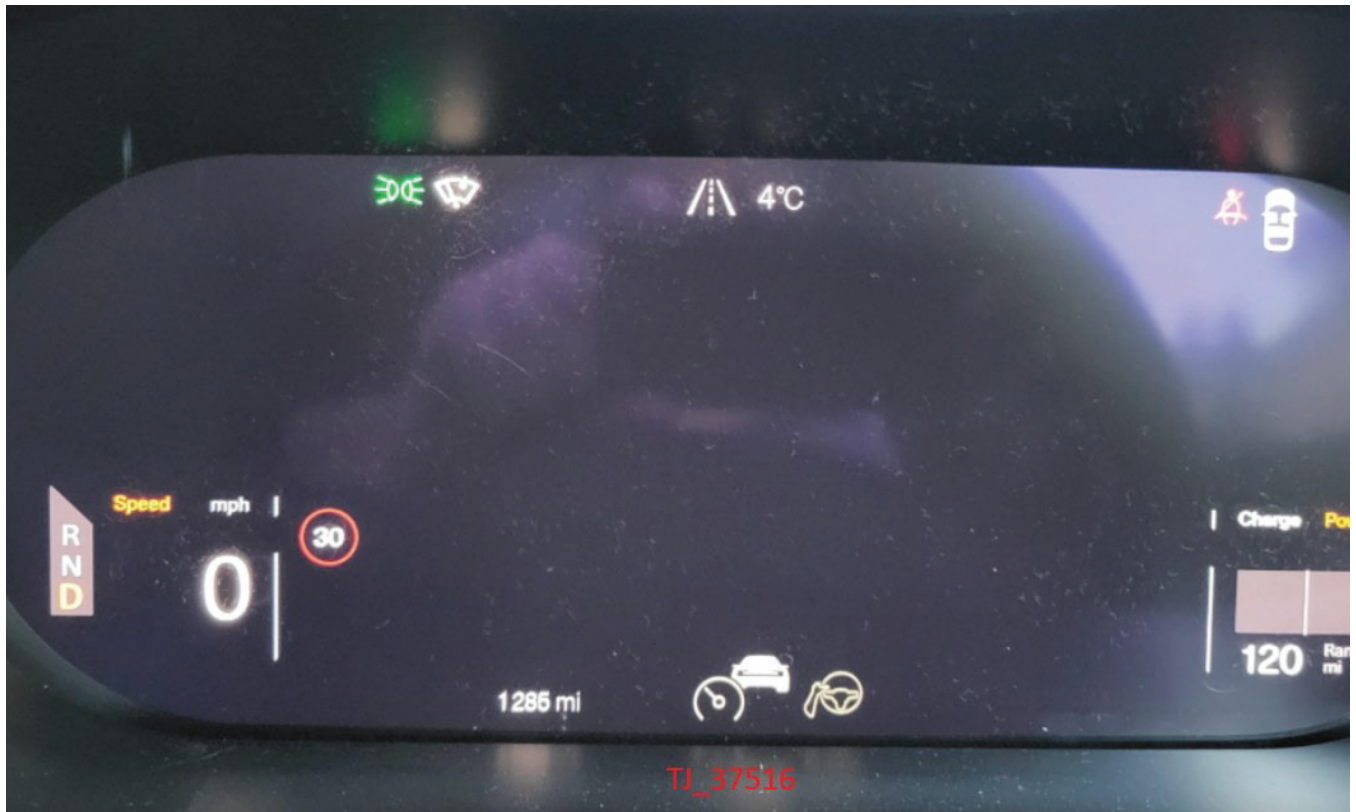
\*If the customer reports the navigation map in the DIM become black during driving or at start-up, follow the instructions under "Service" (see attached picture TJ\_37516\_pdf).

**DO NOT REPLACE** any components for this issue.
