# Quality Bulletin

## Service Action SP1087: PS3 RHS Outer Panel Model Year 2025 Polestar 3

SP1087

QB Instruction VCC-537329-1

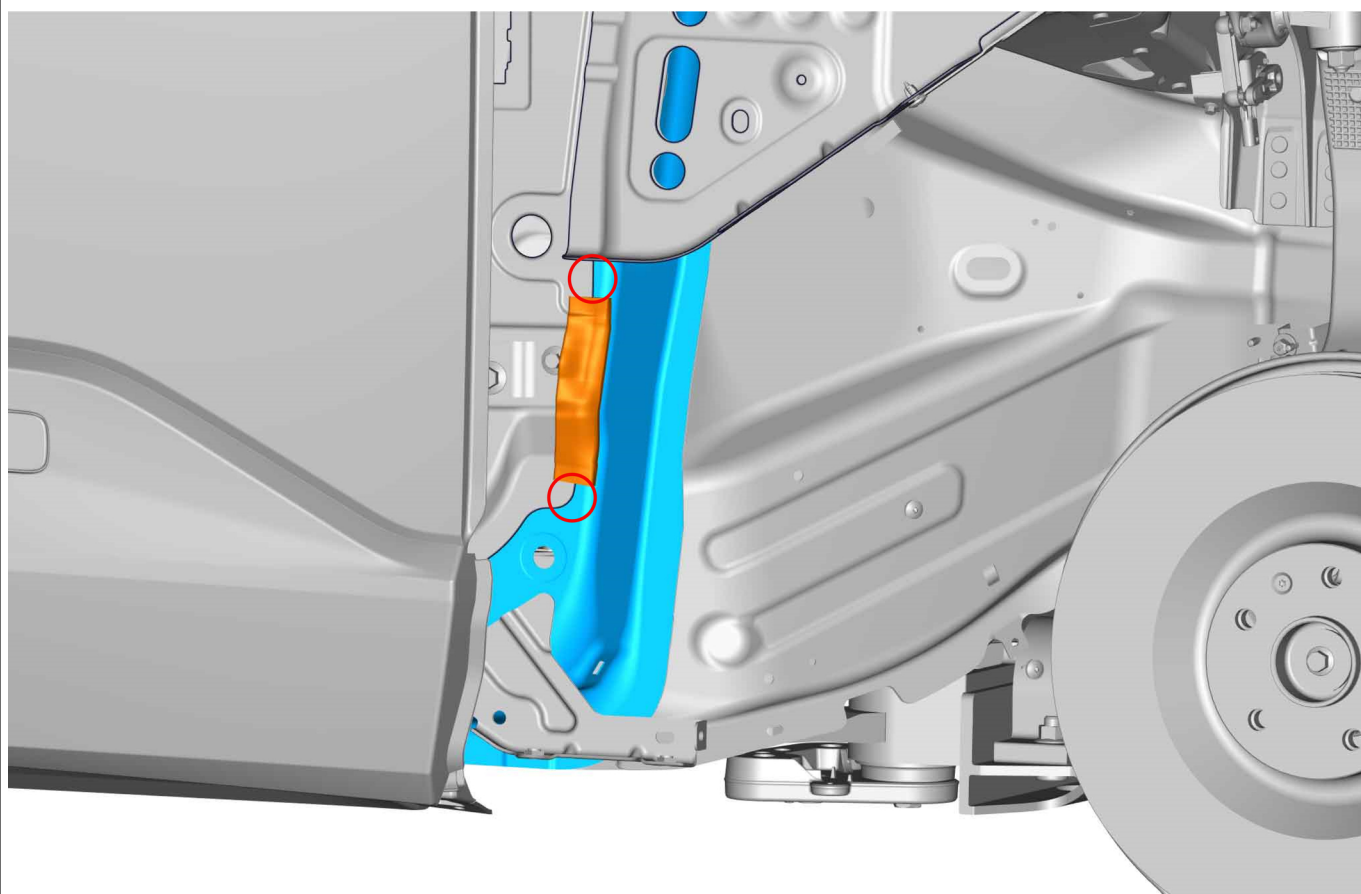
Right-hand side

**Note! Orientation view**

**Note! Make sure that the component is clean and free of foreign material.**

**Use:** Isopropanol ,
