# Rapid Update 820

## Maserati Grecale – Front Fender Trim Paint Check

DATE: July 8, 2026

**VEHICLES INVOLVED:** (M182) Grecale MY25-MY26**Required Action**

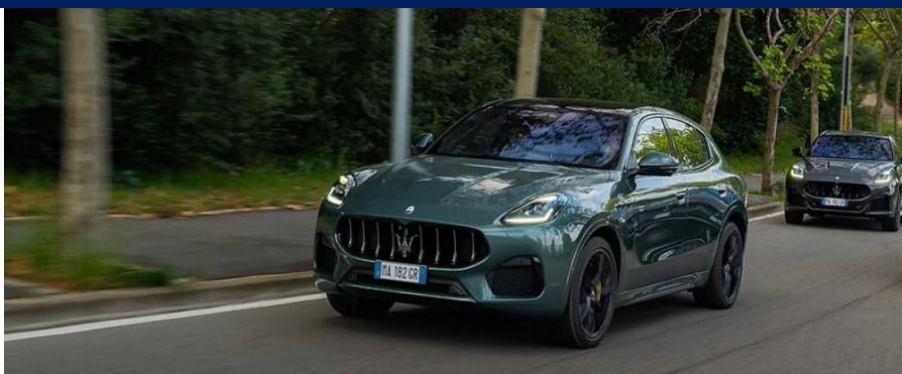
On some vehicles, peeling paint may be visible on the end area of the front fender molding. This condition is related to the component production process and appears only as a localized aesthetic concern in a specific area of the molding. This condition does not affect vehicle safety, functionality, or performance; however, it does not meet Maserati quality standards.

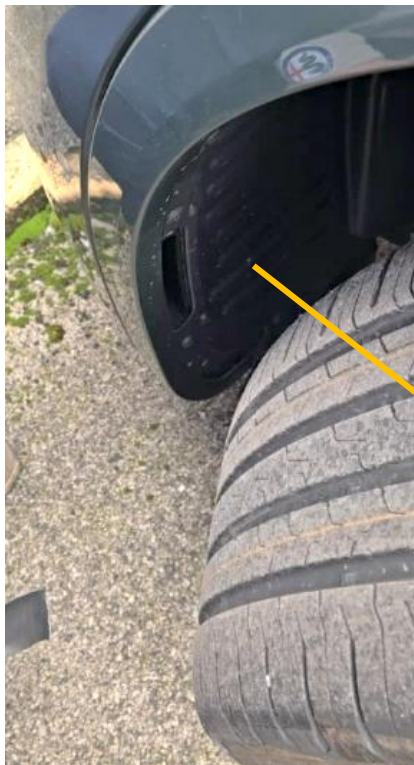
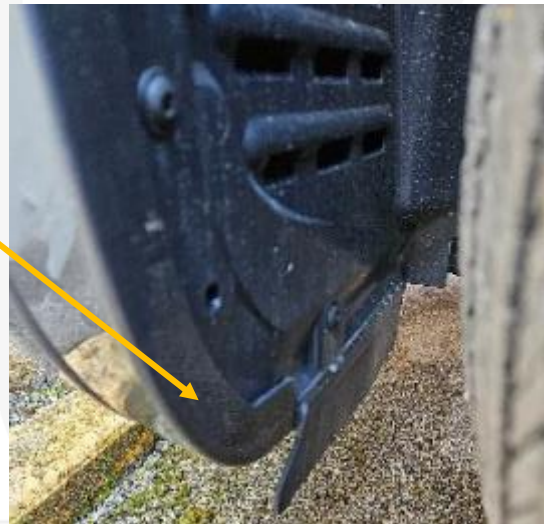
**IMPORTANT:** The inspection procedure below is described for one side of the vehicle only. Although the concern is **limited to the left-hand side**, the inspection must be performed on **both sides of the vehicle**.

**Note:** To facilitate the inspection, rotate the wheel to access the portion of the wheel arch to be checked. Wheel removal is not necessary; the inspection must be performed with the **part correctly installed** on the vehicle.

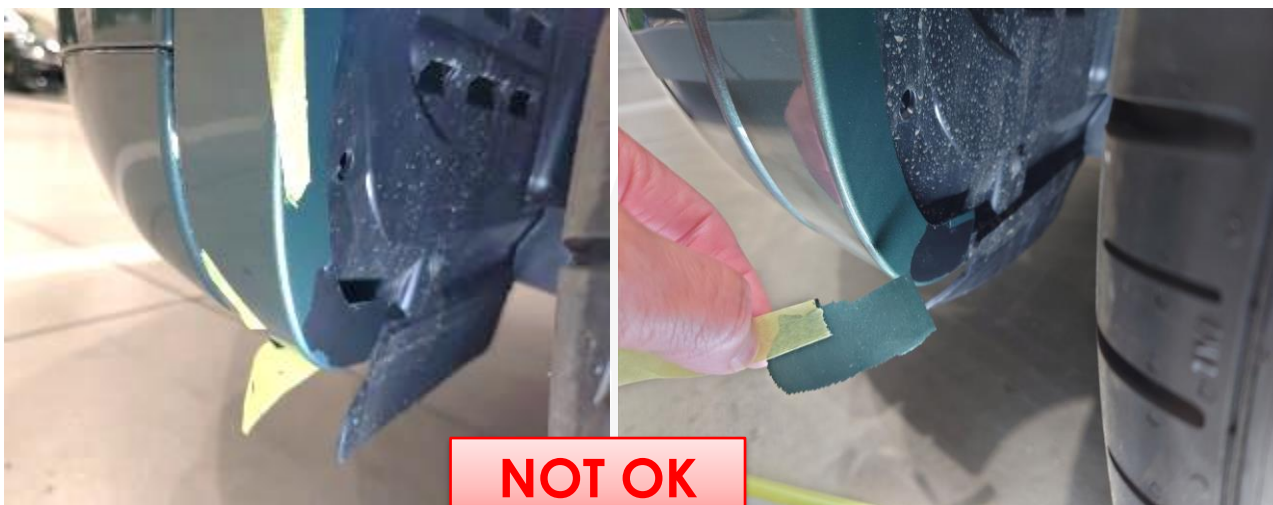
5. Once the tape has been completely removed, **carefully inspect** both the painted surface and the tape for the presence of:
  - a. Paint peeling off with residue on the tape;
  - b. Paint lifting on the molding;
 Localized peeling in the terminal area of the molding;
  - a. Cracking of the paint.

6. If no obvious or visible **anomalies are present, the vehicle is OK** and no further action is needed.
7. If any of the indicated **defects are noted, the molding is NOK** and must be replaced.
8. Replace **ONLY** the defective component following the instructions in the workshop manual.
  - a. **9.13.094 FRONT RIGHT WHEEL ARCH** Removal/Refitting or Replacement
  - b. **9.13.095 FRONT LEFT WHEEL ARCH** Removal/Refitting or Replacement
9. Reinstall all removed components in the reverse order of removal.
10. The procedure is then complete and the vehicle can be released.
