GENERAL MOTORS  
DCS7533  
URGENT - DISTRIBUTE IMMEDIATELY

Subject: N252541251 - Customer Satisfaction Program  
No Rear Turn-Signal Outage Notification

Models: 2024 Chevrolet Corvette

## N252541251 No Rear Turn-Signal Outage Notification

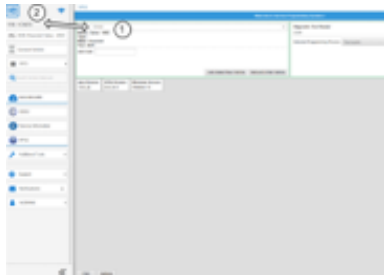
7001095

**IMPORTANT:** The service technician always needs to verify that the VIN displayed in the TLC left side drop down menu (1) and the top center window (2) match the VIN plate of the vehicle to be programmed prior to using Service Programming System 2 (SPS2) for programming or reprogramming a module.

1. Reprogram the Lighting Control Module. Refer to *K219 Lighting Control Module: Programming and Setup* in SI. Carefully read the programming and setup document for further instruction.

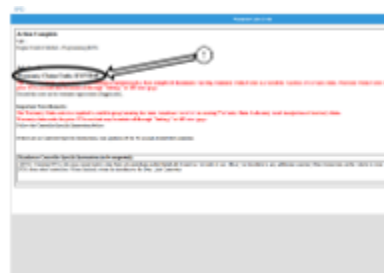
7001097

**Important:** To avoid warranty transaction rejections, you MUST record the warranty claim code provided on the Warranty Claim Code (WCC) screen shown above on the job card. Refer to callout 1 above for the location of the WCC on the screen.

2. Record SPS Warranty Claim Code on job card for warranty transaction submission. Refer to *25-NA-281 Information on SPS Warranty Claim Code Submission and Retrieval* in SI.
