**Technical Service Bulletin (TSB)**  
**Instrument Panel Cluster (IPC) Configuration**

| REFERENCE: | TSB: 08-250-26 REV. A<br>GROUP: 08 - Electrical | Date: | July 10, 2026 | REVISION: | 08-250-26 |
| VEHICLES AFFECTED: | 2026 (RU) Chrysler Pacifica / Voyager<br>This bulletin applies to vehicles built on or after January 19, 2026 (MDH 0119XX) and on or before March 09, 2026 (MDH 0309XX) equipped with 7" Full Color TFT Display (Sales Code JAJ), 120 MPH Primary Speedometer (Sales Code JCB), Instrument Panel Parts Module II (Sales Code X8C), and without PHEV Adaptation Components (Sales Code XDQ). | | | MARKET APPLICABILITY:<br><div><input checked="" type="checkbox"/> NA<input type="checkbox"/> MEA</div> <div><input type="checkbox"/> SA<input type="checkbox"/> IAP</div> <div><input type="checkbox"/> EE<input type="checkbox"/> CH</div><br><b>NOTE:</b> This bulletin applies to the North America market. | |

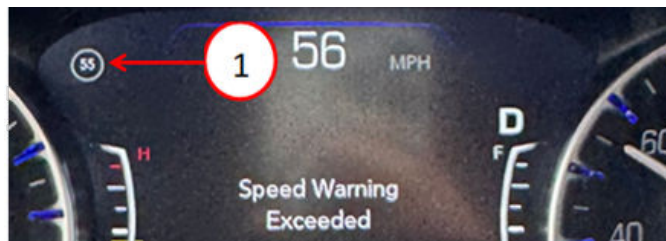
**Fig. 1**  
IPC Display

| CUSTOMER SYMPTOM: | Customers may experience one or more of the following: <ul style="list-style-type: none"><li>Speed limit warning chimes while driving.</li><li>IPC display message speed warning exceeded.</li><li>Speed limit appears on US IPC. <a href="#">Fig. 1</a></li></ul> | | | | |

1 - Speed Limit Indicator

This bulletin involves inspecting and possibly reprogramming the IPC configuration.
