**Technical Service Bulletin (TSB)**  
**Power Folding Seat Wire Harness Pinched**

| REFERENCE: | TSB: 08-274-26<br>GROUP: 08 - Electrical | Date: | July 11, 2026 | REVISION: | — |
| VEHICLES AFFECTED: | 2021 - 2025 (WL) Jeep Grand Cherokee/ Grand Cherokee L<br>This bulletin applies to equipped with 3rd Row 50/50 Power Fold Seat (Sales Code CBB) and one of the following: <ul style="list-style-type: none"><li>3.6L V6 24V VVT Engine Upg I w/ESS (Sales Code ERC).</li><li>5.7L V8 Hemi MDS Engine VVT (Sales Code EZH).</li></ul> | | | MARKET APPLICABILITY:<br><div><input checked="" type="checkbox"/> NA<input checked="" type="checkbox"/> MEA</div> <div><input checked="" type="checkbox"/> SA<input checked="" type="checkbox"/> IAP</div> <div><input checked="" type="checkbox"/> EE<input type="checkbox"/> CH</div><br><b>NOTE:</b> This bulletin applies to North and South America, Enlarged Europe, Middle East & Africa, and India & Asia Pacific markets. | |

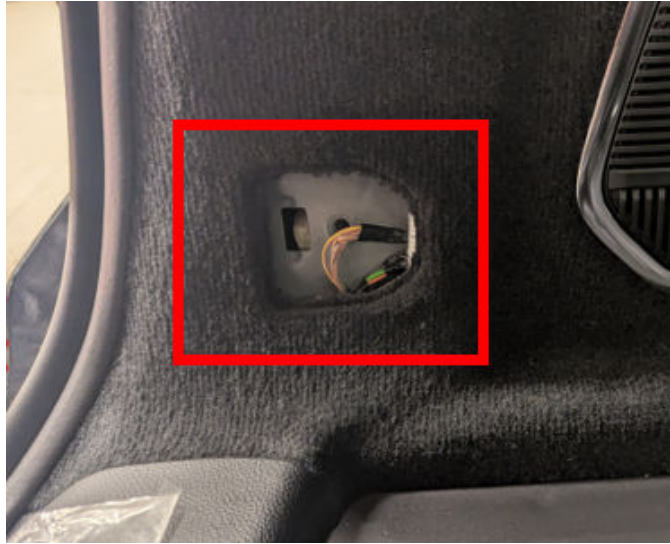
**Fig. 1**

1. Remove the cargo tie down from the left quarter panel to expose the power folding seat wire harness [Fig. 1](#).

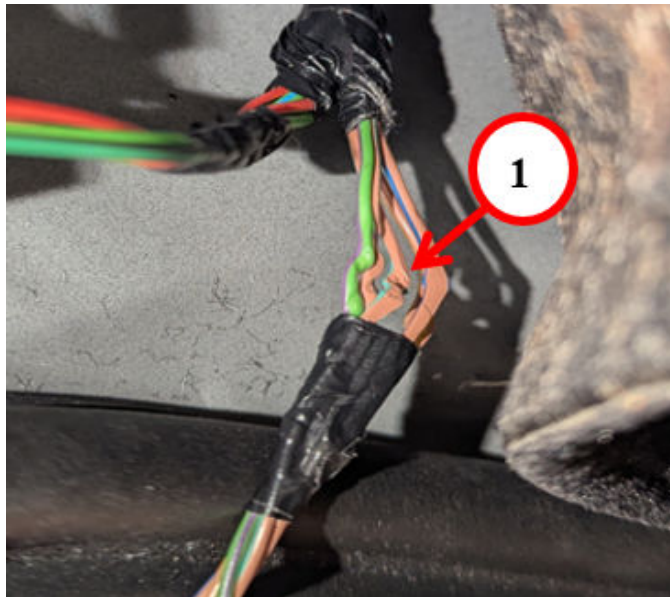
**Fig. 2**

2. Inspect the power folding seat wire harness for damaged or pinched wires [Fig. 2](#).

Inspect Power Folding Seat Wire Harness

1 - Compromised Power Folding Seat Wire Harness

7. Repair the pinched power folding seat wire harness. Refer to the detailed service procedures available in DealerCONNECT/Service Library under: Service Info> 29 - Non-DTC Diagnostics / Circuit Testing Procedures / Standard Procedure
8. Route the power folding seat wire harnesses underneath the left quarter panel.
9. Connect the power folding seat wire harness connectors.
10. Install the cargo load floor. Refer to the detailed service procedures available in DealerCONNECT/Service Library under: Service Info> 23 - Body / Interior / Load Floor, Cargo / Removal and Installation.
11. Install the cargo tie down to the left quarter panel.

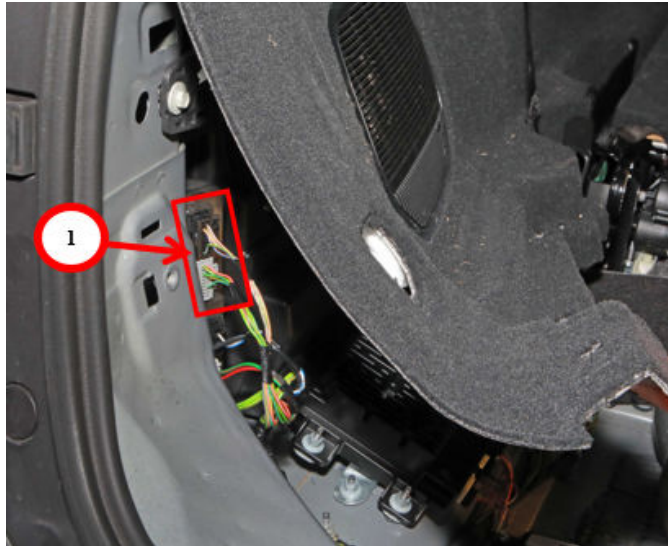
**Fig. 3**

**Power Folding Seat Wire Harness Connectors Locations**

1 - Power Folding Seat Wire Harness Connectors behind the left quarter panel.

5. Gently pull the left quarter trim panel bottom out to gain access to and disconnect the power folding seat wire harness connectors [Fig. 3](#).

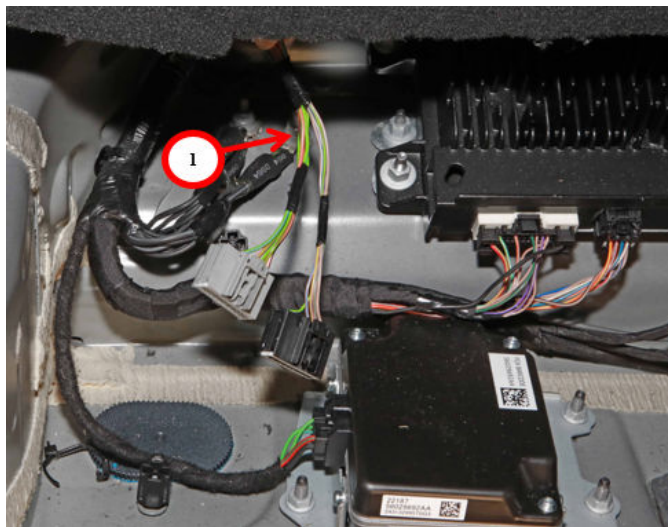
**Fig. 4**

**Power Folding Seat Wire Harness**

1 - Accessing Power Folding Seat Wire Harness

6. Gently pull the power folding seat wire harnesses underneath the left quarter panel [Fig. 4](#).
