**Technical Service Bulletin (TSB)**  
**Engine Runs Rough**

| REFERENCE: | TSB: 09-013-26<br>GROUP: 09 - Engine | Date: | July 10, 2026 | REVISION: | — |
| VEHICLES AFFECTED: | 2026 (WL) Jeep Grand Cherokee / Grand Cherokee L<br>This bulletin applies to vehicles built on or before July 02, 2026 (MDH 0702XX) equipped with the 2.0L Hurricane 4 Turbo W/ESS (Sales Code EC7). | | | MARKET APPLICABILITY:<br><div><input checked="" type="checkbox"/> NA<input type="checkbox"/> MEA<br/><input type="checkbox"/> EE<input type="checkbox"/> IAP<br/><input type="checkbox"/> SA<input type="checkbox"/> CH</div><br>NOTE: This bulletin applies to North America markets. | |

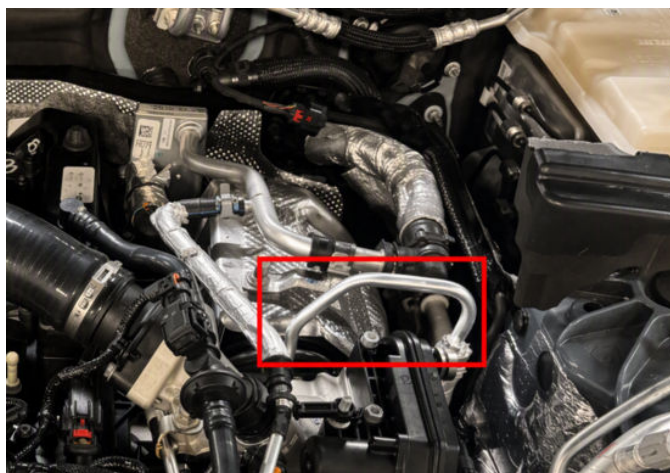
**Fig. 1**

**Do not to grab or lean on the turbo oil feed line. Doing so can damage the tube Fig. 1.**

Turbo Oil Feed Line
