**Technical Service Bulletin (TSB)**  
**High Pressure Fuel Pump**

| REFERENCE: | TSB: 14-002-26 REV. A<br>GROUP: 14 - Fuel System | Date: | July 8, 2026 | REVISION: | 14-002-26 |
| VEHICLES AFFECTED: | 2022 - **2027** (B1) Jeep Renegade<br>2022 - **2027** (H1) Jeep Commander<br>2022 - **2027** (M1) Jeep Compass<br>This bulletin applies to vehicles equipped with a 1.3 I4 Turbo MAIR DI Engine (Sales Code EYJ). | | | MARKET APPLICABILITY:<br><div><input type="checkbox"/> NA<input type="checkbox"/> MEA</div> <div><input checked="" type="checkbox"/> SA<input type="checkbox"/> IAP</div> <div><input type="checkbox"/> EE<input type="checkbox"/> CH</div><br>NOTE: This bulletin applies to the Brazilian market. | |

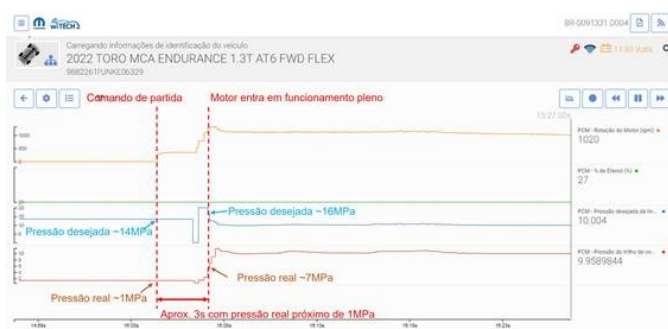
**Fig. 1**

Graphical Mode - KO Result

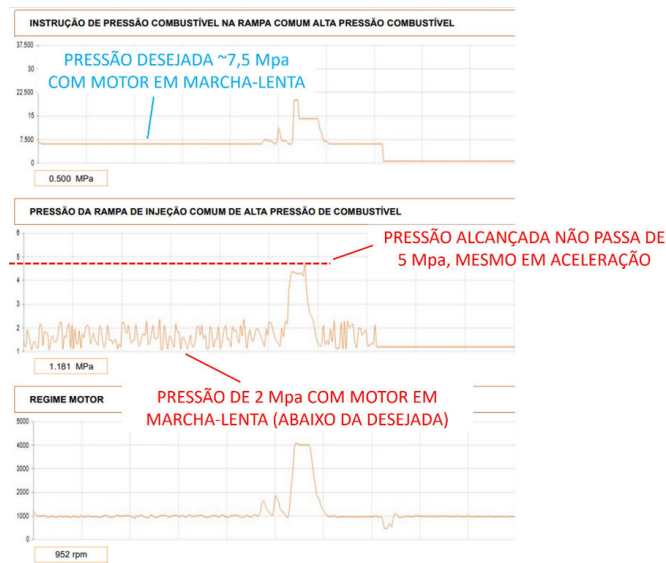
**Fig. 2**  
Engine Start With Failure

8. Monitor wiTECH whether the high-pressure fuel pump will deliver the desired pressure immediately at the time of start-up when the failure occurs:
9. Is there a delay in the pressure increase or does the actual pressure not reach the desired pressure?

Partida do motor de um veículo **COM** falha

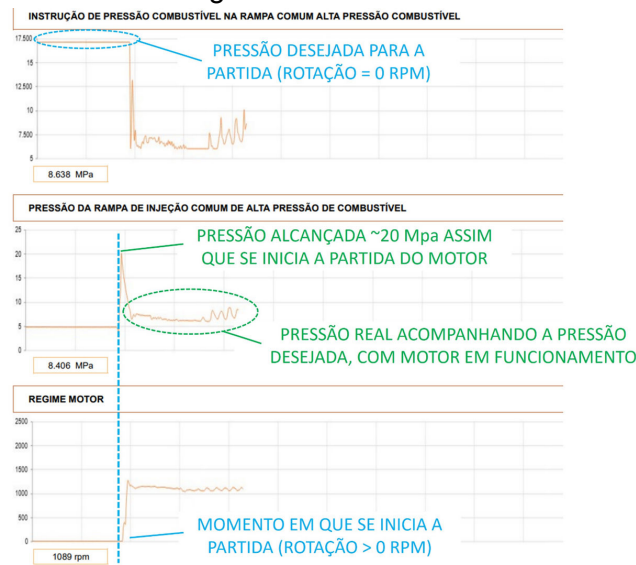
**Fig. 3**  
Engine Start Without Failure

Partida do motor de um veículo **SEM** falha
