**Technical Service Bulletin (TSB)**  
**High Pressure Fuel Pump**

| REFERENCE: | TSB: 14-008-26<br>GROUP: 14 - Fuel System | Date: | July 8, 2026 | REVISION: | — |
| VEHICLES AFFECTED: | 2022 - 2027 (B1) Jeep Renegade<br>2022 - 2027 (H1) Jeep Commander<br>2022 - 2027 (M1) Jeep Compass<br>This bulletin applies to vehicles equipped with a 1.3L I4 Turbo MAir DI Engine w/ESS (Sales Code EYF) or 1.3L I4 Turbo MAir DI Engine (Sales Code EYH). | | | MARKET APPLICABILITY:<br><div><input type="checkbox"/> NA<input type="checkbox"/> MEA<br/><input checked="" type="checkbox"/> SA<input type="checkbox"/> IAP<br/><input type="checkbox"/> EE<input type="checkbox"/> CH</div><br><b>NOTE:</b> This bulletin applies to the South America market and excludes the Brazilian market. | |

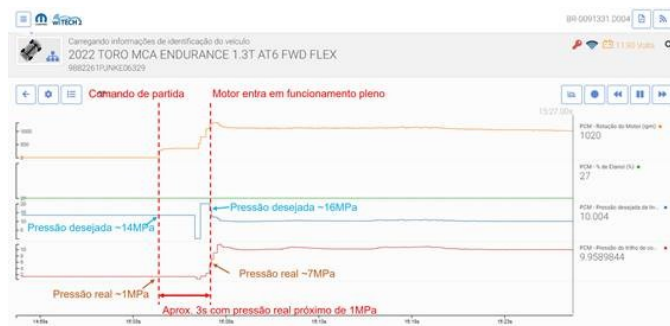
Fig. 1

Graphical Mode - KO Result

8. Monitor wiTECH whether the high-pressure fuel pump will deliver the desired pressure immediately at the time of start-up when the failure occurs:
9. Is there a delay in the pressure increase or does the actual pressure not reach the desired pressure?

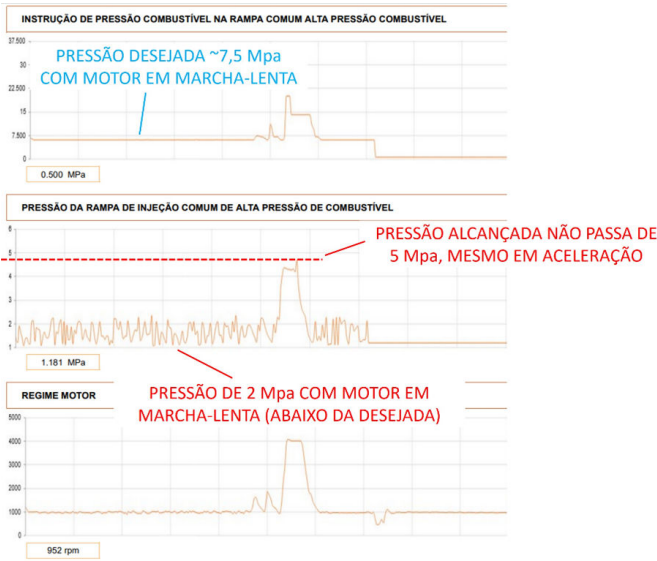
**Fig. 2**  
Engine Start With Failure

- If the pressure measured on the pressure gauge **is between 5.2 and 6.0 bar**, but the rail pressure (injector ramp) measured does NOT follow the desired pressure in the parameters via wiTECH, take a screenshot or PDF print of the screen demonstrating the incident and proceed to **REPAIR PROCEDURE**.

Partida do motor de um veículo **COM** falha

1. Replace the high pressure fuel pump. Refer to the detailed service procedures available in DealerCONNECT/Service Library under: Service Info>1056F72 - Bomba de Pressão - Remoção/Recolocação.
2. Delete the DTCs recorded in the ECM control panel's memory with wiTECH.
3. Perform injector learning with wiTECH.

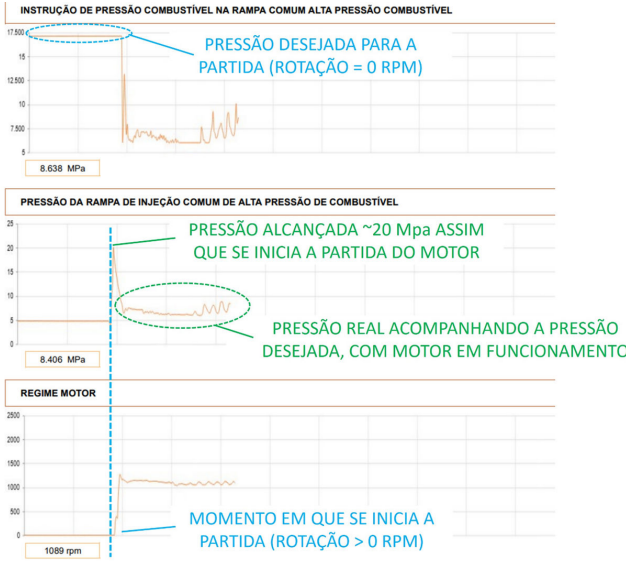
**Fig. 3**  
Engine Start Without Failure

Partida do motor de um veículo **SEM** falha
