**Technical Service Bulletin (TSB)**  
**Missing Hood Silencer Pad**

| REFERENCE: | TSB: 23-025-26<br>GROUP: 23 - Body | Date: | July 11, 2026 | REVISION: | 23-027-22 |
| VEHICLES AFFECTED: | 2022 (B1) Jeep Renegade<br>This bulletin applies to vehicles built on or after February 03, 2022 (MDH 0203XX) and on or before June 07, 2022 (MDH 0607XX). | | | MARKET APPLICABILITY:<br><div><input type="checkbox"/> NA<input type="checkbox"/> CH</div> <div><input type="checkbox"/> EE<input type="checkbox"/> IAP</div> <div><input checked="" type="checkbox"/> SA<input type="checkbox"/> MEA</div><br><b>NOTE:</b> This bulletin applies to the South America markets. | |

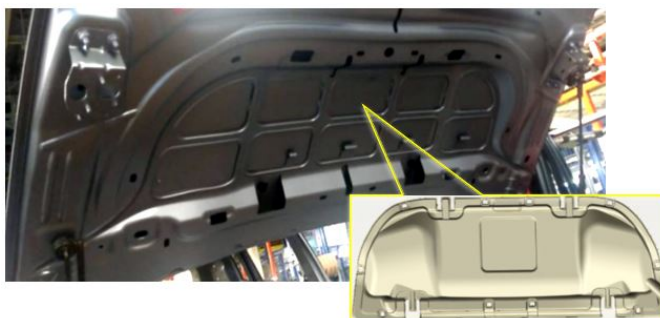
**Fig. 1**  
Location For Silencer Pad

| CUSTOMER SYMPTOM: | Customers may comment on the following: <ul style="list-style-type: none"><li>Hood silencer pad is missing.</li></ul> | | | | |
| CAUSE: | Lack of assembly | | | | |

1. Install missing hood silencer. Refer to the detailed service procedures available in DealerCONNECT> Service Library under: 23 Body / Hood / Hood / Installation > Step 6 [Fig. 1](#).
