## Technical product information

| Topic | DTC P096C00 and / or P096F00 evident within the Engine Control Module |
| Brand | Bentley |
| Transaction No. | 2075941/4 |

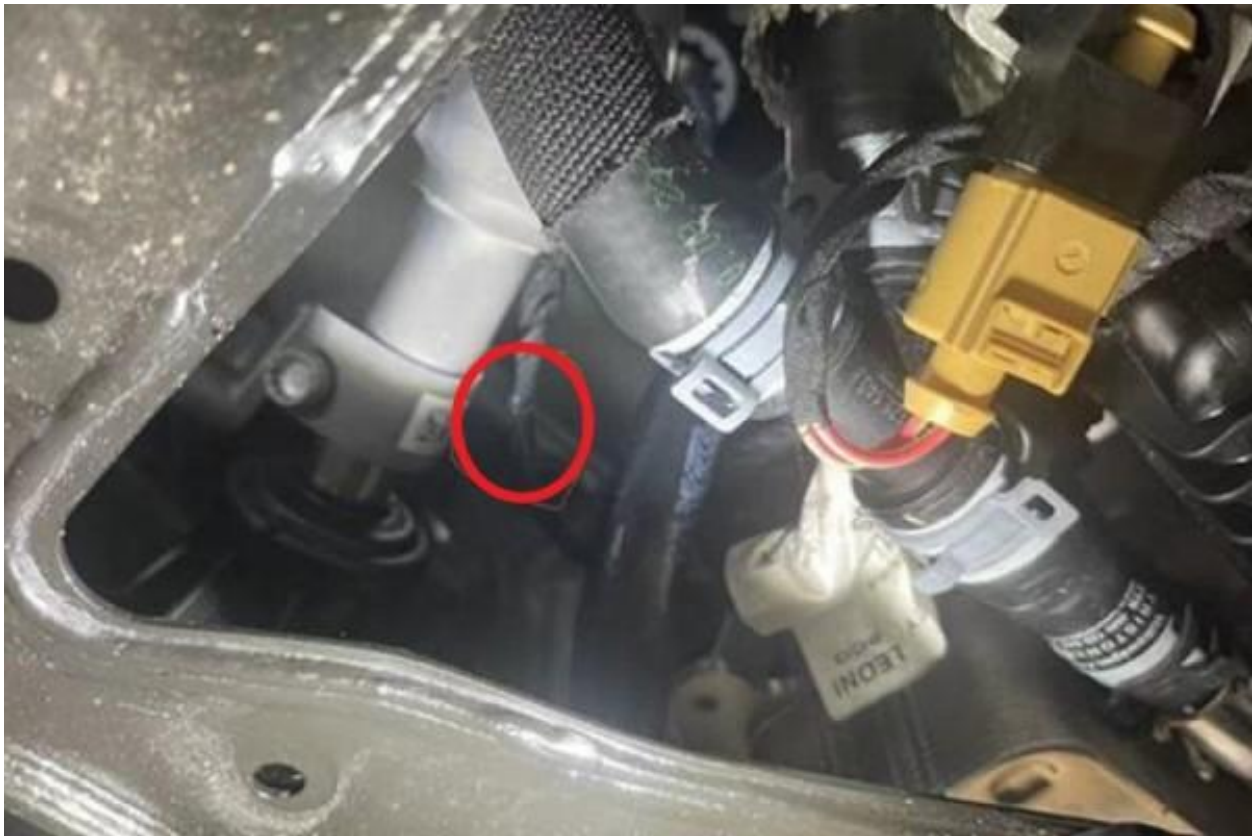
Figure1

2) Referring to Figures 1, 2 and 3 - Conduct a visual inspection to confirm if the harness shown (CIRCLE) has any damage relating to contact with the steering shaft .

**In the event the issue is as described the operative must conduct the remaining instructions (step 3 and 4) to completion and repair the damaged cable(s)**

- 3) Referring to Rep.Gr 97 - Wiring harness repairs - Repair the damaged wiring using the VAS 1978B wiring repair kit
- 4) Secure the harness as shown in Figure 4
