# Service Bulletin

## TSB-2026-ASC-003-R0

## Trunk Socket Modification

**Applies To:** All Current Ascent Vehicles

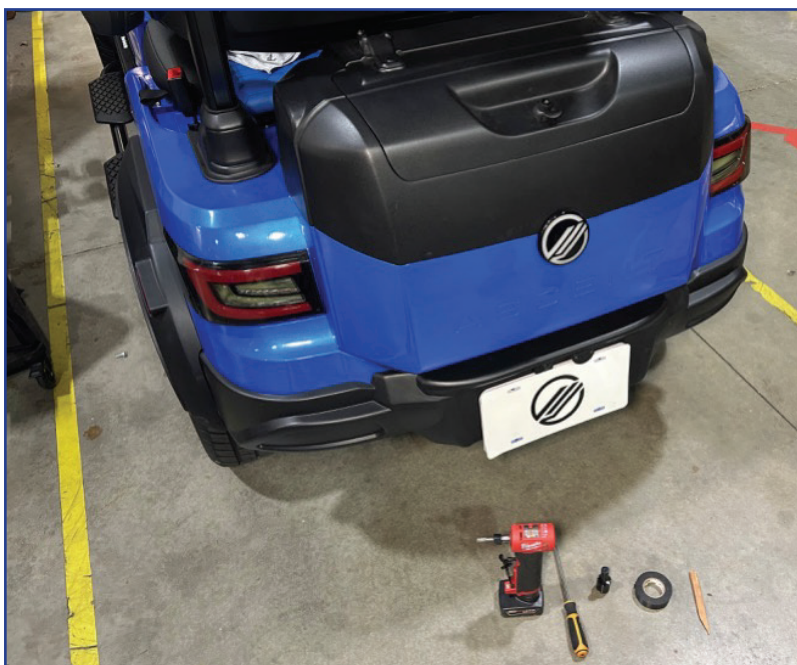
The Ascent has an electrical connector/socket under the rear trunk to power the lighted rear emblem, this socket is located above a rear bracket, the hole in the bracket the wiring runs through is too small and contacts the wire going into the socket.

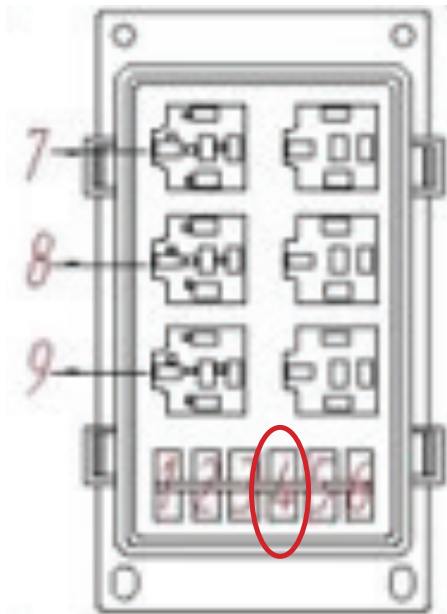
## Fuse Troubleshooting

If the socket becomes shorted, this is the fuse that will be affected.
