| <b>Topic</b> | HVAC failing to cool DTC B16A1F0 in diagnostic address 00C5 Bentayga Series (Hybrid) |
| <b>Transaction No.</b> | 2071190/4 |

HVAC failing to cool | DTC B16A1F0 in diagnostic address 00C5 | Bentayga

Release date: 16 Jul 2026

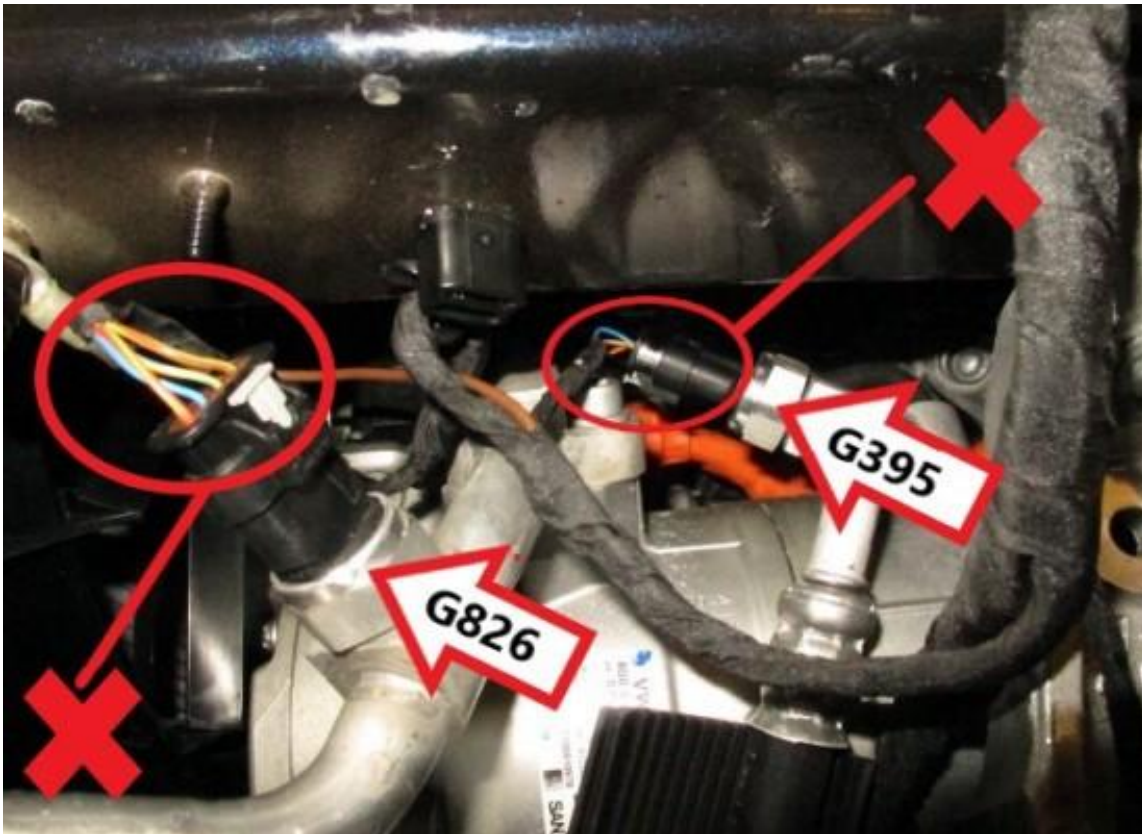
- 1) Referring to Rep.Gr 44 - Remove the left hand front wheel
- 2) Referring to Rep.Gr 66 - Remove the left hand front foremost wheel arch liner
- 3) Remove (x3) speaker box fixings (5Nm)
  - Disconnect the speaker box electrical connector
  - Remove the speaker box
- 4) Access can now be gained to the required connector plugs - Figure 1 shows G826 and G395 with the connector plugs fitted incorrectly
  - Low pressure sender G826 connector plug with 4 wires **(Incorrect)**
  - High pressure sender G395 connector plug with 3 wires **(Incorrect)**

In the event the pressure sender connector plugs are fitted incorrectly the plugs should be disconnected and refitted correctly as shown in Figures 2 and 3

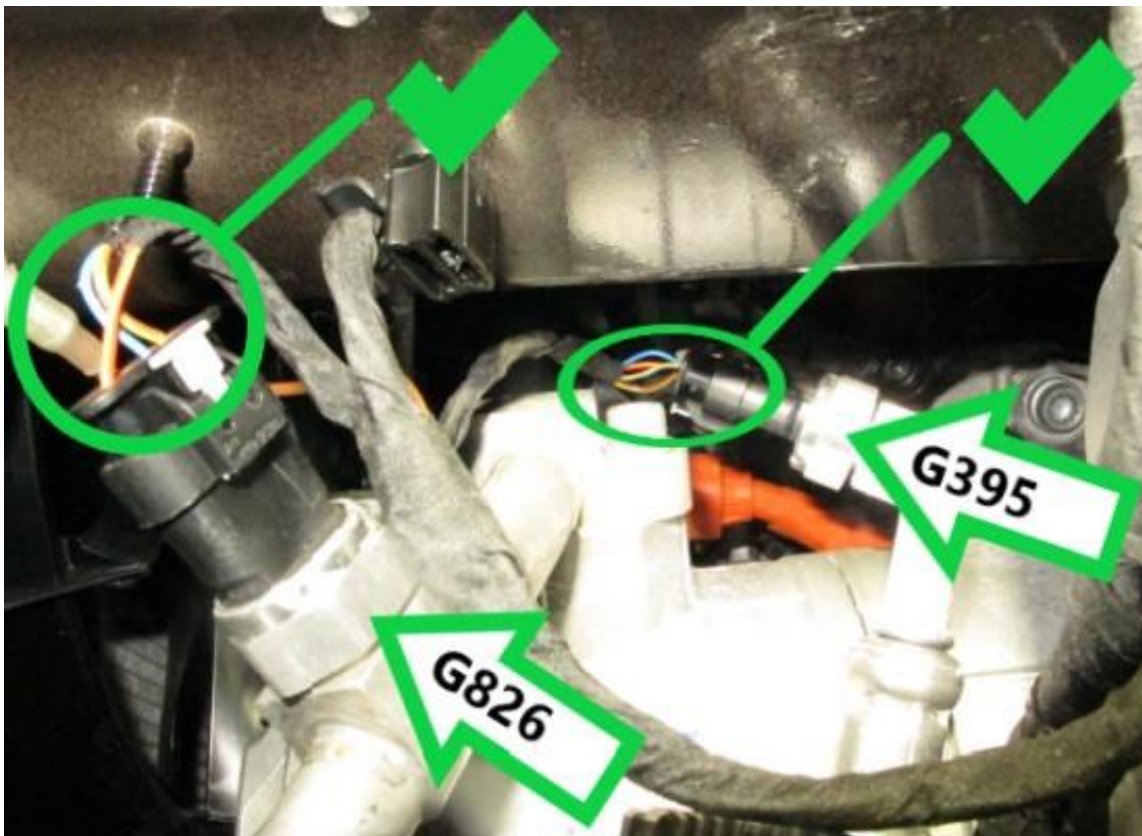
- Figure 2 shows G826 and G395 connector plugs fitted correctly
- Low pressure sender G826 connector plug with 3 wires **(Correct)**
- High pressure sender G395 connector plug with 4 wires **(Correct)**

- 5) Once the orientation of the connector plugs is correct - Refit all previously components
- 6) Check the HVAC system is operating to specification

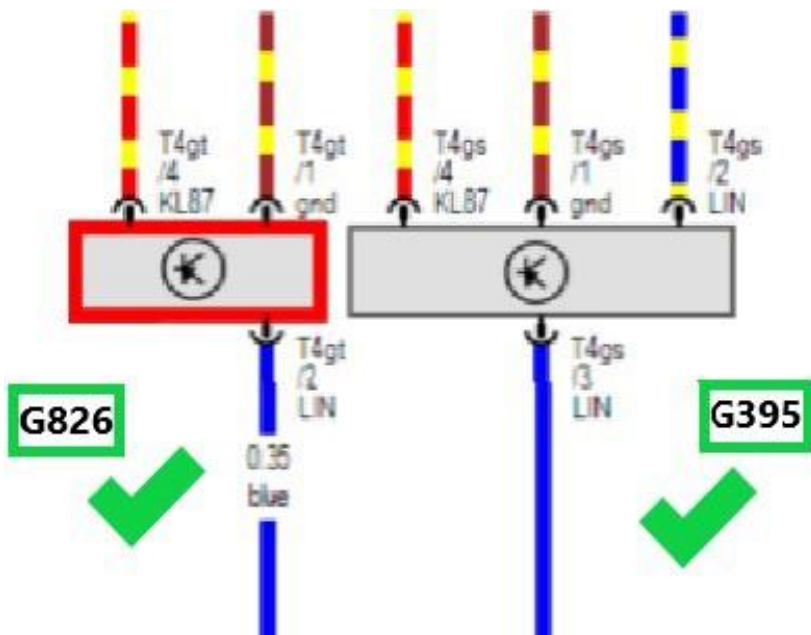
Hint: Figure 3 shows G826 and G395 as per the applicable Current Flow Diagram (Correct)
