| | ELE | 2027MY<br>Telluride Hybrid<br>(LQ2AH) |
| | 267 | July 2026 |
| SUBJECT: <b>CRANKCASE EJECTOR<br/>INSPECTION/REPLACEMENT (SA650)</b> | | |

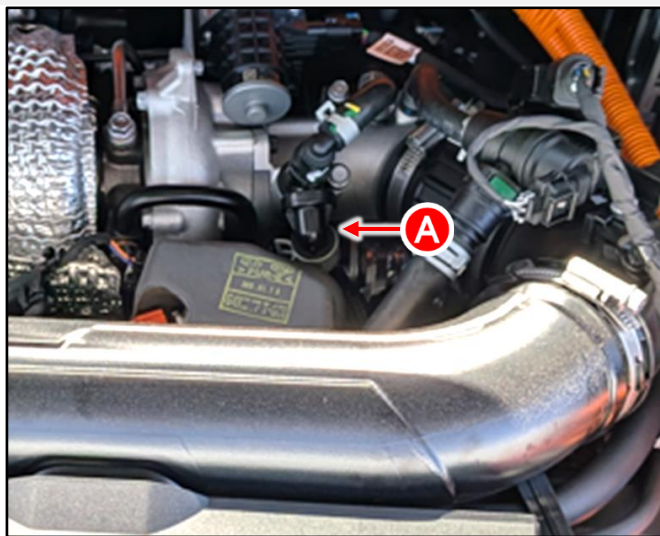
1. Open the hood and locate the crankcase ejector (A).

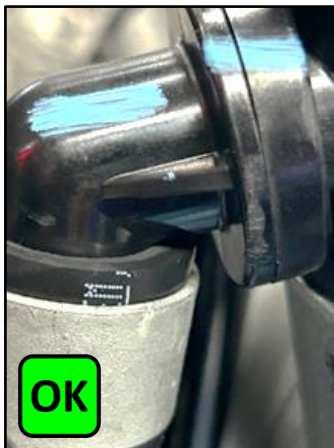
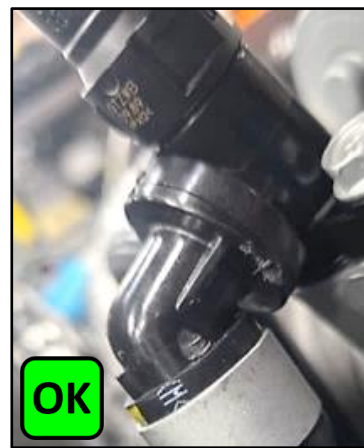
- If the crankcase ejector is not cracked or broken (OK), then the inspection is complete. Claim labor operation code 260A2010 only.

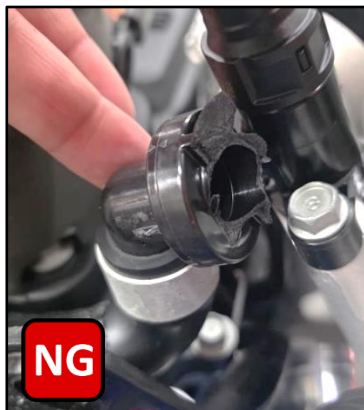
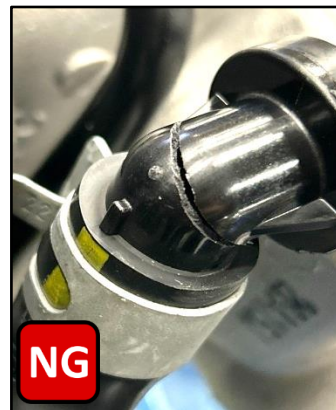
- If the crankcase ejector is cracked or broken (NG), then proceed to ejector assembly replacement.
