# Fifth Gen Cascadia Turn Signal/DRL - Update

Date: 07/14/2026  
CAL FTL 54-043\_REV1

### Subject: 5<sup>th</sup> Generation Cascadia Headlamp Turn Signal Not Functioning

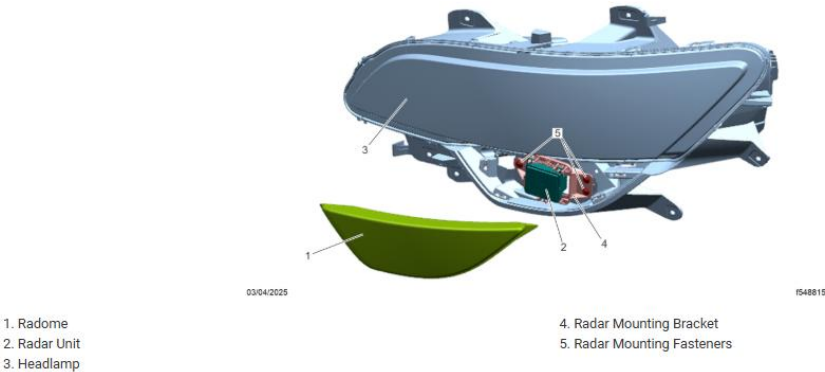
**Root Cause:** Solder delamination on PCB due to thermal fatigue

Status Update:  
Solder improvement created a part number change from A66-20649-008/009 to 010/011 (blue)  
New higher efficiency LED was implemented to use less current. This will be marked by deviation number PDNY01+D4  
In short: p/n **A66-20649-010 or 011 w/ PDNY01+D4 is a good part** or A66-20649-012 or A66-20649-013 once they are available. These do not need replaced

Headlamp assembly image showing new p/n

**Correction:** Follow CAL 054-043. Make sure you have part before downing a truck.  
Replace the headlamp assembly.

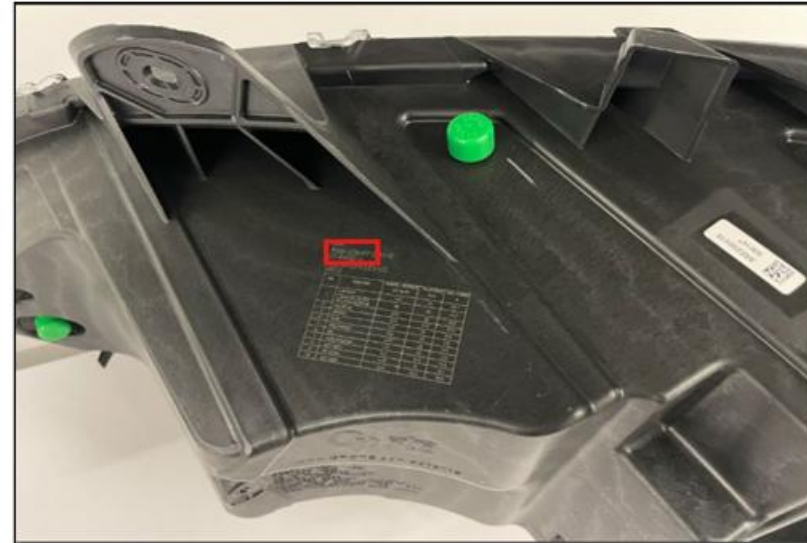
1. Park the vehicle on a level surface, shut down the engine, and set the parking brake. Chock the tires.
2. Identify the headlamp part number (A66-20649-XXX) by locating the part number stamp on the top of the headlamp housing.

3. If the part number is A66-20649-006 through A66-20649-009, it is a suspect part and should be replaced.
