**Complaint - Battery Low and Yellow Warning Message "Battery low \_ Service necessary" in Instrument Cluster: Re-Programming Gateway Control Unit (Battery Sensor) (168/18)**

Model Year: **As of 2018 up to 2019**

Model Line: **Cayenne (9YA)**

Subject: **Battery Sensor**

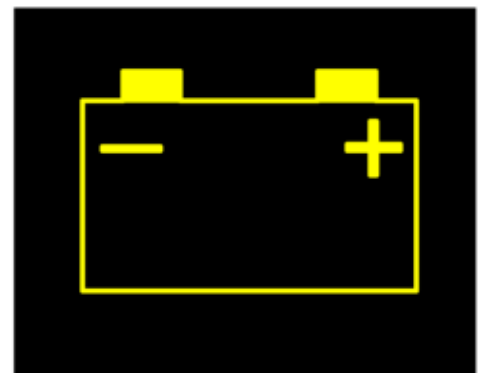
**In the event of a customer complaint** about a **flat battery** and if the yellow warning message "**Battery low \_ Service necessary**" (⇒ *Yellow warning message: Battery low \_ Service necessary*) appears in the instrument cluster, the following points must be observed before doing any other work:

- A chain of different factors can cause an increased closed-circuit current (greater than 1.0 A) after charging.
- A **battery sensor software version lower than "1000"** can bring about this symptom.
- In the event of a customer complaint and if the **battery sensor software version in the gateway control unit is lower than "1000"**, **re-program** the **battery sensor** as described in the "Procedure" section.

*Yellow warning message: Battery low \_ Service necessary*
