| Technical Service Bulletin: TSB260114 | Released Date: 27-Jul-2026 |

## MCI Motor Coach - Water Manifold Coolant Leak – Repair Procedure

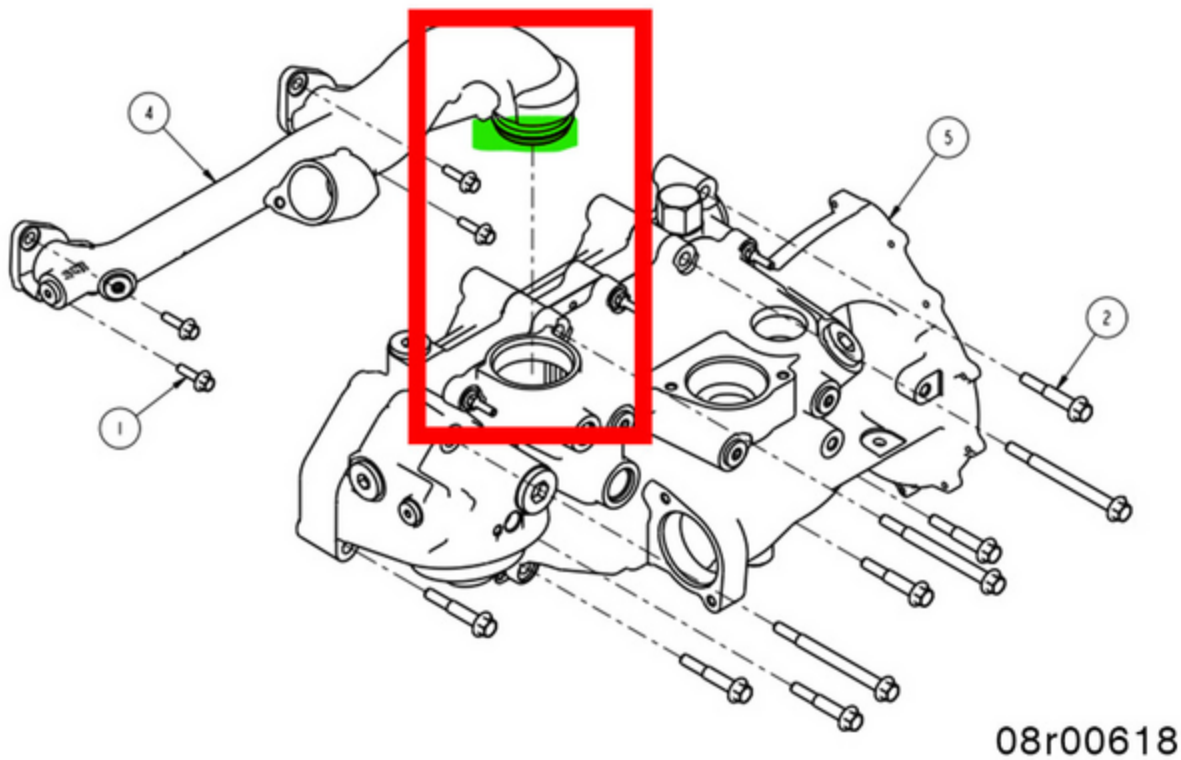
Figure 1, Coolant Leak Location Root Cause:

- External Coolant Leak

- Water manifold connection is **not** in specification. This issue affects engines in Motor Coach Industries® (MCI) Motor Coach **only**.

- If the connection shown in Figure 1 is leaking coolant and there is **not** a paint mark on the top of the water manifold, the manifold is **not** in specification.

- Replace water manifold, diamond ring seals, and o-ring. See Table 1.

- After the water manifold has been replaced; mark the top of the manifold with a paint pen to show the correct water manifold has been installed.
