## Technical product information

| <b>Topic</b> | Window Drop Glass Operation Continental GT/GTC 25-26MY |
| <b>Transaction No.</b> | 2080372/4 |

Window Drop Glass Operation | Continental GT/GTC | 25-26MY

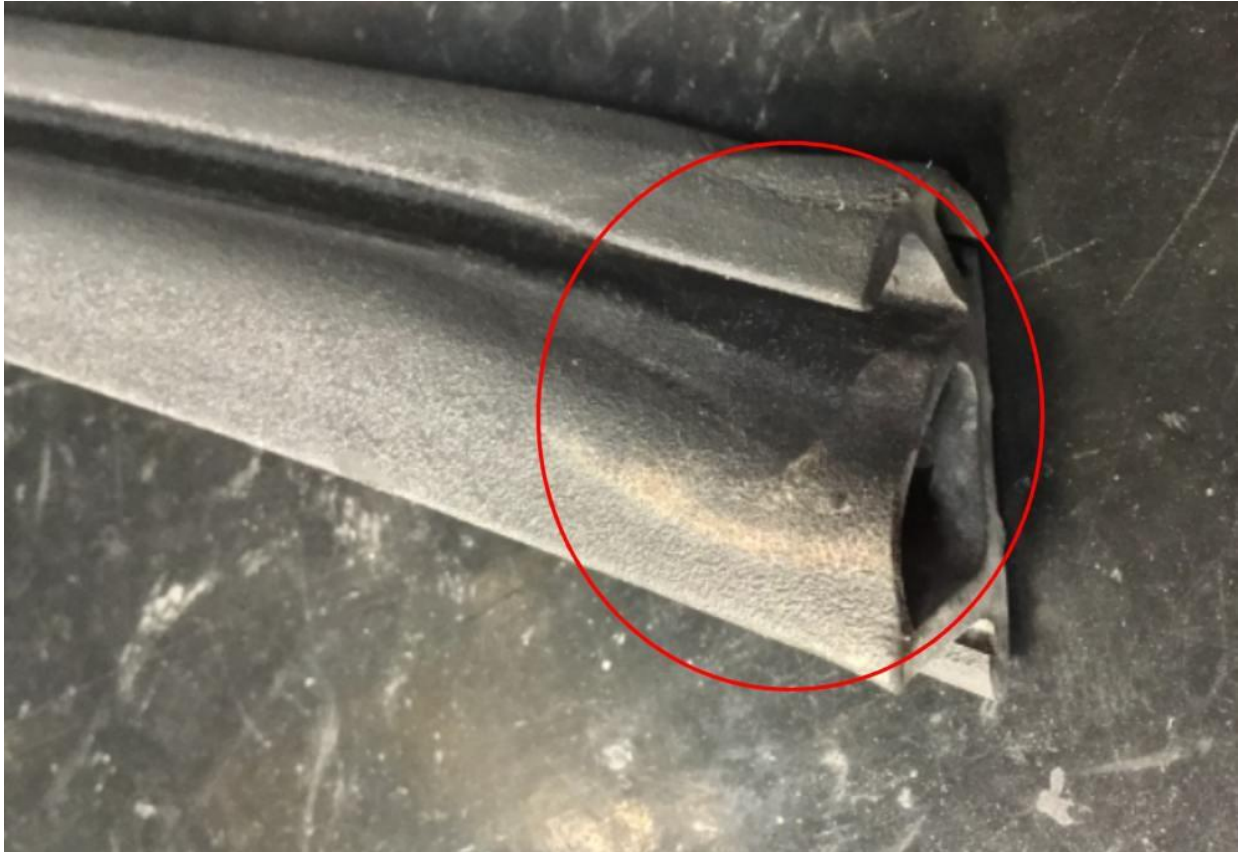
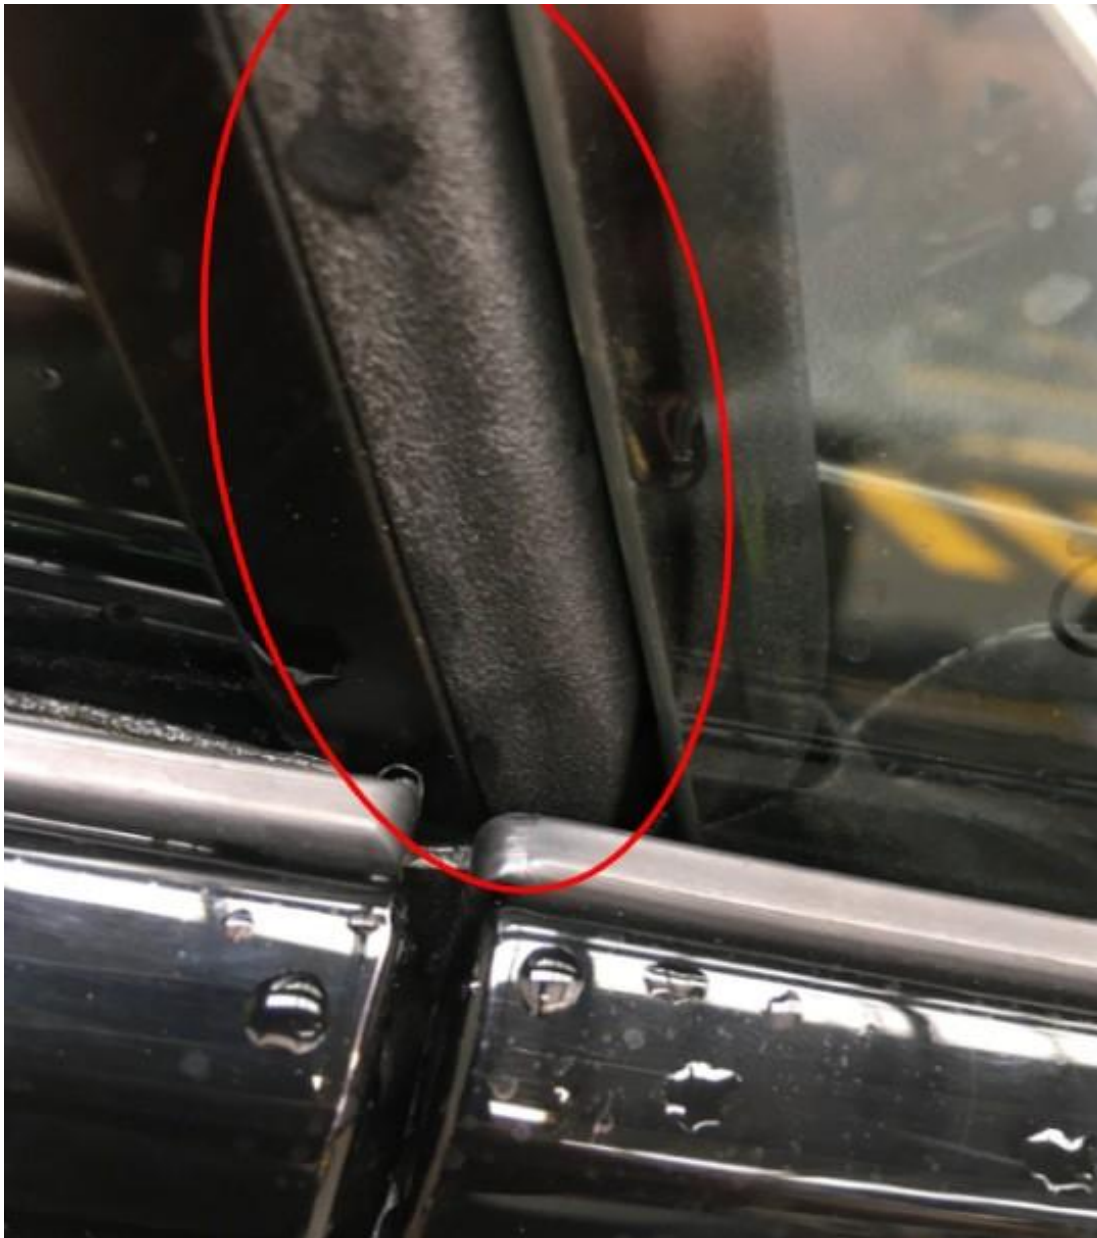
Figure 1

- Damage
- Splits
- Tears
- Misalignment
- Incorrectly fitted / located
- Drop glass seal deformation (see Figures 1 and 2 as examples)

**NOTE:** Any issues found with the window seals must be rectified before conducting the remaining steps

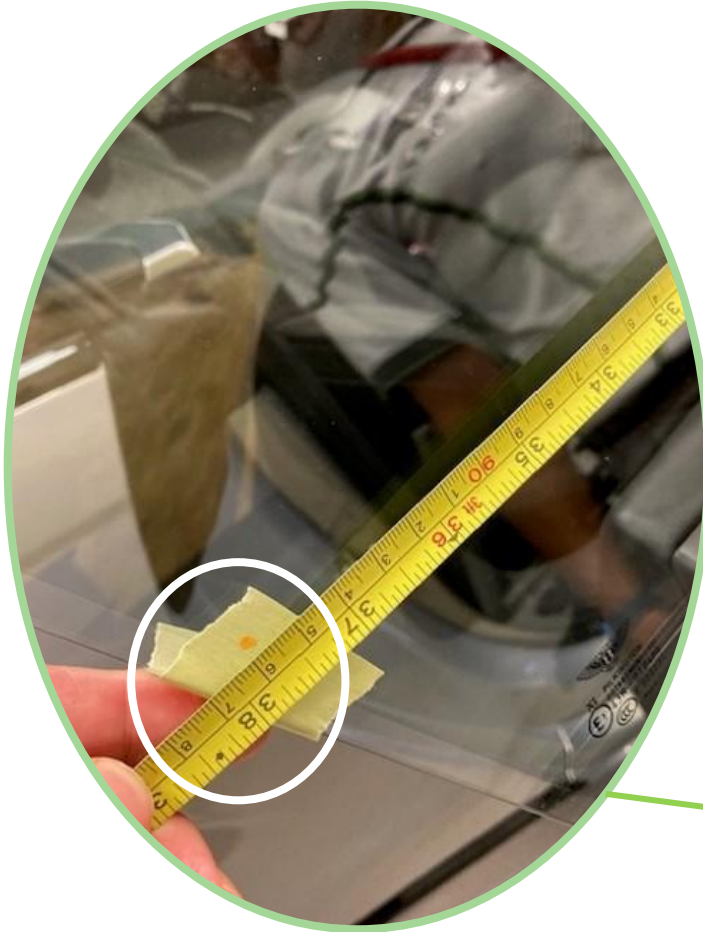
## Measuring from front div bar to rear of the glass

**Specification**  
971mm +2mm

If out of specification, refer to the next slide to adjust the glass position
