# Knocking Noise from Rear Suspension Member Cushion When Turning or Driving on an Uneven Road

**Market** USA and Mexico

**Section** Rear Suspension

Some 2025 model year ES 250, ES 300h, and ES 350 vehicles may exhibit a knocking noise from the cushion of rear suspension member when turning or driving on an uneven road. Follow the Repair Procedure in this bulletin to improve this condition.

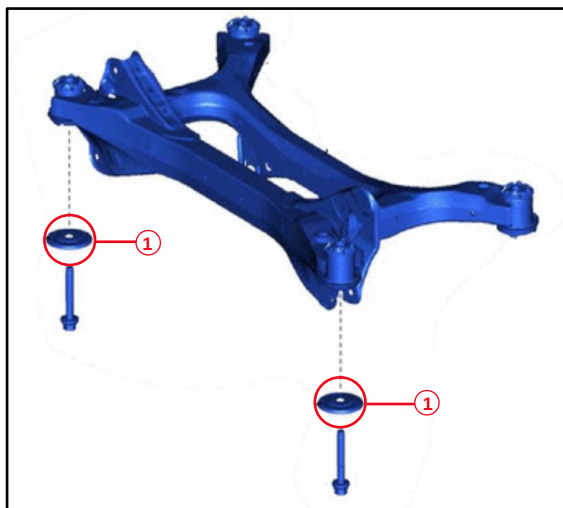
Figure 1.

1 Lower Stopper

2. Inspect two front cushions of the rear suspension member at vehicle installed condition.
  - A. Remove the lower stopper from front cushion.

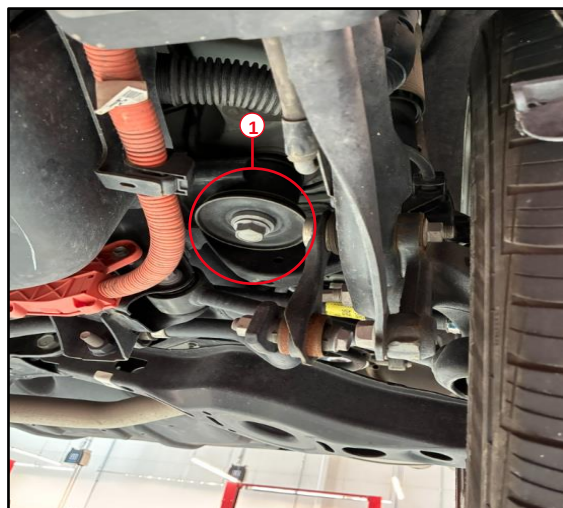
Figure 2.

1 Lower Stopper

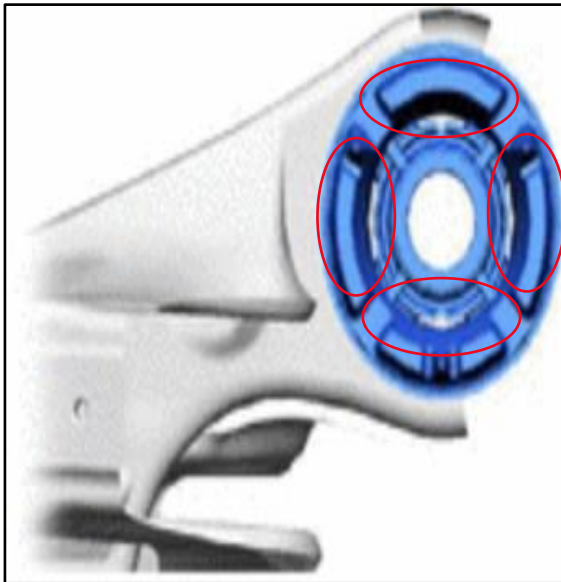
- B. Insert a 0.5 mm (0.02 in.) feeler gauge into four cavities of each cushion.  
Does the feeler gauge hit a metallic object in one of the cavities?
- **YES** — Continue to step 3.
  - **NO** — This bulletin does NOT apply. Continue diagnosis using the applicable Repair Manual.

Figure 3. Cavities in Cushion

3. Replace one or both sides of the front body mounting cushion(s) with the NEW part listed in the Parts Information table.

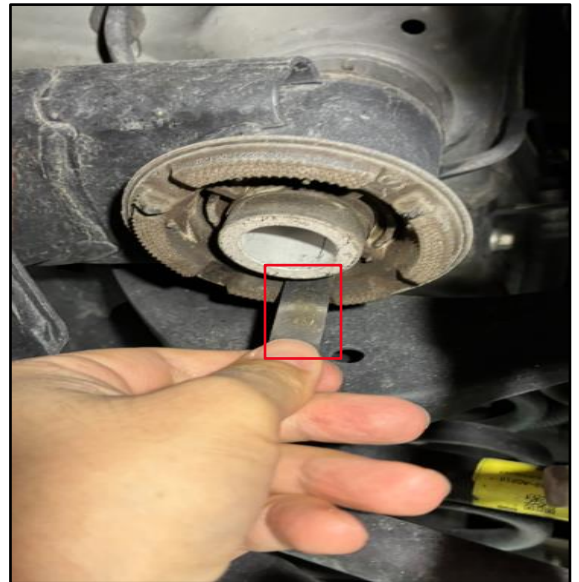
Figure 4. Feeler Gauge
