**TECHNICAL INSTRUCTIONS**  
**FOR**  
**EMISSION NONCOMPLIANCE RECALL 26TC03**  
**Certain 2022 – 2025 Model Year RAV4**  
**Incorrect Mass Air Flow Sensor Reading**

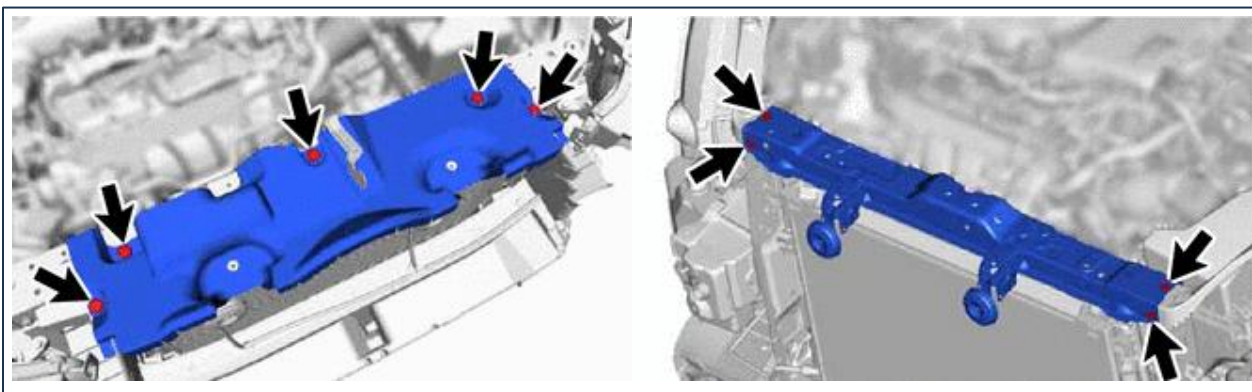
| 1 | UPPER RADIATOR AIR GUIDE PLATE |
| 2 | RADIATOR SUPPORT SUB-ASSEMBLY |
