**Technical Service Bulletin (TSB)**  
**AWD Drivetrain Control Module (DTCM) Reconfiguration**

| REFERENCE: | TSB: 08-307-26<br>GROUP: 08 - Electrical | Date: | August 5, 2026 | REVISION: | — |
| VEHICLES AFFECTED: | 2026 (KM) Jeep Cherokee<br>This bulletin applies to vehicles built on or after January 02, 2025 (MDH 0102XX) and built on or before July 16, 2026 (MDH 0716XX) equipped with a Jeep Active Drive I (Sales Code DK2). | | | MARKET APPLICABILITY:<br><div><input checked="" type="checkbox"/> NA<input type="checkbox"/> MEA<br/><input type="checkbox"/> SA<input type="checkbox"/> IAP<br/><input type="checkbox"/> EE<input type="checkbox"/> CH</div><br>NOTE: This bulletin applies to the North American market. | |

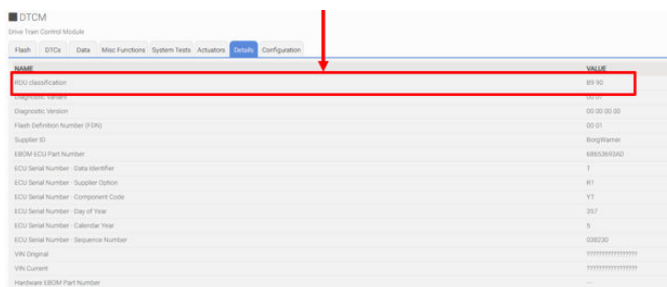
**Fig. 1**  
wiTECH Display

- Using wiTECH, Inspect the RDU Classification Code located under the details tab of the DTCM.

- Is the Current Class Code 6844?

- YES>>> Proceed to [Step 5](#).
- NO>>> Proceed to [Step 3](#).

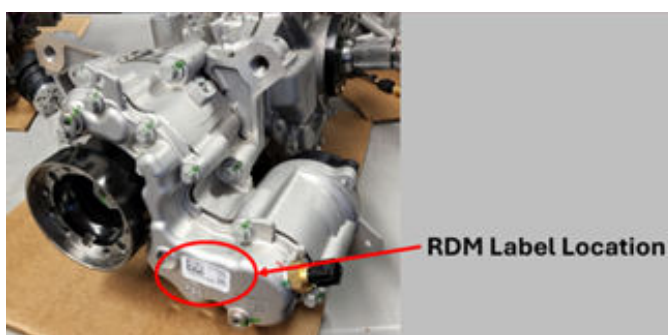
**Fig. 2**  
RDM Label Location

3. Raise the vehicle, record the Classification Code from the RDU Part Number Label.

4. Does the RDU Classification value from wiTECH match the recorded value from the RDU label?
  - YES>>> No further action is required. Use the Inspection LOP (18-19-07-BL) to close this active RSU.
  - Proceed to [Step 5](#).
5. Using wiTECH, located under the “Misc. Functions” tab of the DTCM, depending what option is presented, select "Program RDU Factory Classification Code" or “Program RDU Classification Code” and follow the screen prompts.
6. Disconnect wiTECH POD, turn ignition to the OFF position, allow the vehicle to go to sleep. (Cluster and PRND lights will go out).
7. Using wiTECH, located under the “Details” tab of the DTCM, verify the RDU Classification Code was successfully written.
8. Clear any DTCs that may have been set.
