**Technical Service Bulletin (TSB)**  
**Umbrella Valve Seal Missing From Cylinder Head Cover**

| REFERENCE: | TSB: 09-017-26<br>GROUP: 09 - Engine | Date: | August 5, 2026 | REVISION: | — |
| VEHICLES AFFECTED: | 2026 - 2027 (WL) Jeep Grand Cherokee / Grand Cherokee L<br>This bulletin applies to vehicles built on or before August 15, 2026 (MDH 0815XX) equipped with a 2.0L Hurricane 4 Turbo W/ESS (Sales Code EC7). | | | MARKET APPLICABILITY:<br><div><input checked="" type="checkbox"/> NA<input type="checkbox"/> MEA</div> <div><input type="checkbox"/> EE<input type="checkbox"/> IAP</div> <div><input type="checkbox"/> SA<input type="checkbox"/> CH</div><br><b>NOTE:</b> This bulletin applies to North America markets. | |
| CAUSE: | Cover Cylinder Head Umbrella valve seal missing | | | | |

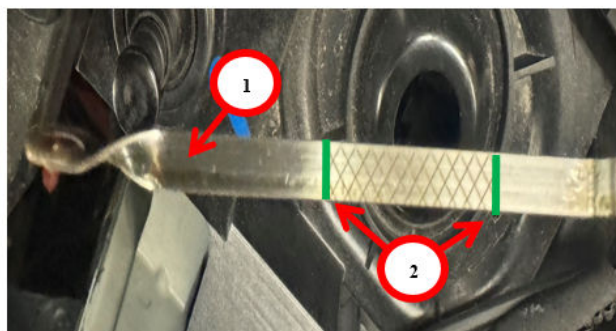
**Fig. 1**  
Oil Level Inspection

1 - Oil Level - Low  
2 - Oil Level - Acceptable Range

2. Is the oil level low [Fig. 1](#)?
  - YES>>> Proceed to [Step 3](#).
  - NO>>> This bulletin has been completed. Use Inspection LOP 09-35-20-98) to close the active RSU.  
**Refer to service library for further misfire diagnosis.**

3. If the engine oil level is found to be low, remove the Positive Crankcase Ventilation (PCV) valve. Refer to the detailed service procedures available in DealerCONNECT/Service Library under: Service Info> 25 - Emissions Control / Crankcase Ventilation / Valve, Positive Crankcase Ventilation (PCV) / Removal and Installation.

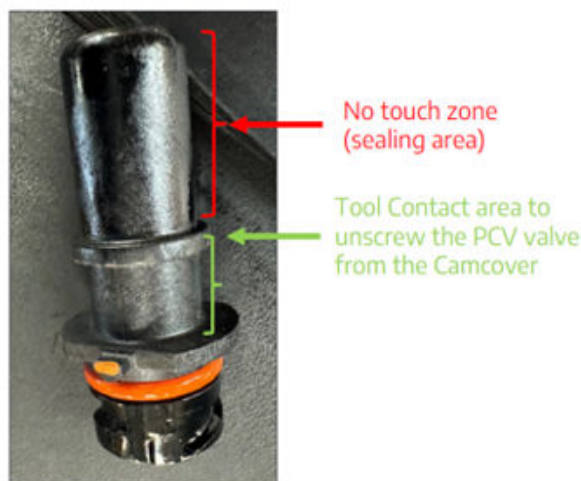
**Fig. 2**  
PCV Valve During Removal

**NOTE: Be sure to follow warnings regarding location on the PCV valve where tool contact should be avoided [Fig. 2](#).**
