## Technical Service Bulletin (TSB)

### Potential Engine Oil Overfill

| REFERENCE: | TSB: 09-019-26<br>GROUP: 09 - Engine | Date: | August 8, 2026 | REVISION: | — |
| VEHICLES AFFECTED: | 2026 (WL) Jeep Grand Cherokee / Grand Cherokee L<br>This bulletin applies to vehicles built on or before July 30, 2026 (MDH 0730XX) equipped with the 2.0L Hurricane 4 Turbo W/ESS (Sales Code EC7). | | | MARKET APPLICABILITY:<br><div><input checked="" type="checkbox"/> NA<input type="checkbox"/> MEA<br/><input type="checkbox"/> EE<input type="checkbox"/> IAP<br/><input type="checkbox"/> SA<input type="checkbox"/> CH</div><br>NOTE: This bulletin applies to North America markets. | |

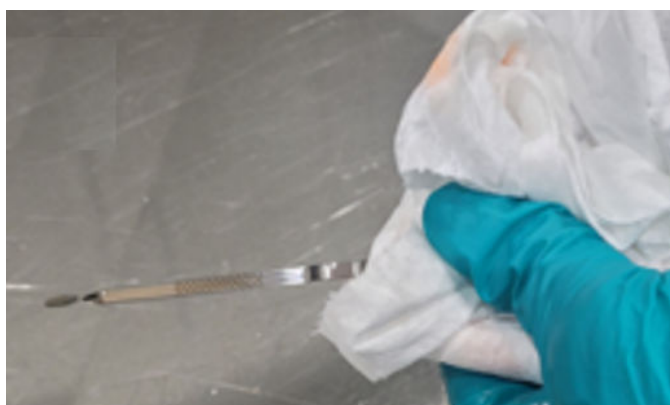
**Fig. 1**

Wipe Oil Dipstick Clean

1. **Ensure the vehicle is on level ground and has either sat overnight or not been run for a minimum of two hours before proceeding.**
2. Open the hood.
3. Pull the engine oil dipstick from the dipstick tube.
4. Clean any engine oil from the engine oil dipstick [Fig. 1](#).

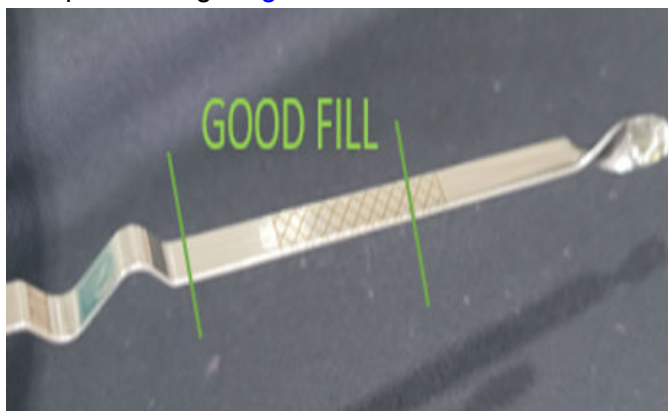
**Fig. 2**  
Engine Oil Level - Acceptable Range

- YES>>> This bulletin has been completed. Use Inspection LOP (09-55-20-90) to close the active RSU.
  - NO>>> Proceed to [Step 8](#).
8. If the oil level is found to be in an unacceptable range [Fig. 3](#), inspect the engine oil level two more times to confirm the oil level. If the engine oil level is still at an unacceptable range, proceed to [Step 9](#).

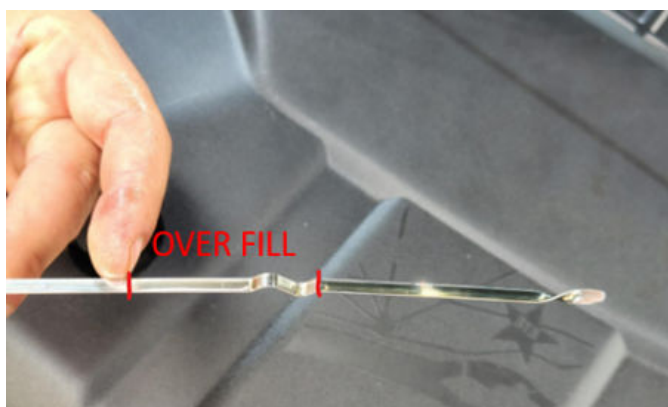
**Fig. 3**  
Engine Oil Level - Unacceptable Range

9. Perform an engine oil and filter change. Refer to the detailed service procedures listed in DealerCONNECT>Service Library>Service Info>under: 09 - Engine, 2.0L / Lubrication / Standard Procedure.
