## Technical Service Bulletin (TSB)

### Alignment Gap And Flush

| REFERENCE: | TSB: 23-030-26<br>GROUP: 23 - Body | Date: | August 7, 2026 | REVISION: | — |
| VEHICLES AFFECTED: | 2025 - 2027 (M1) Jeep Compass<br>2025 - 2027 (N4) RAM Rampage<br>This bulletin applies to vehicles built on or after July 01, 2025 (MDH 0701XX) and on or before July 18, 2026 (MDH 0718XX). | | | MARKET APPLICABILITY:<br><div><input checked="" type="checkbox"/> NA<input type="checkbox"/> CH</div> <div><input checked="" type="checkbox"/> EE<input type="checkbox"/> IAP</div> <div><input checked="" type="checkbox"/> SA<input type="checkbox"/> MEA</div> <p>NOTE: This bulletin applies to the North and South America, and Enlarged Europe markets.</p> | |

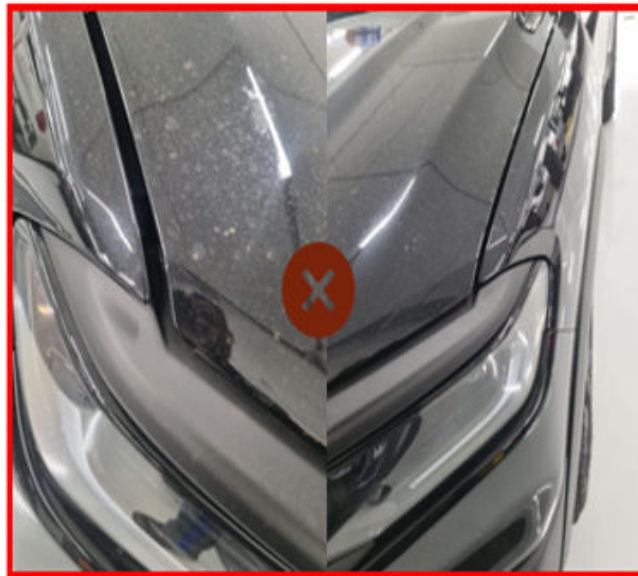
**Fig. 1**

1. Check the relationship between sides so that the deviations are equally distributed [Fig. 1](#).

Irregular Game Hood With Fender

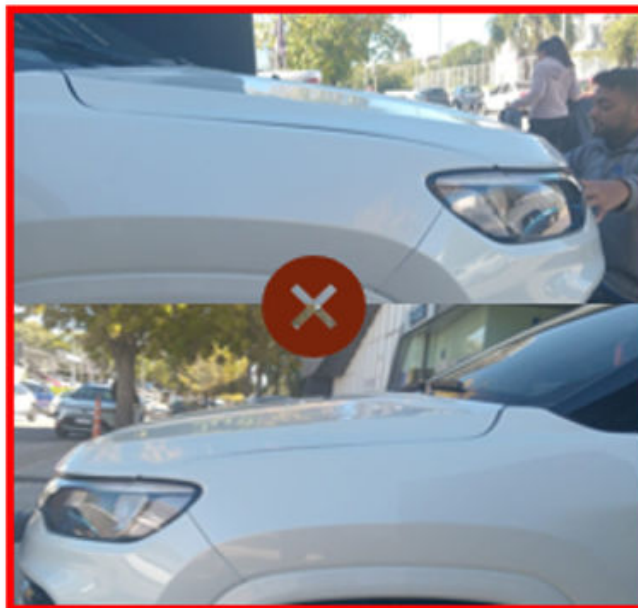
**Fig. 2**

2. Check the relationship between hood and fender [Fig. 2](#).

Irregular Profile Hood With Fender

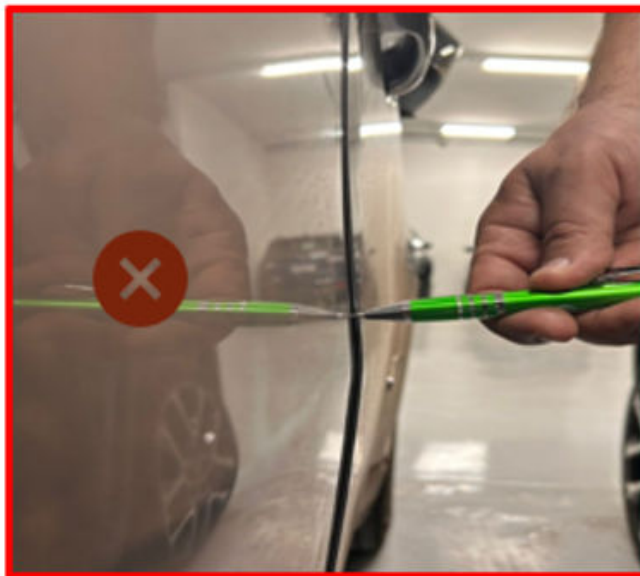
**Fig. 3**

3. Check region between ports (front and back) [Fig. 3](#).

Outstanding Profile Back Holder

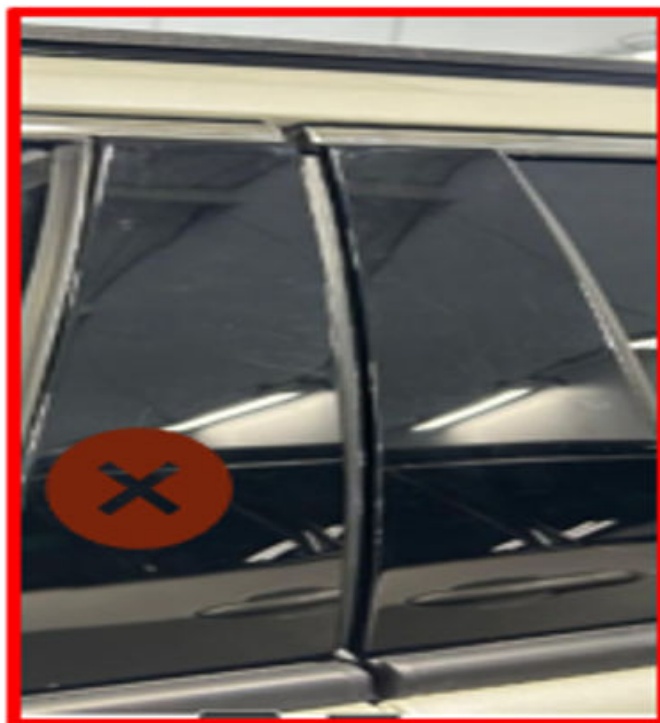
**Fig. 4**

4. Check the relationship between the rear door and the body [Fig. 4](#) and [Fig. 5](#).

Excessive Play Door Frame

**NOTE: For Vehicle Repair Follow The Service Library Guidance procedure 7005A14, 7010A14 and 7025A10.**

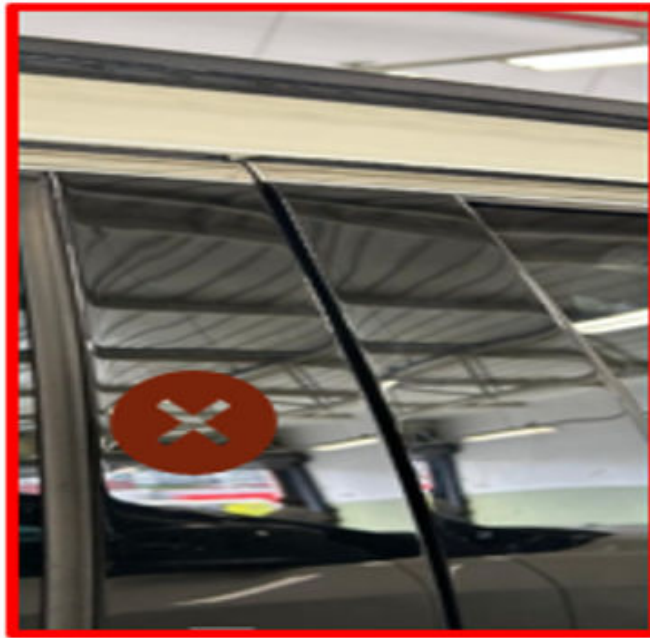
**Fig. 5**  
Closed Game Door Frame
