**Technical Service Bulletin (TSB)**  
**Missing Cargo Boxes**

| REFERENCE: | TSB: 23-032-26<br>GROUP: 23 - Body | Date: | August 7, 2026 | REVISION: | 23-078-23 |
| VEHICLES AFFECTED: | 2023 (B1) Jeep Renegade<br>This bulletin applies to vehicles built on or after March 24, 2023 (MDH 0324XX) and on or before May 25, 2023 (MDH 0525XX). | | | MARKET APPLICABILITY:<br><div><input type="checkbox"/> NA<input type="checkbox"/> CH</div> <div><input type="checkbox"/> EE<input type="checkbox"/> IAP</div> <div><input checked="" type="checkbox"/> SA<input type="checkbox"/> MEA</div><br><b>NOTE:</b> This bulletin applies to the South America markets. | |

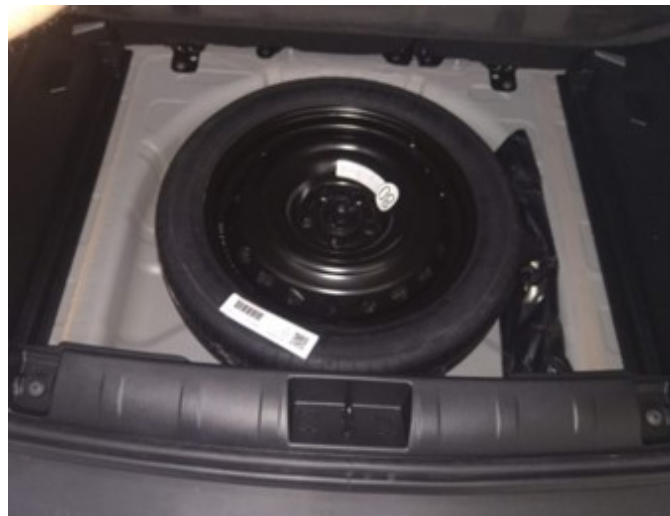
| CUSTOMER SYMPTOM: | Customers may comment on the following: <ul style="list-style-type: none"><li>Excessive noise from the rear of the vehicle.</li></ul> | | | | |
| CAUSE: | Missing cargo boxes Fig. 1 | | | | |

**Fig. 1**  
Cargo Box Missing

This bulletin involves installing cargo boxes to the vehicle.

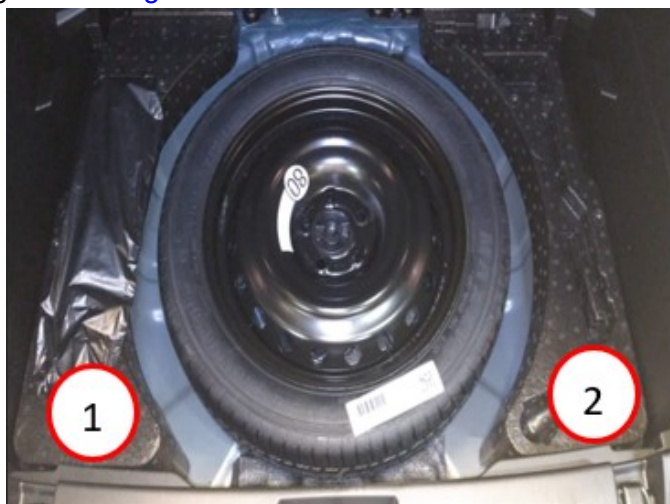
**Fig. 2**  
Cargo Boxes Installed

1 - Left Cargo Box  
2 - Right Cargo Box

1. Open the liftgate.
2. Lift up on the load floor.
3. Install the left and right cargo boxes [Fig. 2](#).
