# Service Bulletin

Bulletin No.: PIC6654A

**Subject:** Blank Head Up Display (HUD) Screen

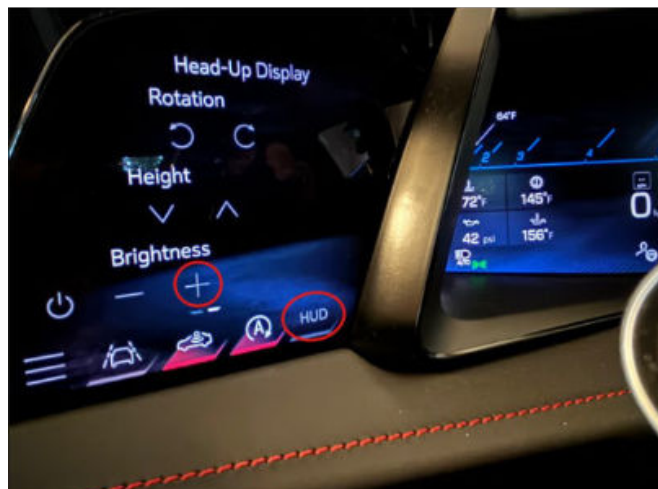
7162922

| <b>Condition</b> | Some customers may notice a blank Head-Up Display (HUD) on the windshield that does not recover. He or she may comment that it is simply inoperative or appears to be broken. |
| <b>Cause</b> | Engineering is currently investigating an anomaly in the radio system that affects how the previously selected HUD brightness level is stored and retained across ignition cycles. |

Using the HUD control panel in the outboard auxiliary display screen, located to the left of the main IPC screen, swipe left to access the HUD controls, then tap the brightness "up" button until the HUD image reappears.

Do not replace the HUD or Radio (Vehicle Control Unit) for this condition, as it will not permanently solve the problem. Engineering is currently working on this concern. In the meantime, please advise the customer that they may continue to drive the vehicle. To reduce the likelihood of having a customer experience this issue while a fix is being developed, please perform the following actions. First, while the HUD is showing, increase or decrease the brightness level by three taps and then resave the memory position for the transmitter number (driver 1 or driver 2) that is currently being used. Repeat this step for the other memory position. Saving the HUD brightness setting to a different position may help to alleviate this concern. The PI will be updated with additional information as it becomes available, or it will be replaced with a TSB once a permanent fix has been released.
