**TECHNICAL SERVICE BULLETIN, VIN:  
SB-81 Allegro Bus 45 BP, Opening in D/S Wheel Well**

### **Technical Service Bulletin SB-81 Repair Instructions**

Models Involved: 2026 & 2027 45 BP Allegro Bus Motorhomes

Purpose: To cover an opening in the drivers' side rear wheel well.

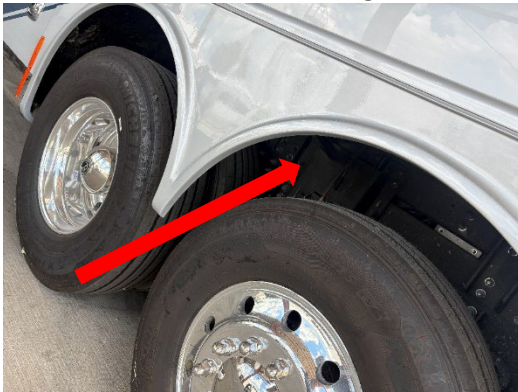
1. Inspect driver's side wheel well. See Figure 1A & 1B.

Figure 1A - D/S wheel well

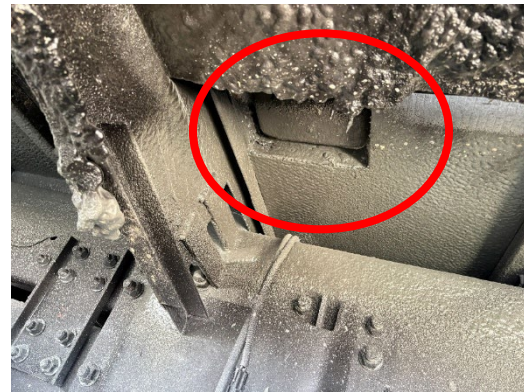
Figure 1B needs plate installed

1. Install part #5197384 to cover the hole. Install with at least 6, 1" self-tapping wood screws, but use more if needed. Make sure to install a screw in each corner.
2. Use Quad or Silicon caulk to seal the edges, see Figure 2 for repaired wheel well.
