## Engine, crankcase ventilation, oil leakage

V-257-001

(August 2026)

This TSB is valid for Volvo trucks.

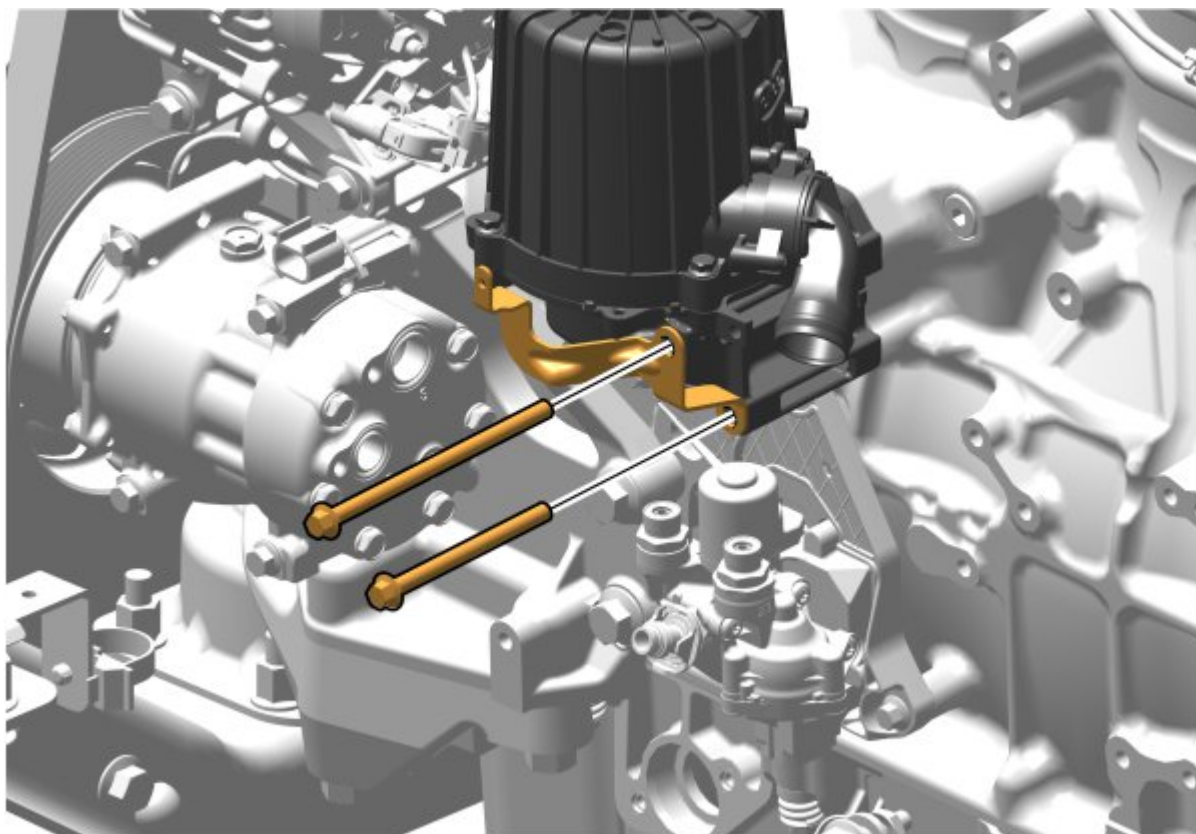
Loose CCV mounting bolts and oil leak at CCV due to cracking of the housing. Mounting hardware found to be under-torqued after the vehicle was delivered.

If the CCV is found to be leaking or cracked due to loose mounting hardware, replace the alternator cable bracket (24927871), which is mounted using the CCV housing bolts, with the new-design bracket (26096433). If CCV damage is found, the CCV must be renewed following IMPACT operation ID 2571-03-02-03 or 2571-03-03-01.
