## 247 (GLA/GLB) - Rearview Camera Noise Optimization

| Topic number | LI54.71-P-080349 |
| Function group | 54.71 - Camera and radar-assisted assistance systems |

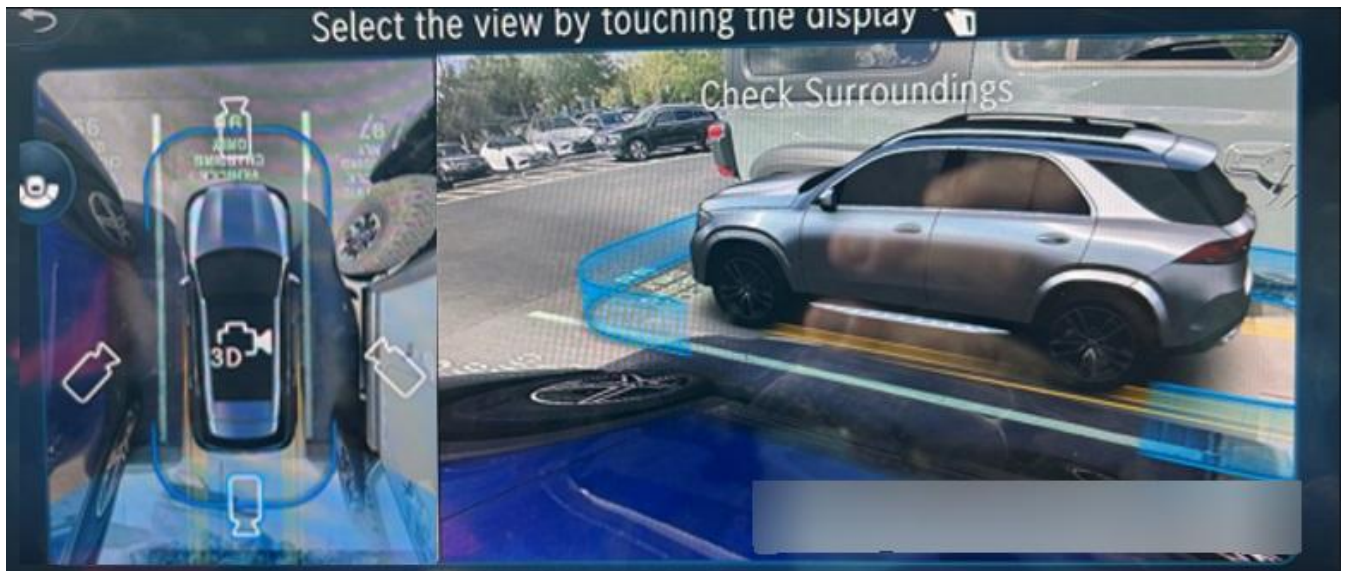
### View PRIOR to SCN Coding:

After both control units have been SCN coded, the "Movable 3D View" feature in the head unit will no longer be available. With this change there will be two distinct differences:

- 1) The "3D" icon when in the top down vehicle view, will no longer be present on the head unit.
- 2) The digital rendering of the vehicle with the ability to spatially move around the vehicle is no longer possible. This view is replaced with 2D static images of the left and right sides.
