| | | <b>Tesla, Inc.</b><br>Service Bulletin | | <b><i>Inspect Door Assemblies For Low-Pitched Noises And LH Side Mirror Shaking</i></b> | |
| SB-25-10-002 R2<br>August 14, 2026 | | | | | |

On some Cybertruck vehicles, customers may experience low frequency shaking, rattling, and/or vibrations at the door assemblies and/or LH side mirror when the vehicle is driven at high speeds.

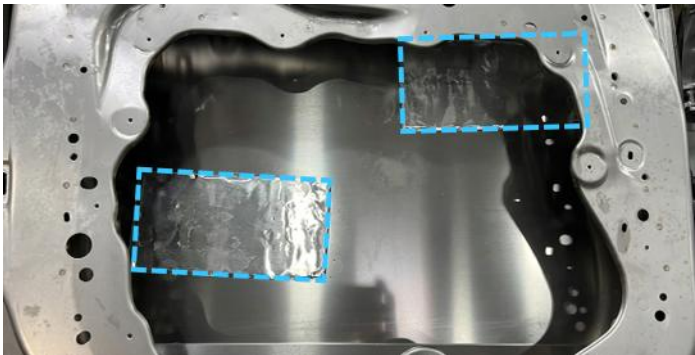
| Butyl Layout on Door Panel | Butyl Rework Required? | | Adhesive Rework Required? | | Instructions |
|---|---|---|---|---|---|
| <p><b>Figure 1 – Original Butyl Layout:</b> 2 butyl patches positioned diagonally across from each other</p> | Yes | Depends on symptoms | Yes | Depends on symptoms | <ul style="list-style-type: none"> <li>Skip to the <a href="#">“Rework Front Door Butyl Patches (Original Butyl Layout)”</a> section</li> </ul> |

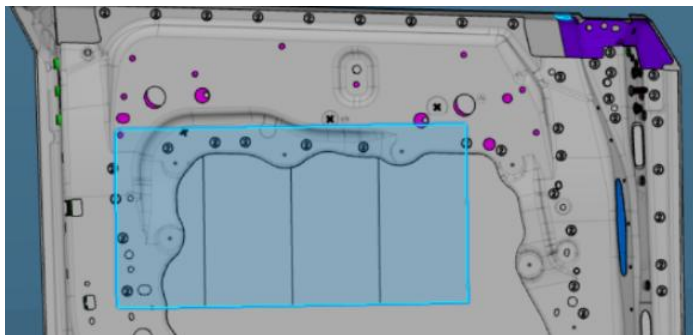
| Butyl Layout on Door Panel | Butyl Rework Required? | | Adhesive Rework Required? | | Instructions |
|---|---|---|---|---|---|
| <p><b>Figure 2 – Updated Butyl Layout A:</b> 4 vertically oriented butyl patches positioned side-by-side</p> | Yes | No | Yes | Depends on symptoms | <ul style="list-style-type: none"> <li>Skip to the <a href="#">“Rework Front Door Butyl Patches (Updated Butyl Layout A)”</a> section.</li> </ul> |

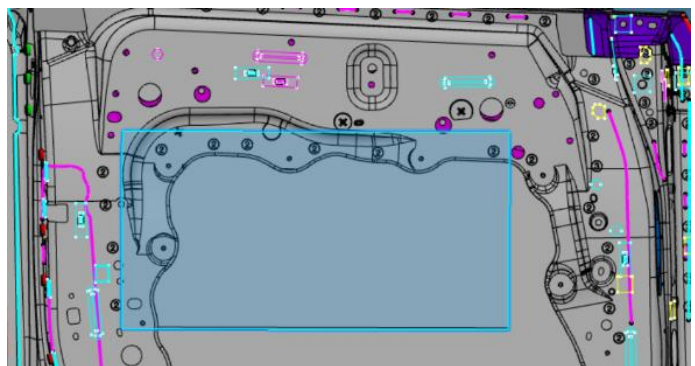
| Butyl Layout on Door Panel | Butyl Rework Required? | | Adhesive Rework Required? | | Instructions |
|---|---|---|---|---|---|
| <p><b>Figure 3 – Updated Butyl Layout B:</b> 1 large butyl patch</p> | No | No | Yes | Depends on symptoms | <ul style="list-style-type: none"> <li>Skip to the <a href="#">“Determine Next Steps (Updated Butyl Layout B)”</a> section.</li> </ul> |

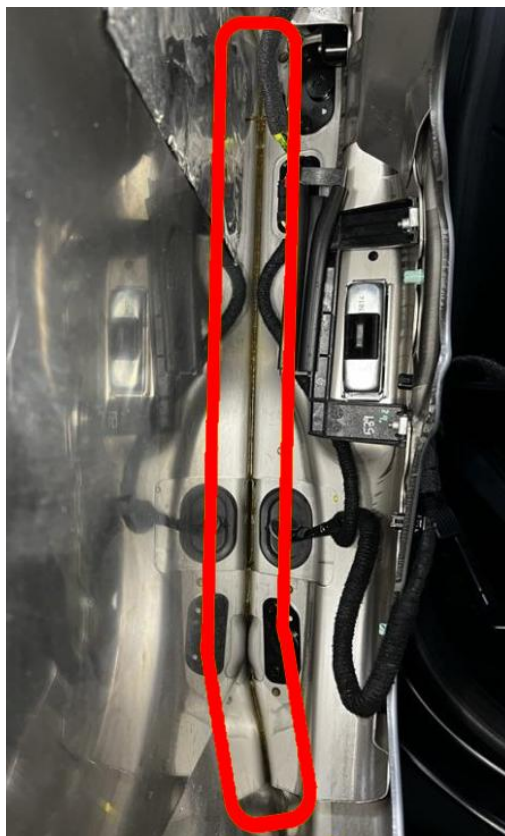
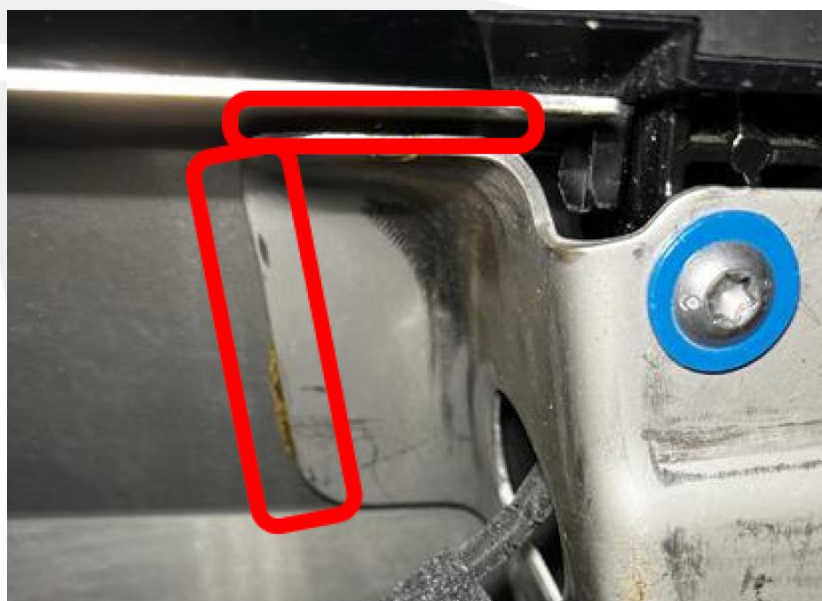
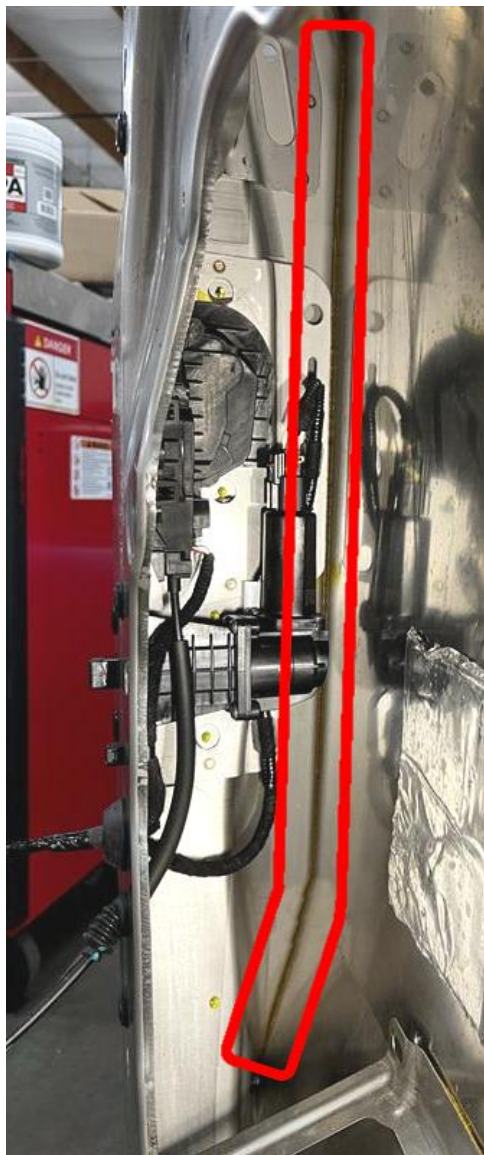
Figure 10 – Reinforcement bracket at front end of front door; rear door similar

Figure 11 – LH side mirror bracket at front end of front door

**Figure 12 – Reinforcement bracket at rear end of front door; rear door similar**

32. Use the wire brush, gasket scraper, and IPA wipes to remove the old adhesive from where the edges of the reinforcement brackets meet the front end (Figures 10 and 11) and rear end (Figure 12) of the inner front door panel.

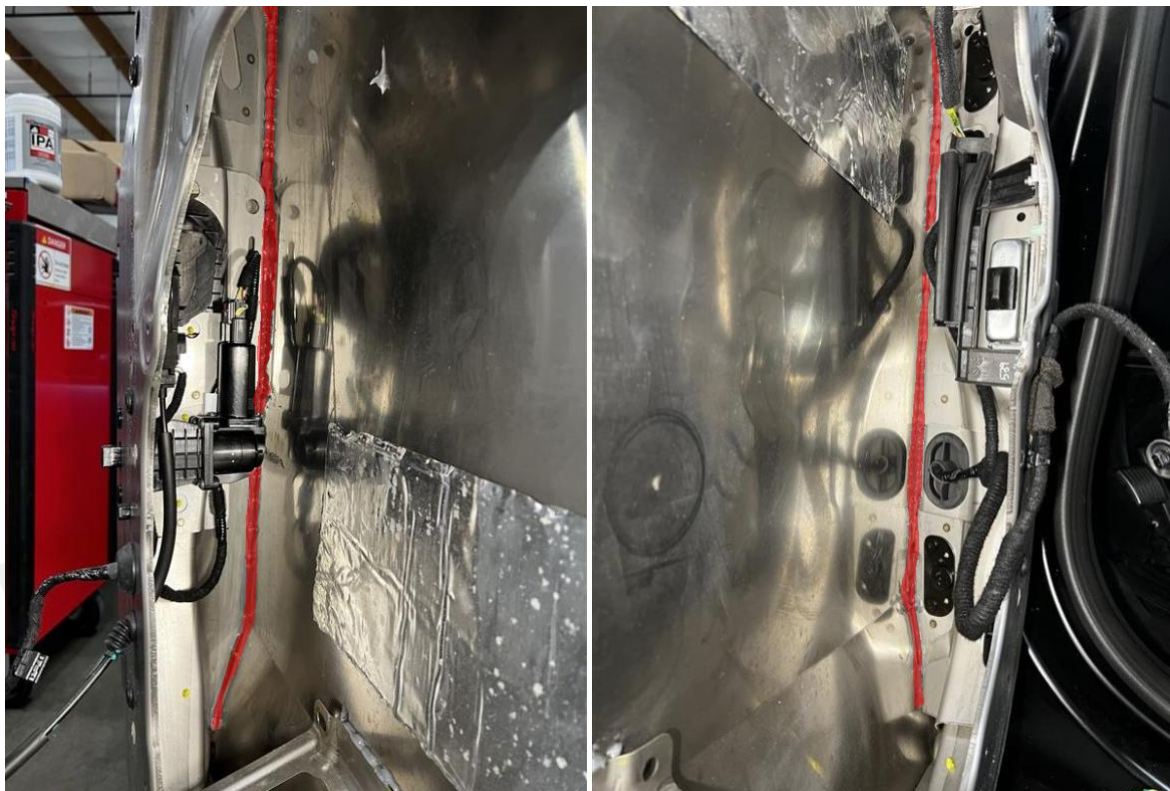
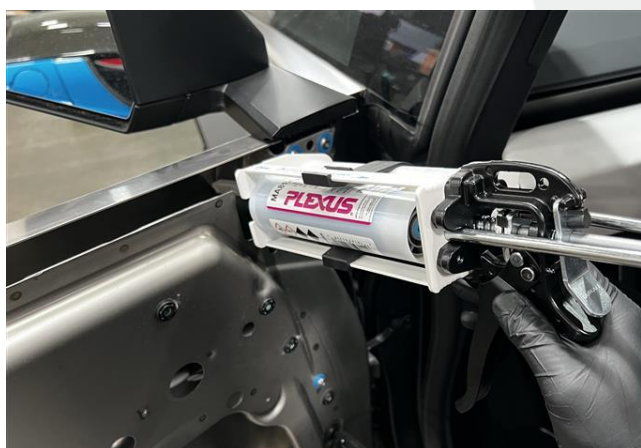
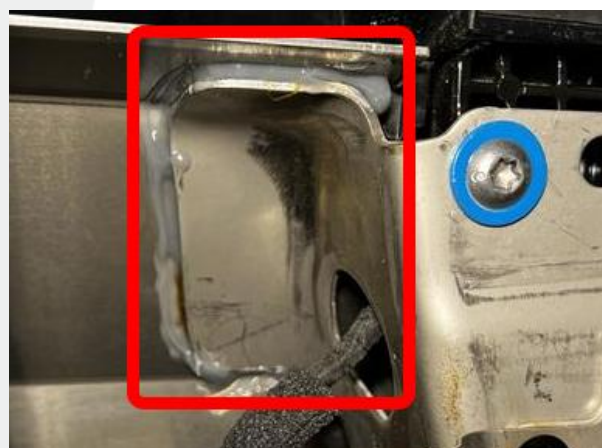
**Figure 14 – Rear end of door (left) and front end of door (right); front and rear doors similar**

**Figure 15 – Apply adhesive to front door side mirror bracket**

**Figure 16 – Side mirror bracket at forward upper corner of the front door panel**

34. Load the adhesive into the applicator and apply the adhesive to the reinforcement bracket and inner door panel joints that were cleaned in step 32 (Figures 14–16).

**📋 NOTE:** Make sure adhesive is applied from the tops of the brackets down to the bottoms of the brackets, just before the drain holes.

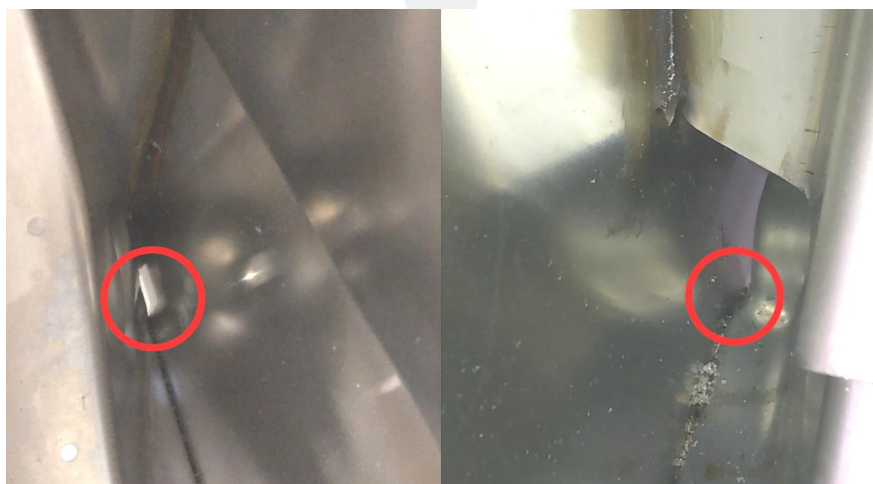
**Figure 17 – Do not block the drain holes at the front and rear ends of the door panel**

**⚠ CAUTION:** Do not apply adhesive to the drain holes (x2) at the bottom of the front and rear ends of the front door panel (Figure 17).
