# HYUNDAI

## Technical Service Bulletin

| GROUP<br>EV SYSTEM | NUMBER<br>26-EV-006H |

**SUBJECT:** LIMITED CHARGING - BATTERY SYSTEM ASSEMBLY (BSA)  
REPLACEMENT - DTC P0AA600, P1AA800

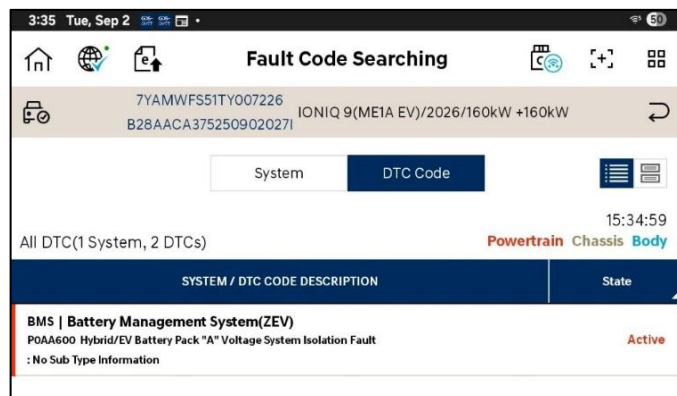
**1. Using the GDS tablet, scan for active DTCs.**

- If DTCs **P0AA600** or **P1AA800** are detected and in “Active” status, then proceed to **step 2**.
- If DTCs **P0AA600** or **P1AA800** are **NOT** detected, then this TSB does not apply. Follow the normal diagnostic process.

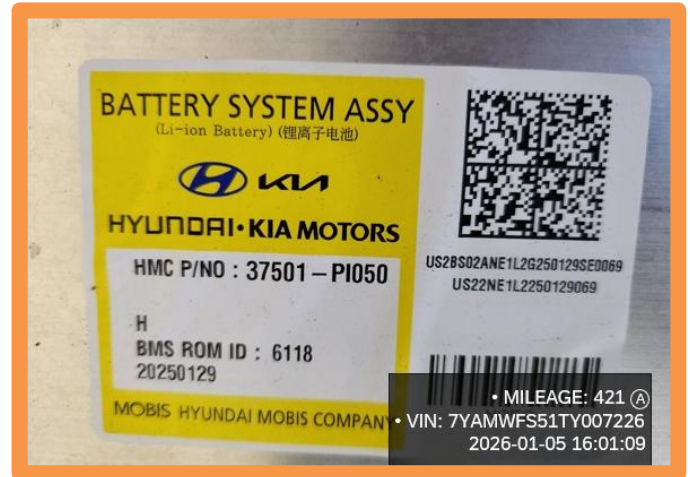
Using the STUI camera function, take a photo of the new High Voltage Battery label.

Upload the photo to STUI.

**NOTE:** If the STUI camera function is **NOT** used, write the last 6 digits of the VIN and date of repair on a piece of paper to include in the photo.
