# **HYUNDAI** **Technical Service Bulletin**

| GROUP<br><b>BODY</b> | NUMBER<br><b>26-BD-005H</b> |
| DATE<br><b>AUGUST 2026</b> | MODEL(S)<br><b>SANTA FE HYBRID<br/>(MX5A HEV)</b> |

**SUBJECT:** LOOSE WALK-IN SWITCH REPLACEMENT

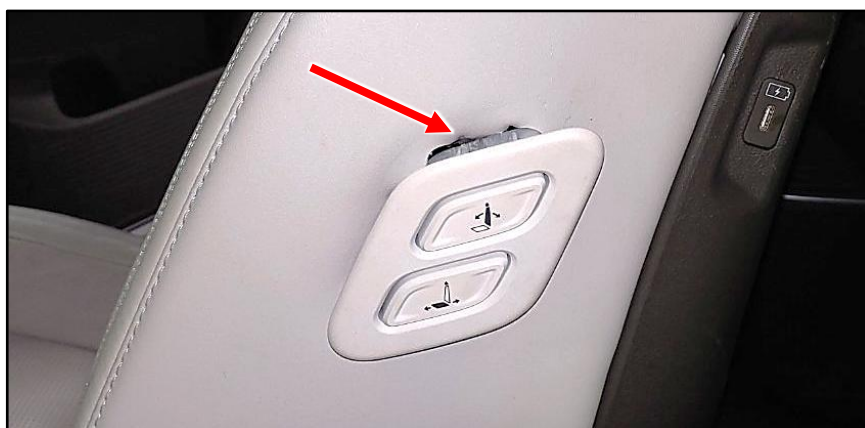
**Description:** Some Santa Fe Hybrid (MX5A HEV) vehicles may have walk-in switches that are not fully secured. This bulletin provides instructions to trim the seat cover and replace the walk-in switch with improved parts.

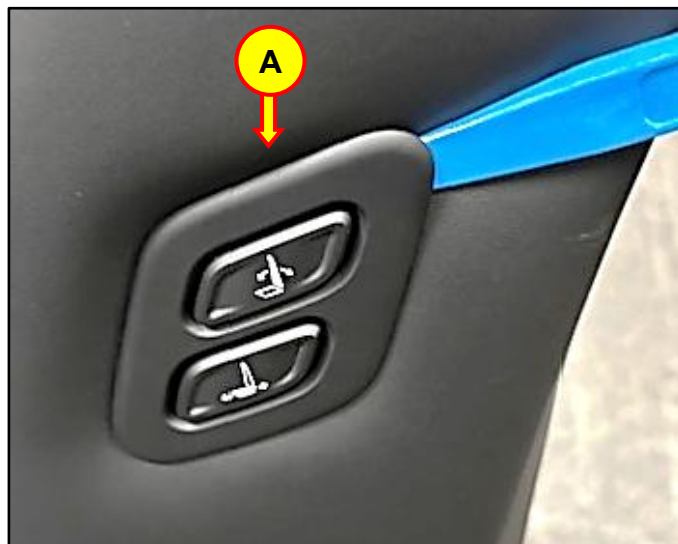
The locking tabs on the walk-in switch assembly may be damaged upon removal. Do **NOT** reuse the walk-in switch assembly.

1. Gently pry off the walk-in switch assembly then disconnect the connector (A).

Use a plastic trim removal tool to prevent damage to parts.

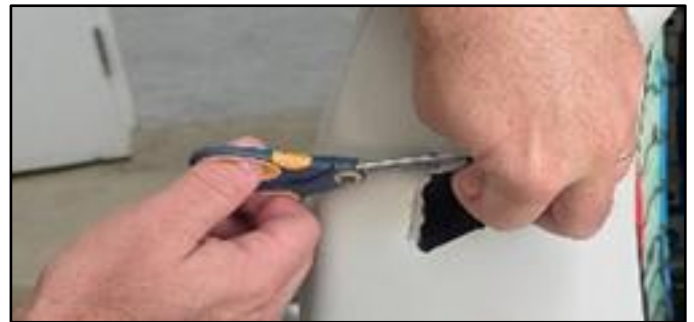
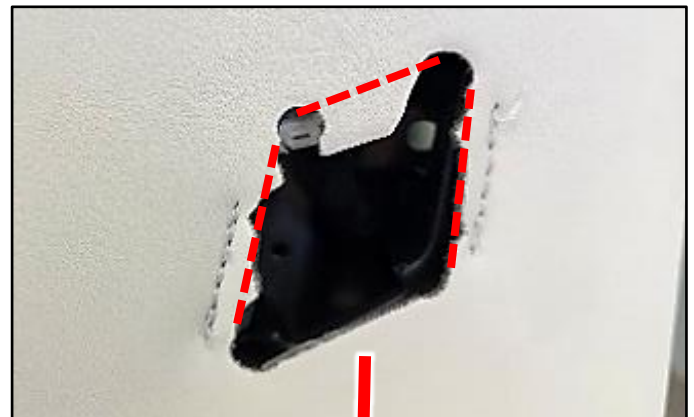
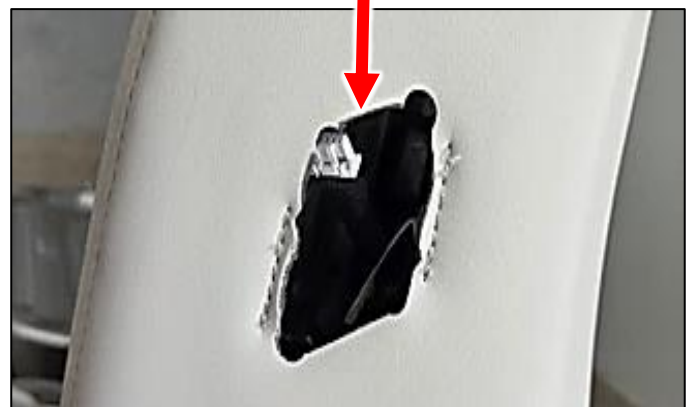
Removing too much material may cause poor appearance after the new walk-in switch is installed.

3. Use scissors to trim the top and both edges of the cutout in the seat cover for the walk-in switch.

After trimming, the shape of the cutout should resemble a parallelogram.

Do **NOT** excessively trim or enlarge the cutout of the seat cover.
