# Broken DD16 GATS 2.0 Exhaust Pressure Tubes

**FIELD SOLUTION:** Replace exhaust manifold pressure sensor tubes.

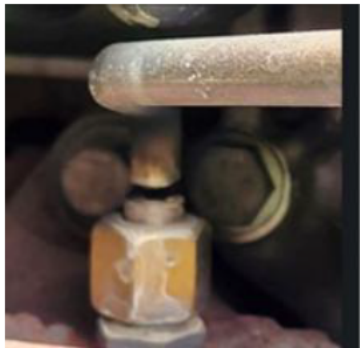
- The exhaust pressure sensor tubes break on some DD16s. Breaks occur near the fitting ends.
- Heavy haul applications are failing at the highest rate
- The engine may set fault code 8619/14 for "P3 sensor 1 stuck in range check low"

Example of broken pressure tube.

- The final resolution is tubes built by bending before brazing the ends on. This prevents cracks in the tube that occur when they bend after brazing.

- 12/12/2025 replaced parts stock in the PDCs with 100% visually inspected parts as an interim corrective action.
- Bend-before-braze trial tubes have accumulated over 75,000 miles with no failures.
- Estimated SOP 9/1/2026 for bend-before-braze tubes. Will Improve this date if possible.
