# Oil Suction Manifold Weld Issues

**FIELD SOLUTION:** Replace Oil Suction Manifold

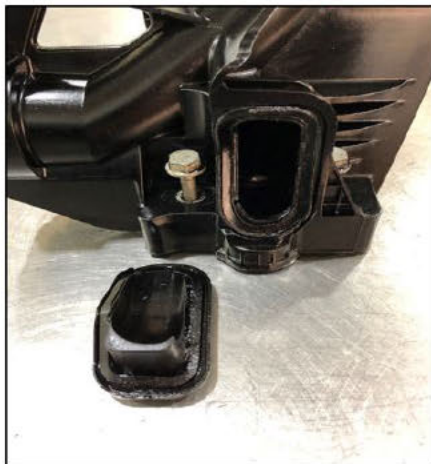
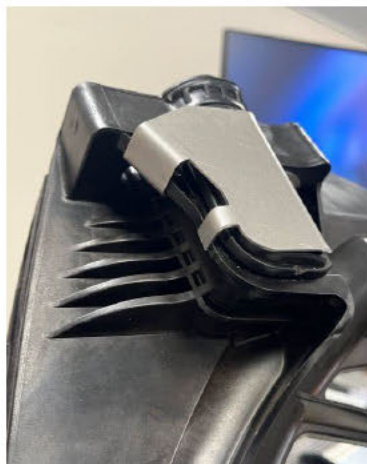
- CEL, low oil pressure caused by an oil suction manifold weld failure to the cap.

- Have seen some weld failures since the last clean point of May 2016, both end cap weld failures and drain back valve cover failures, along with some oil suction manifolds having a hole in the bridge.
- The hole in the suction manifold should only affect manifolds manufactured between 2018 and 2019.
- There was a machine change made by the supplier in December of 2020, unrelated to any failures, and we have seen a decline in failures in parts made after that date.
- Working on a potential "field fix" concept bracket to hold the cap in place. Testing of the bracket will be starting soon.
