# GEN 5 DD13 Turbo Oil Drain Tubes

**PUBLISH DATE:** 7/30/2024

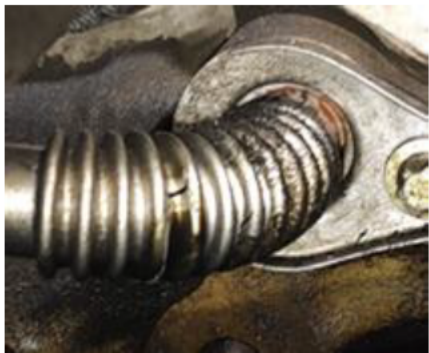
- Some Gen 5 DD13 turbo oil drain tubes are cracking and causing oil leaks. Missing or loose turbo support bracket bolts is the cause.

Example of cracked turbo oil drain tube.

**FIELD SOLUTION:** Replace drain tube along with turbo mounting brackets and bolts.

- For engines built before December of 2024, please reference the DD13 GEN 5 workshop manual, section 5.7.3 and be sure to follow step #2. For engines built on or after December 2024, please reference TSB-01-002-DDC.
