**Technical Service Bulletin (TSB)**  
**Headlamp And Dash Wiring Not Secure**

This bulletin involves inspecting and possibly rerouting and securing a wiring harness.

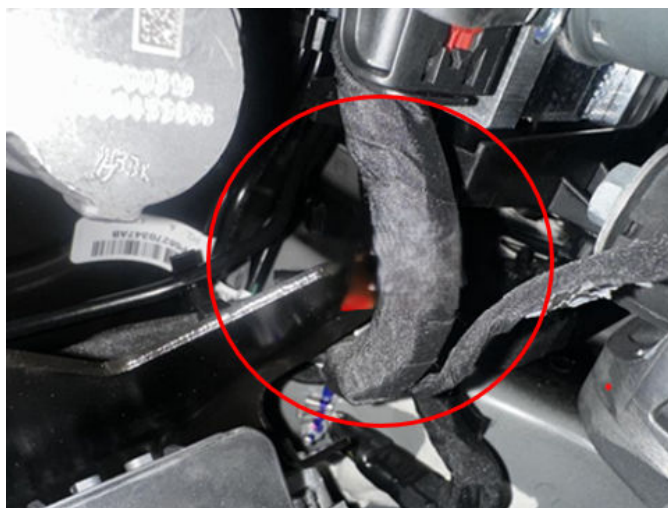
**Fig. 1**  
Incorrectly Routed Harness

1. Open the hood.
2. Inspect the Anti-lock Braking System (ABS) module harness routing [Fig. 1](#).
3. Is the ABS module harness routed forward of the Transmission control module (TCM) mounting bracket **OR is the ABS module harness clip not attached to the brake line?**
  - YES>>> Proceed to [Step 4](#).
  - NO>>> This bulletin does not apply. Use Inspect LOP (08-91-PN-91) to close this active RSU.
4. Remove the battery tray. Refer to the detailed service procedures listed in DealerConnect>ServiceLibrary under:08 - Electrical / 8F - Engine Systems / Battery System / Tray, Battery / Removal.
5. Disconnect the ABS module harness connector and route the harness **rearward** of the TCM bracket then reconnect the harness [Fig. 2](#).

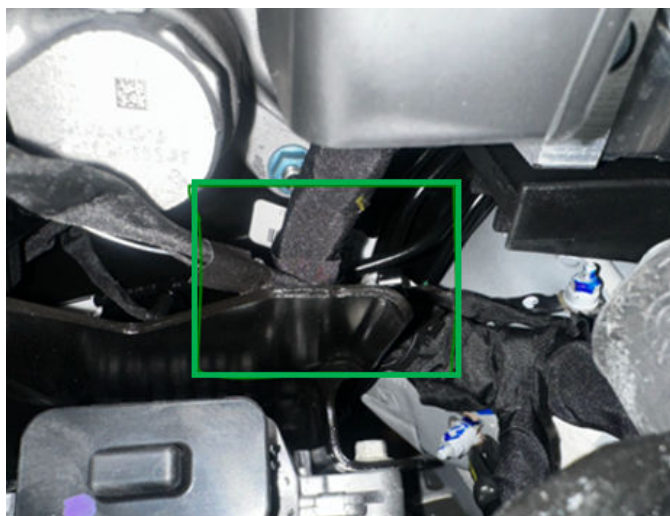
**Fig. 2**  
Correctly Routed Harness

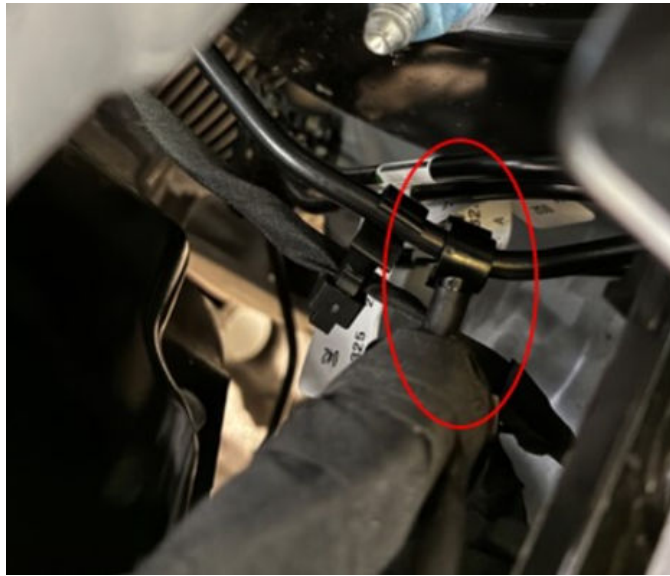
**Fig. 3**

6. Identify the C-clip retainer attached to the brake lines [Fig. 3](#).

C-Clip At Brake Line

7. Add the strap tie from the harness to the brake line at the C-clip retainer area to better secure the harness.
