## PRODUCT CAMPAIGN BULLETIN

**APPLICABILITY:** 2026MY Solterra

**NUMBER:** WRG-26R

**SUBJECT:** Battery ECU Reprogramming

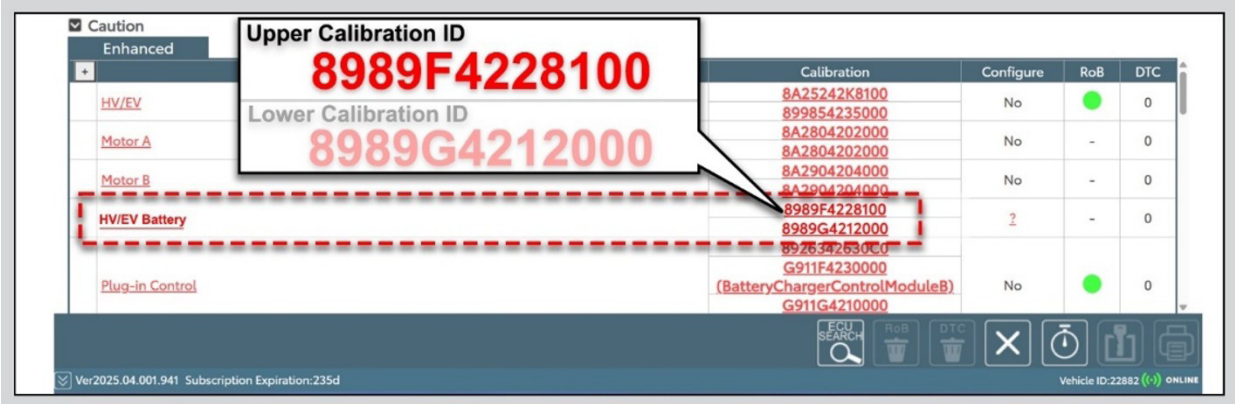
**NOTE: ONLY** the upper HV/EV battery system Calibration ID is updated after performing the reprogramming procedure.

8989F422 “**8100**”: [Reprogramming required](#).

8989F422 “**8200**” / “**8300**”: [Reprogramming NOT required](#) (updated software already applied).
