## SERVICE BULLETIN

**APPLICABILITY:** 2019-**26**MY Forester  
2022-25MY Forester Wilderness  
**SUBJECT:** Water Intrusion From Sunroof Area

**NUMBER:** **12-269-25R**  
**DATE:** 08/26/25  
**Revised:** **08/31/26**

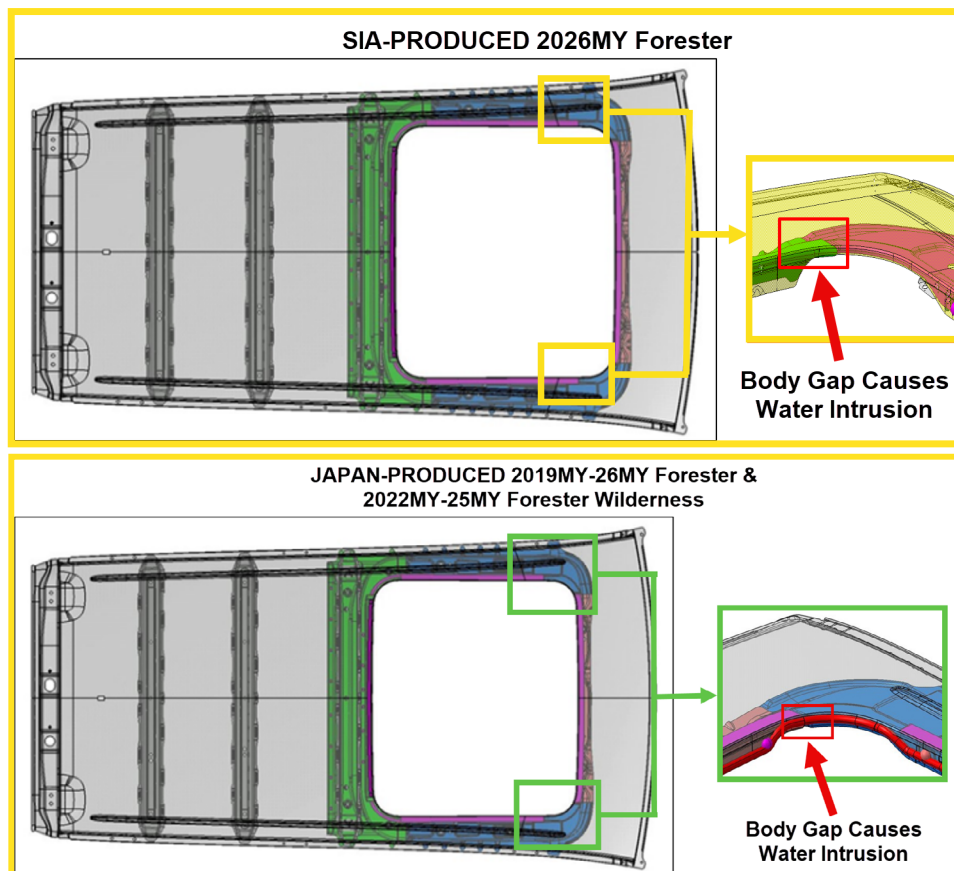
This bulletin announces the service procedures to be followed when encountering instances of water intrusion from the sunroof area. In some cases, water enters along the sunroof frame passing down the A-Pillar trim reaching the footwell area. If water intrusion is encountered, follow the service procedure outlined in this bulletin.
