**Subject:** New Unit Incorrect Fuel Level Sensor Installation Sequence - Alarm Code 98

**Units:** All SR-3/SR-4 Truck and Trailer, Precedent S-750i, and Advancer units with TKV5 Firmware Prior to T-0110-000014

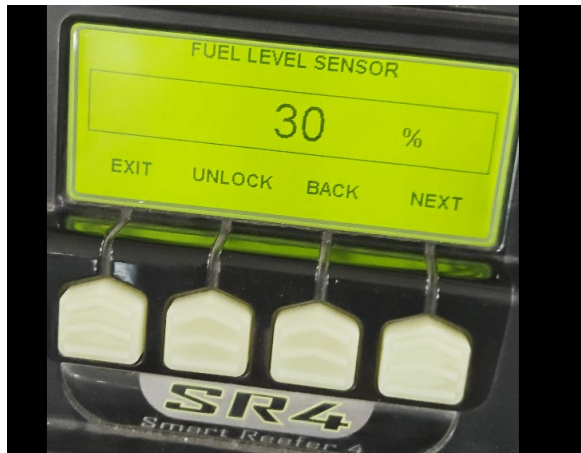
1. Confirm the fuel sensor is correctly wired and configured.
2. Verify the HMI (SR-4 shown) displays the correct fuel level reading. If possible, also check the TDAC Fuel Sensor Detail to confirm it displays the same fuel level reading as the HMI.

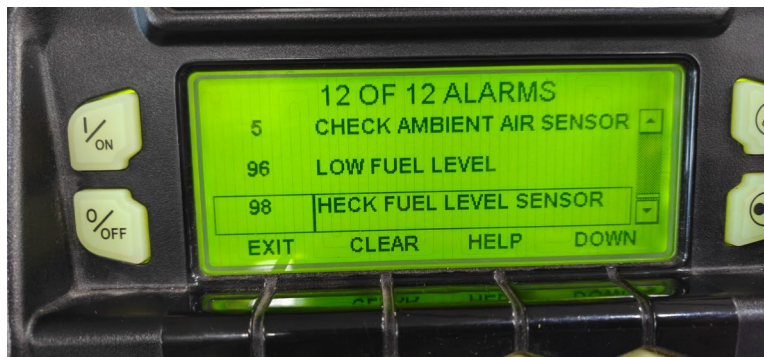
3. Alarm Code 98 is present in the alarm section of the HMI.

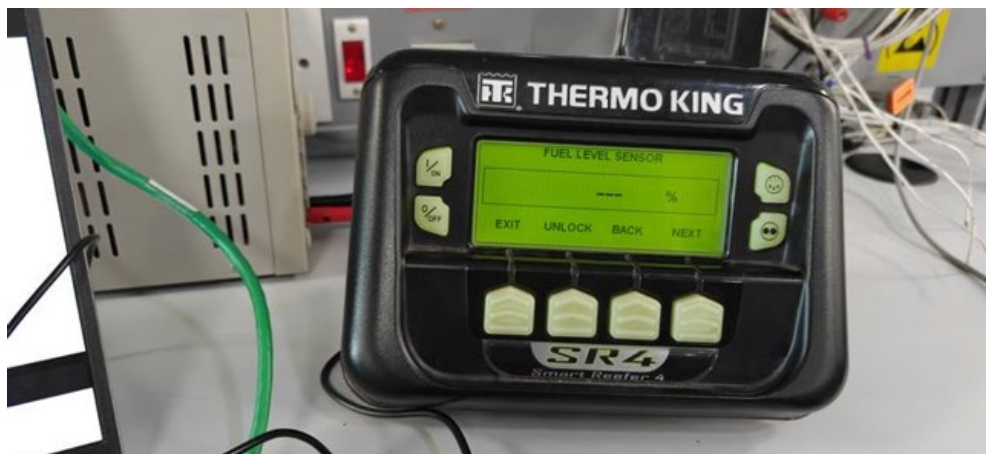
1. Check the Fuel Level Sensor reading on the SR-3/SR-4 HMI. If it displays (---%), the reading is invalid.

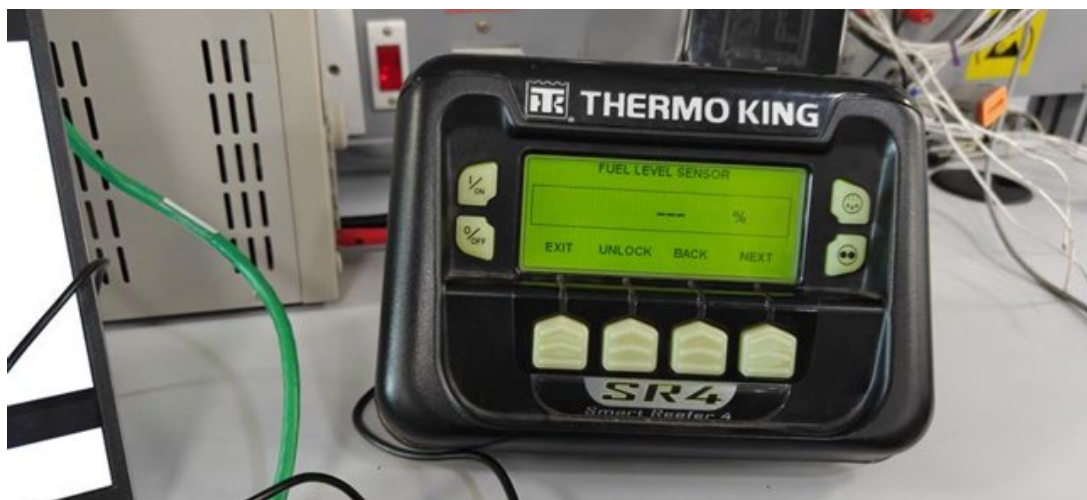
1. Confirm the fuel sensor is correctly wired and configured.
2. Check TDAC and review Fuel Sensor Detail. If displayed as Invalid or the HMI displays an invalid value (---%), proceed to step 3.
