## BCU SOFTWARE UPDATE

### AFFECTED MODELS:

**2026 1390 SUPER ADVENTURE R**

**2026 1390 SUPER ADVENTURE S EVO**

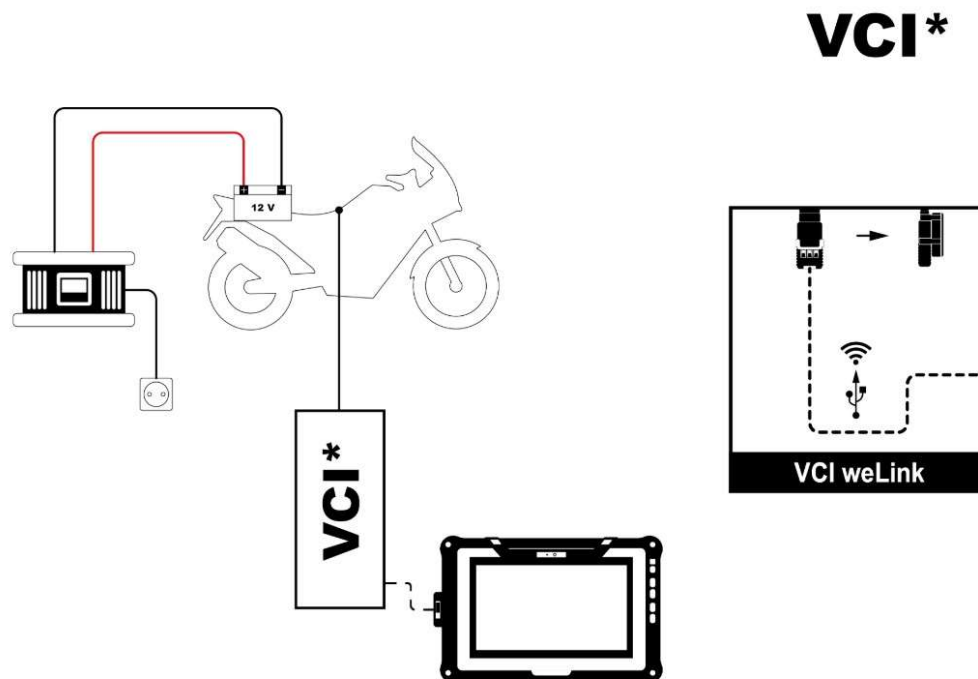
- Connect the motorcycle to the diagnostic tool and external power supply (XCharge) as shown in the XC 3 diagnostic tool illustration.
- Check XC 3 diagnostic for software version #26.4.1 or higher, and update it if necessary.

- Update the control unit.
- After a successful update, turn off the ignition for at least 1 minute.
- Turn on the ignition.
- Select ECU diagnostics to perform AutoScan.
- Check the control unit for any errors and correct variant coding.
- Correct variant coding if necessary.
- Clear the fault memory.
