# Service Action

## Code: 24BD

#### Engine Control Module (ECM) Software – 12V Battery

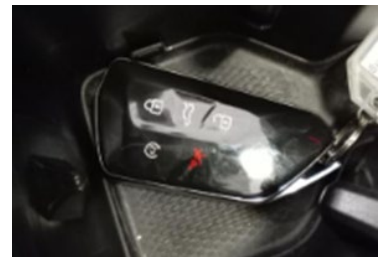
- Ensure the key is placed on the reader coil located in the cupholder.
