**Condition**

When applying the brakes at highway speeds the following symptoms may occur:

## Technical Background

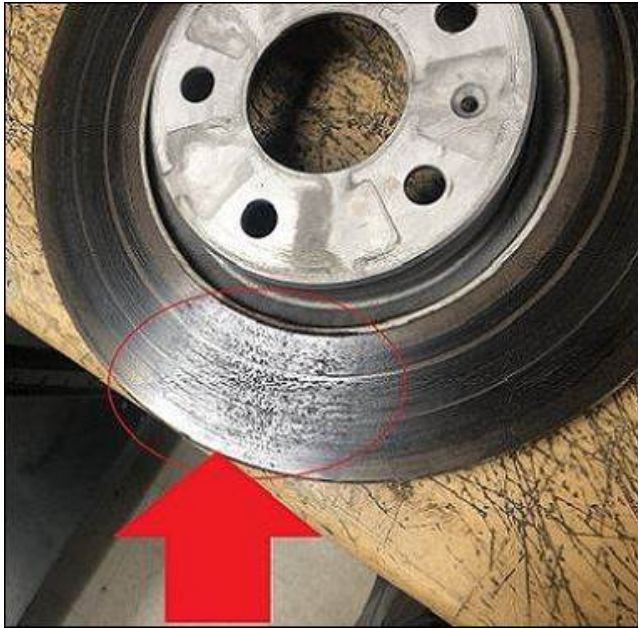
Figure 1: Brake pad imprint.

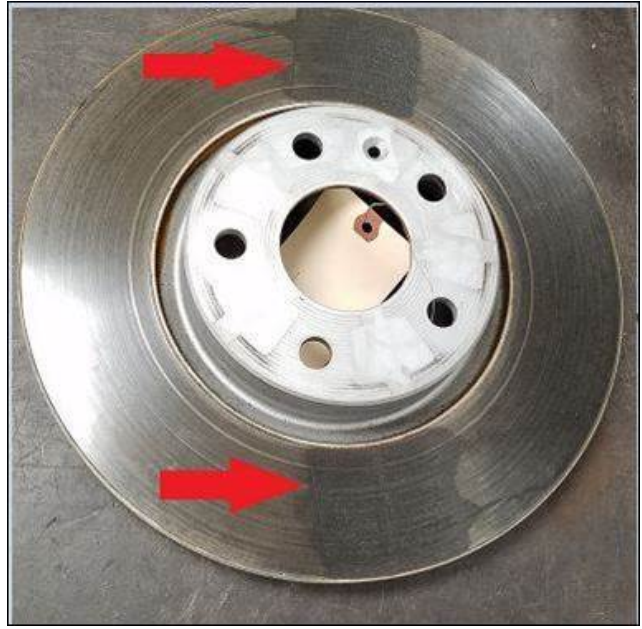
Figure 2: Brake pad imprint.

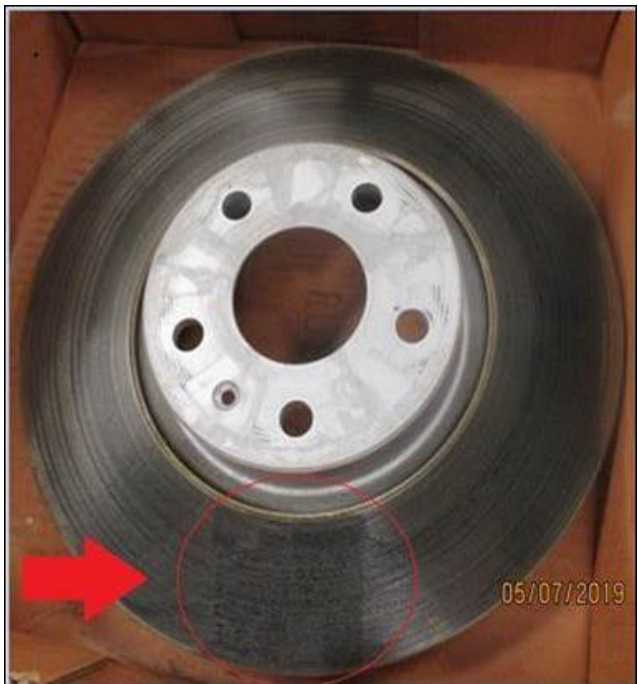
Figure 3: Brake pad imprint.

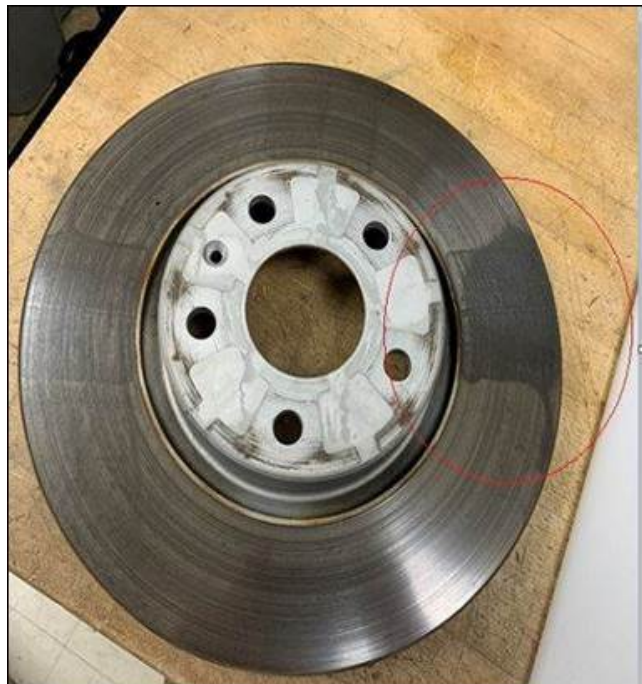
Figure 4: Brake pad imprint.

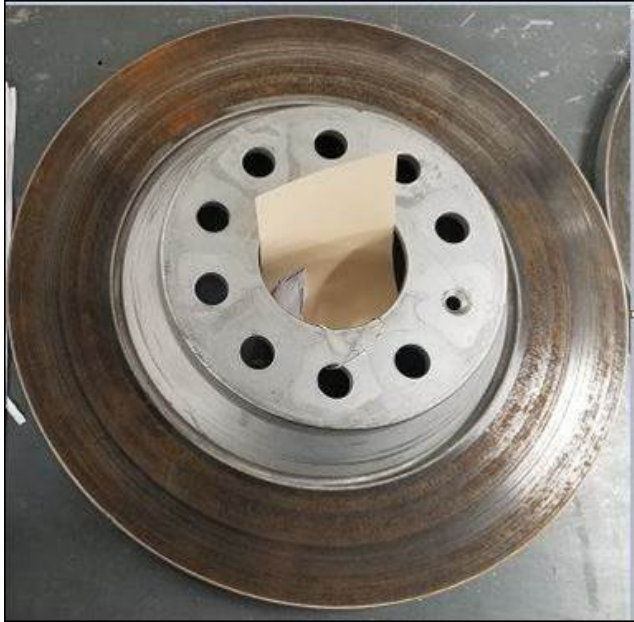
Figure 5: Corrosion.

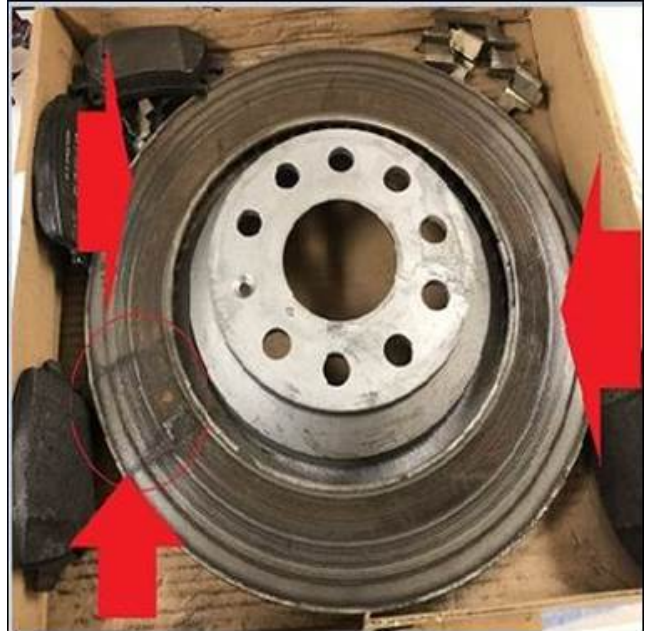
Figure 6: Corrosion, brake pad stuck to brake rotor.

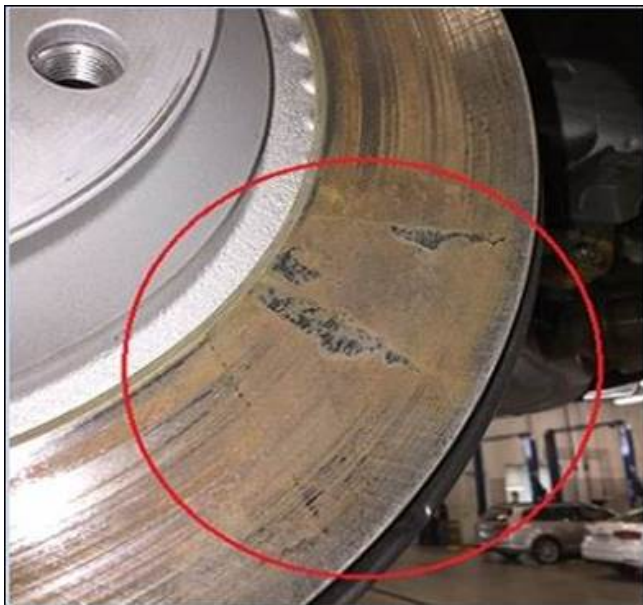
Figure 7: Corrosion, brake pad stuck to brake rotor.

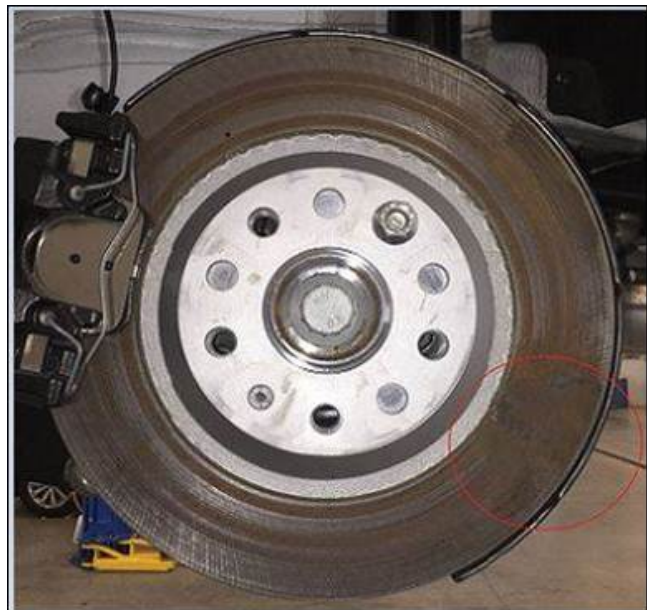
Figure 8: Corrosion, brake pad stuck to brake rotor.

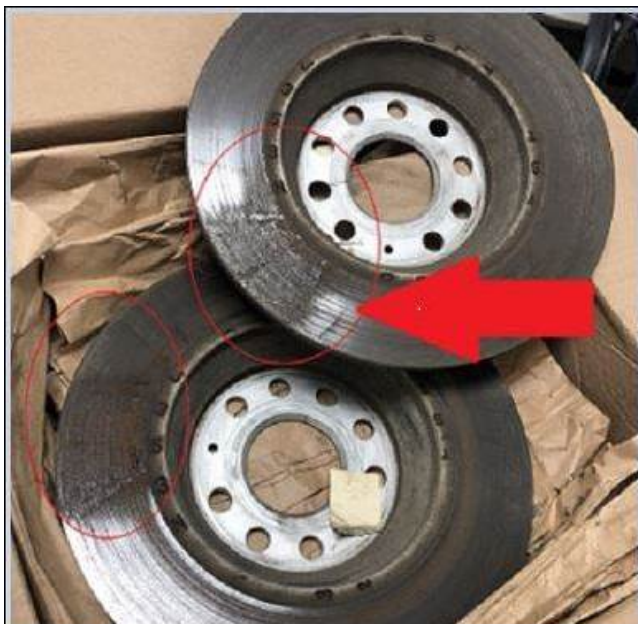
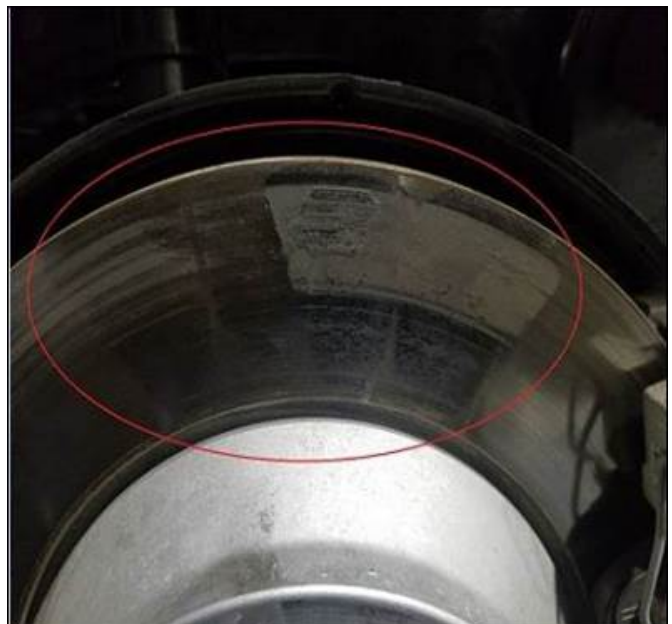
Figure 9: Brake pad stuck to brake rotor

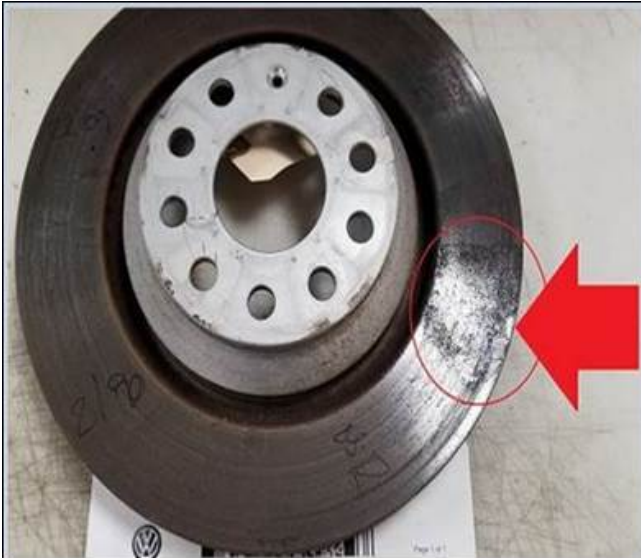
Figure 10: Brake pad stuck to brake rotor.

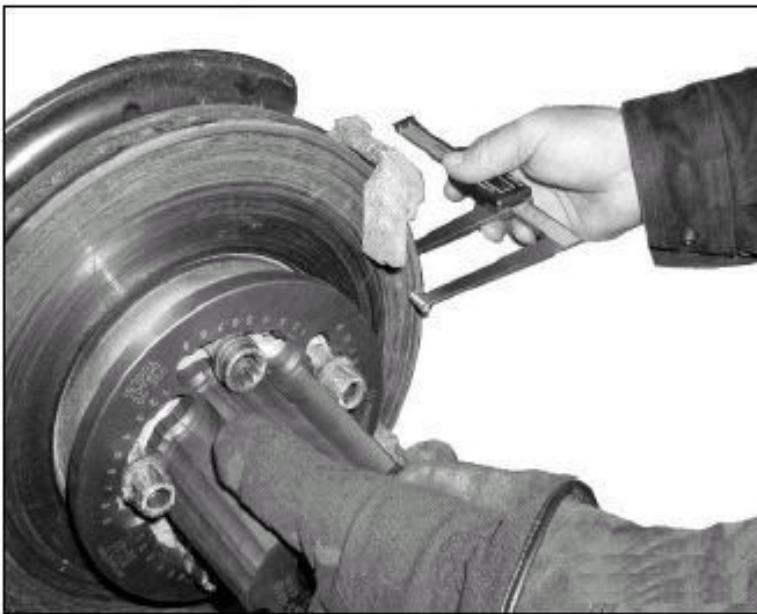
Figure 11: Brake pad imprint.
