## Technical Service Bulletin

93-26-05 - Service Information, High-Voltage Battery DTCs P0AA6, P0D0F, and P0D08

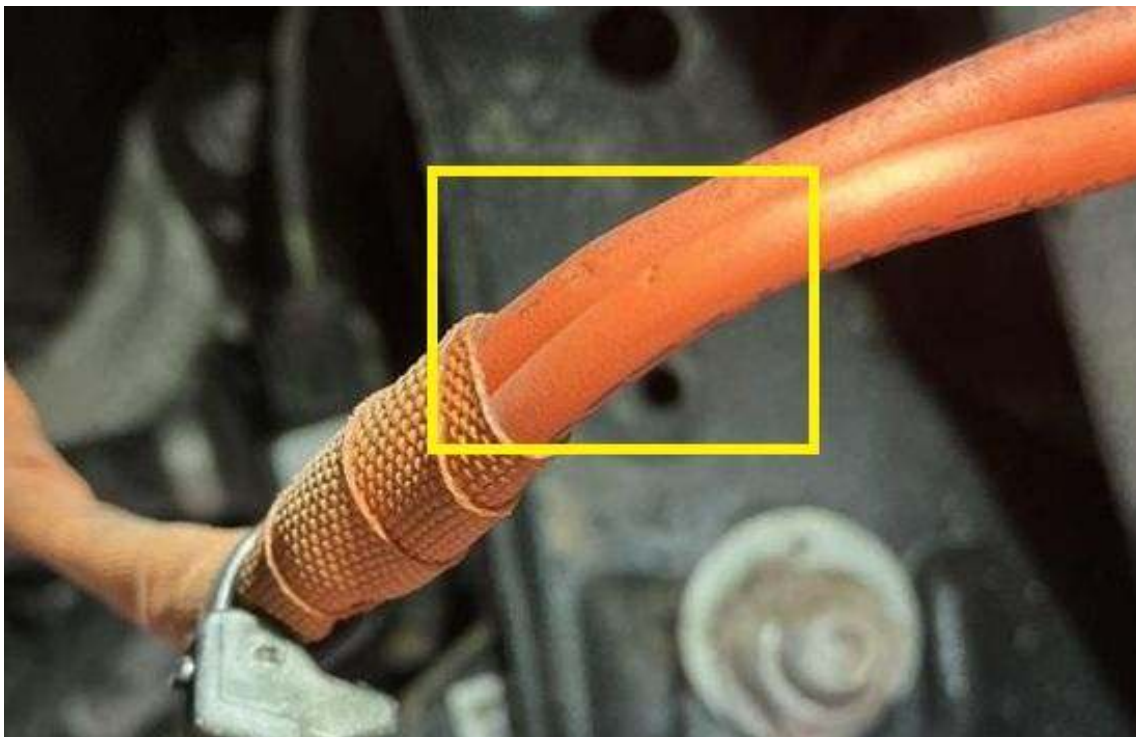
Figure 10.

Wiring insulation damage may result from outside influence (e.g. a rodent bite, Figure 10). If damage was caused by outside influence, neither diagnosis nor any subsequent repairs are covered under warranty.

- Repair or replace the high-voltage component auxiliary harness wire according to the repair manual and parts catalog.
