## Technical Service Bulletin

Transaction No.: **2074899/5**

93 Q4 transmission: clacking noises during load changes/when changing direction  
(Gearbox UYX)

Release date: Aug 11, 2026

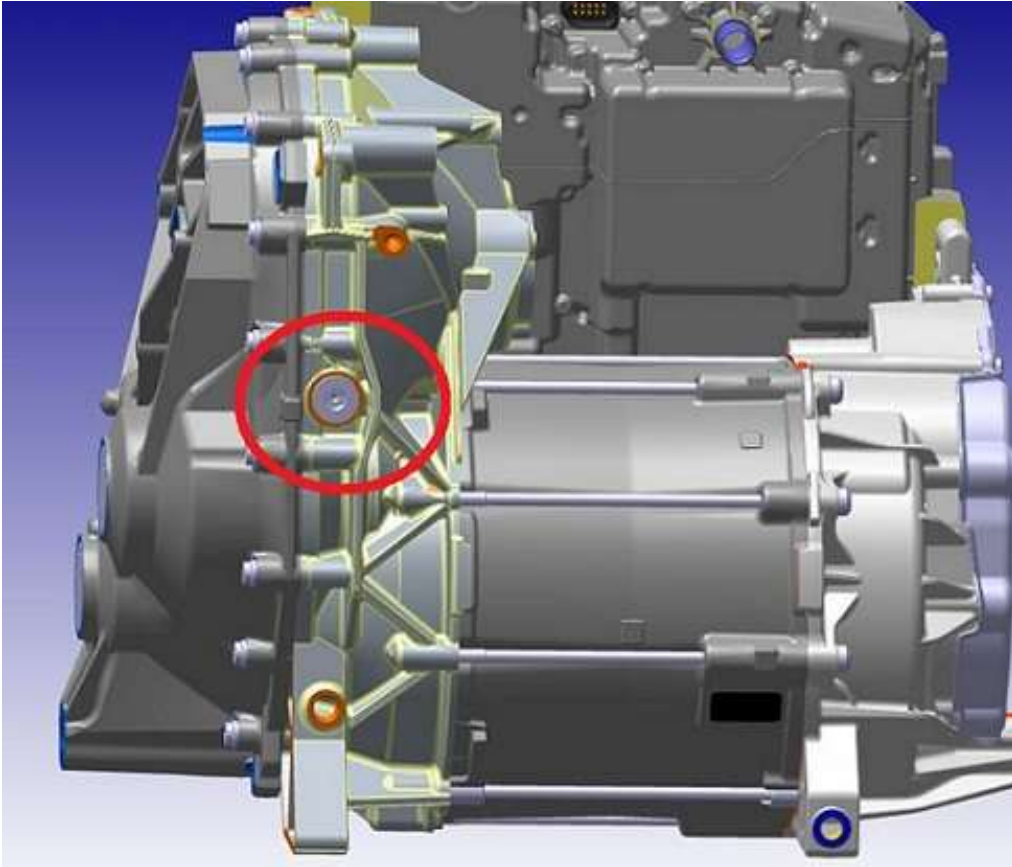
**Figure 1.** Filler cap for gear oil.

- Attach the gearbox to the engine and gearbox support -VAS6095A- as described in the ELSA Repair manual.
- Drain the gear oil via the filler cap (refer to Figure 1, red oval).

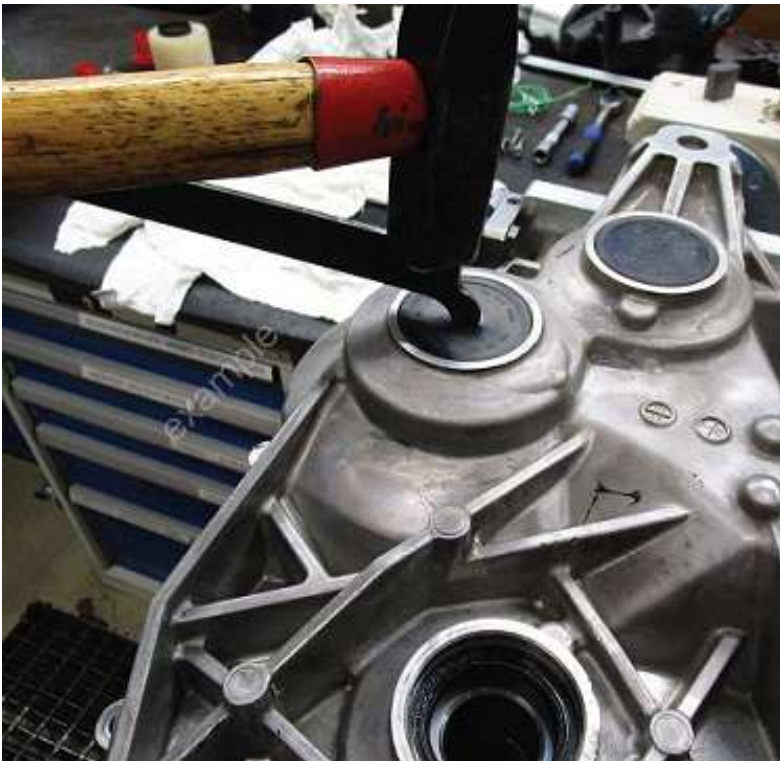
**Figure 2.** Removing the filler cap with the extractor lever -VW681- (example).

- Remove the center filler cap using the extractor lever -VW681- (refer to Figure 2).

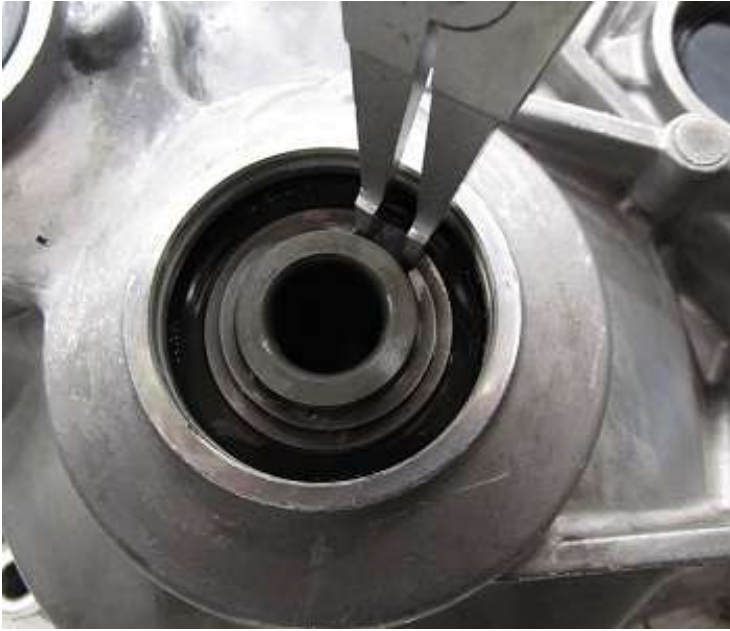
**Figure 3.** Removing the retaining ring for the inner ring of the intermediate shaft (example).

- Remove the retaining ring for the inner ring of the intermediate shaft (refer to Figure 3). The retaining ring must not be damaged and will need to be used again during the repair procedure.

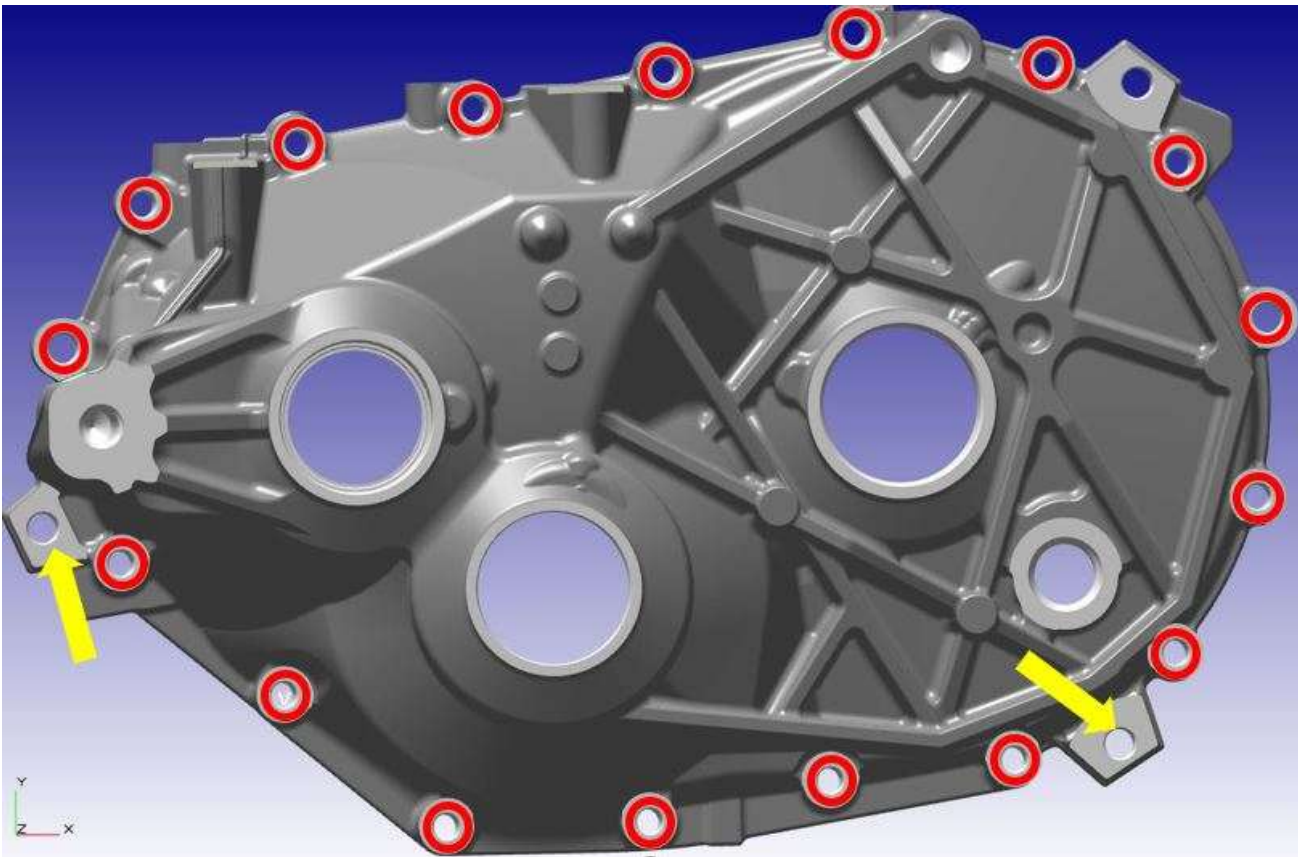
**Figure 4.** Positions of the housing bolts (red circles), and positions of contact points (yellow arrows).

- Remove 17 housing bolts (refer to Figure 4, red circles).

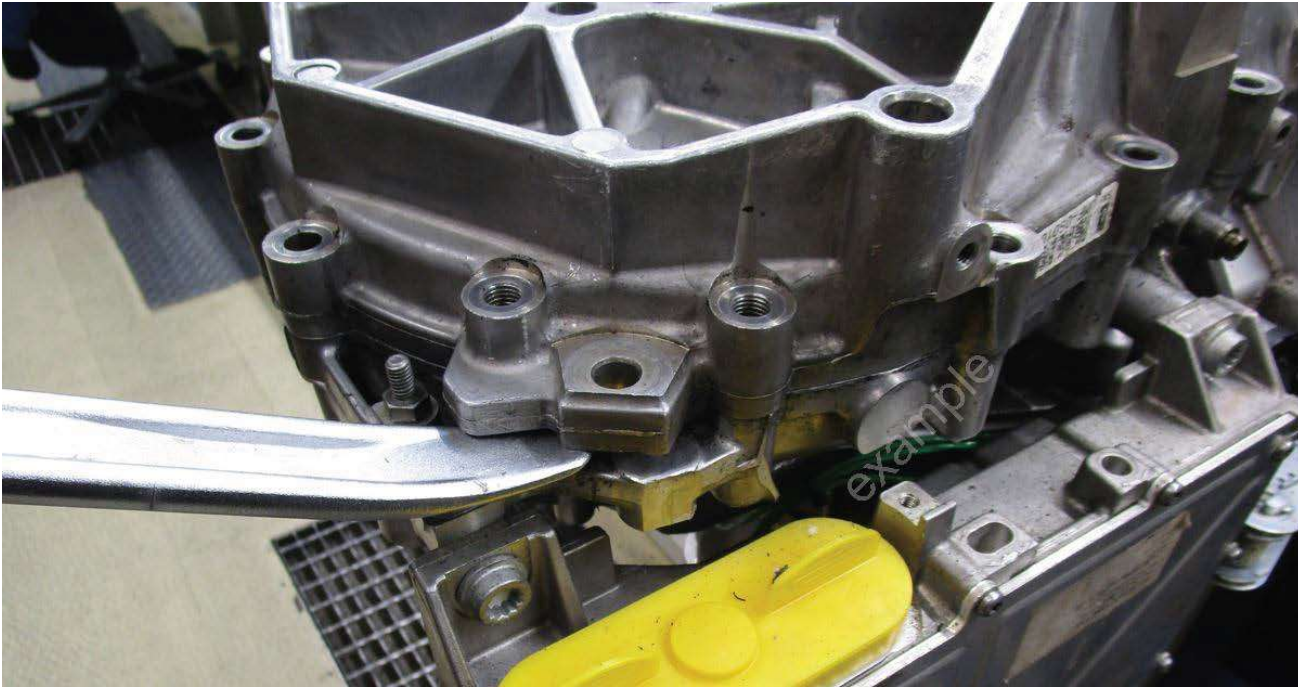
**Figure 5.** Separating sections of the gearbox housing from each other using the assembly lever.

- Apply a commercially available assembly lever under the contact points (refer to Figure 4 (yellow arrows), Figure 5 and Figure 6), carefully separate the two sections of the gearbox housing from each other and detach the gearbox housing.

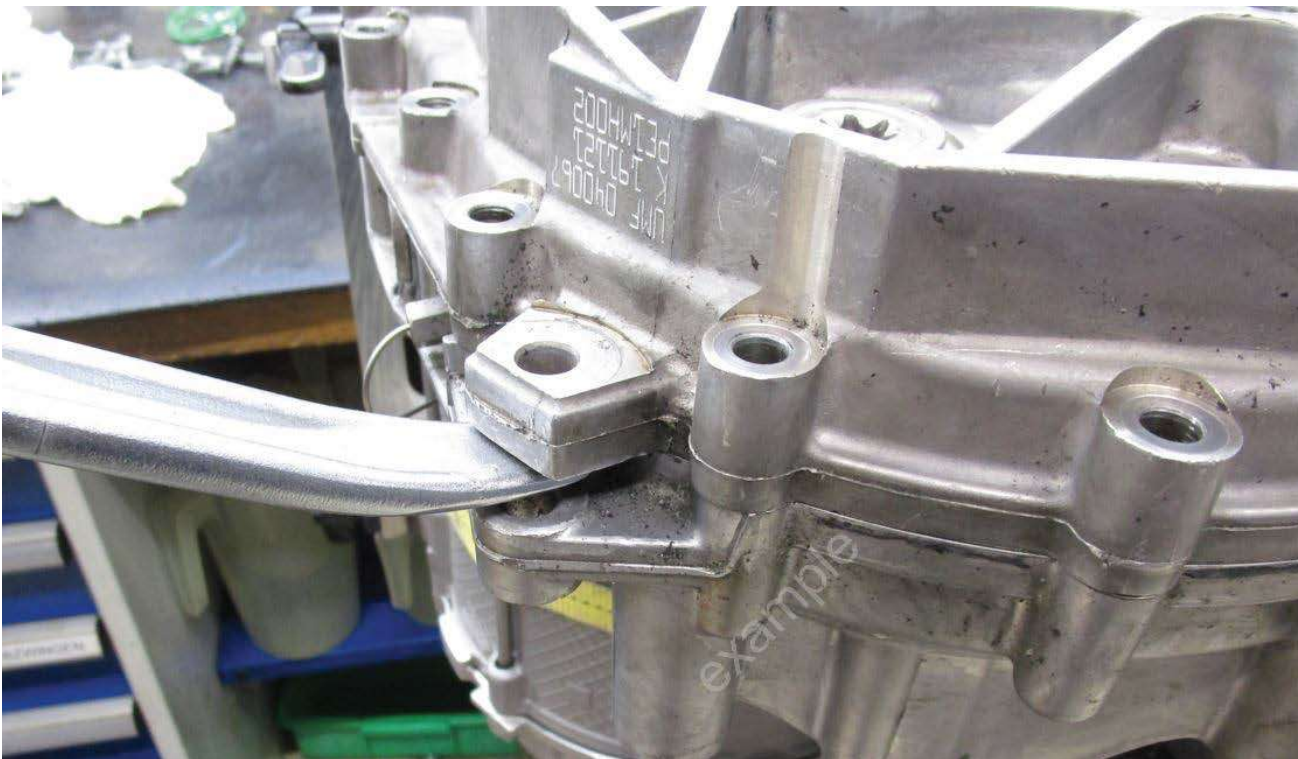
**Figure 6.** Separating sections of the gearbox housing from each other using the assembly lever.

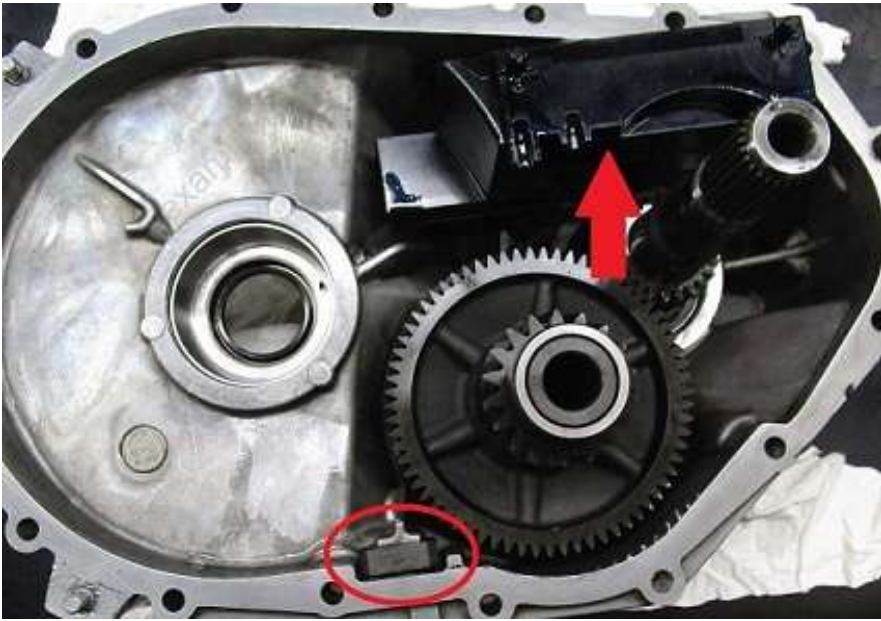
**Figure 7.** Positions of oil the reservoir and the magnet in the gearbox housing.

- Remove the oil reservoir (refer to Figure 7, red arrow) from the gearbox housing.

- Remove the magnet (refer to Figure 7, red oval) from the gearbox housing.

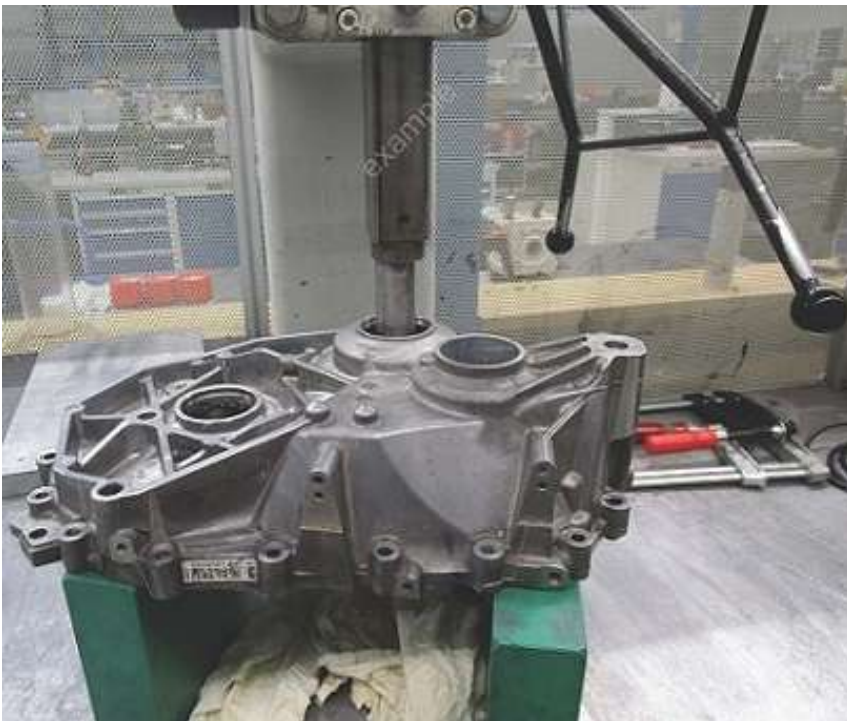
**Figure 8.** Pressing out the intermediate shaft (example).

- Press the intermediate shaft out using the removing and installing tool -VW459/2- (refer to Figure 8).

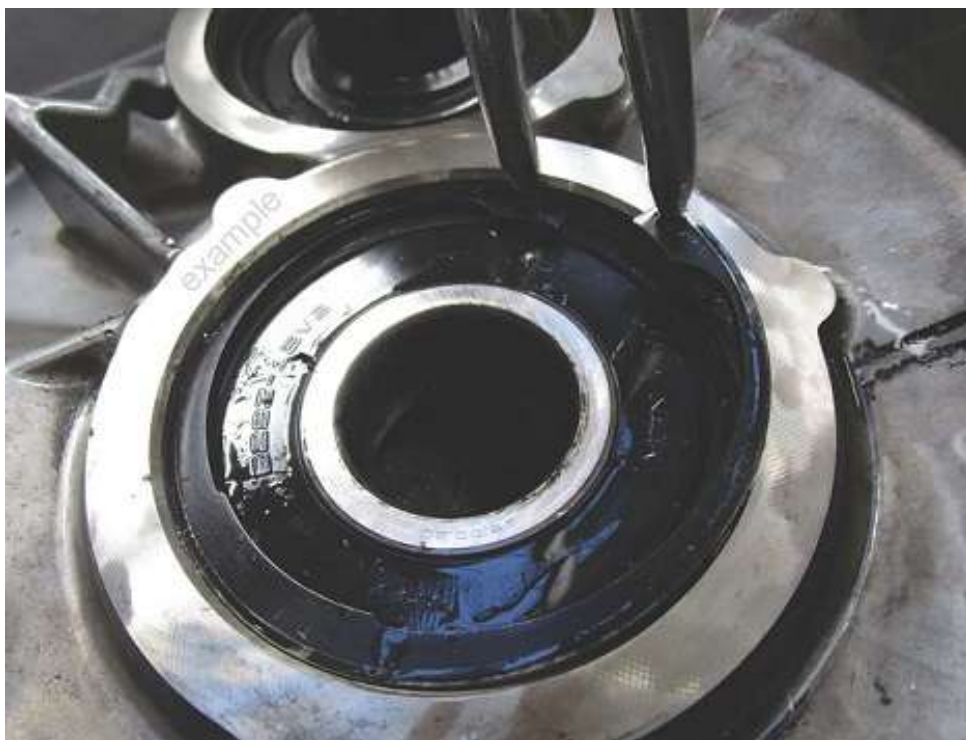
**Figure 9.** *Removing the retaining ring (example).*

- Remove the retaining ring for the outer ring (refer to Figure 9) of the bearing for the intermediate shaft. The retaining ring must not be damaged and will need to be used again during the repair procedure.

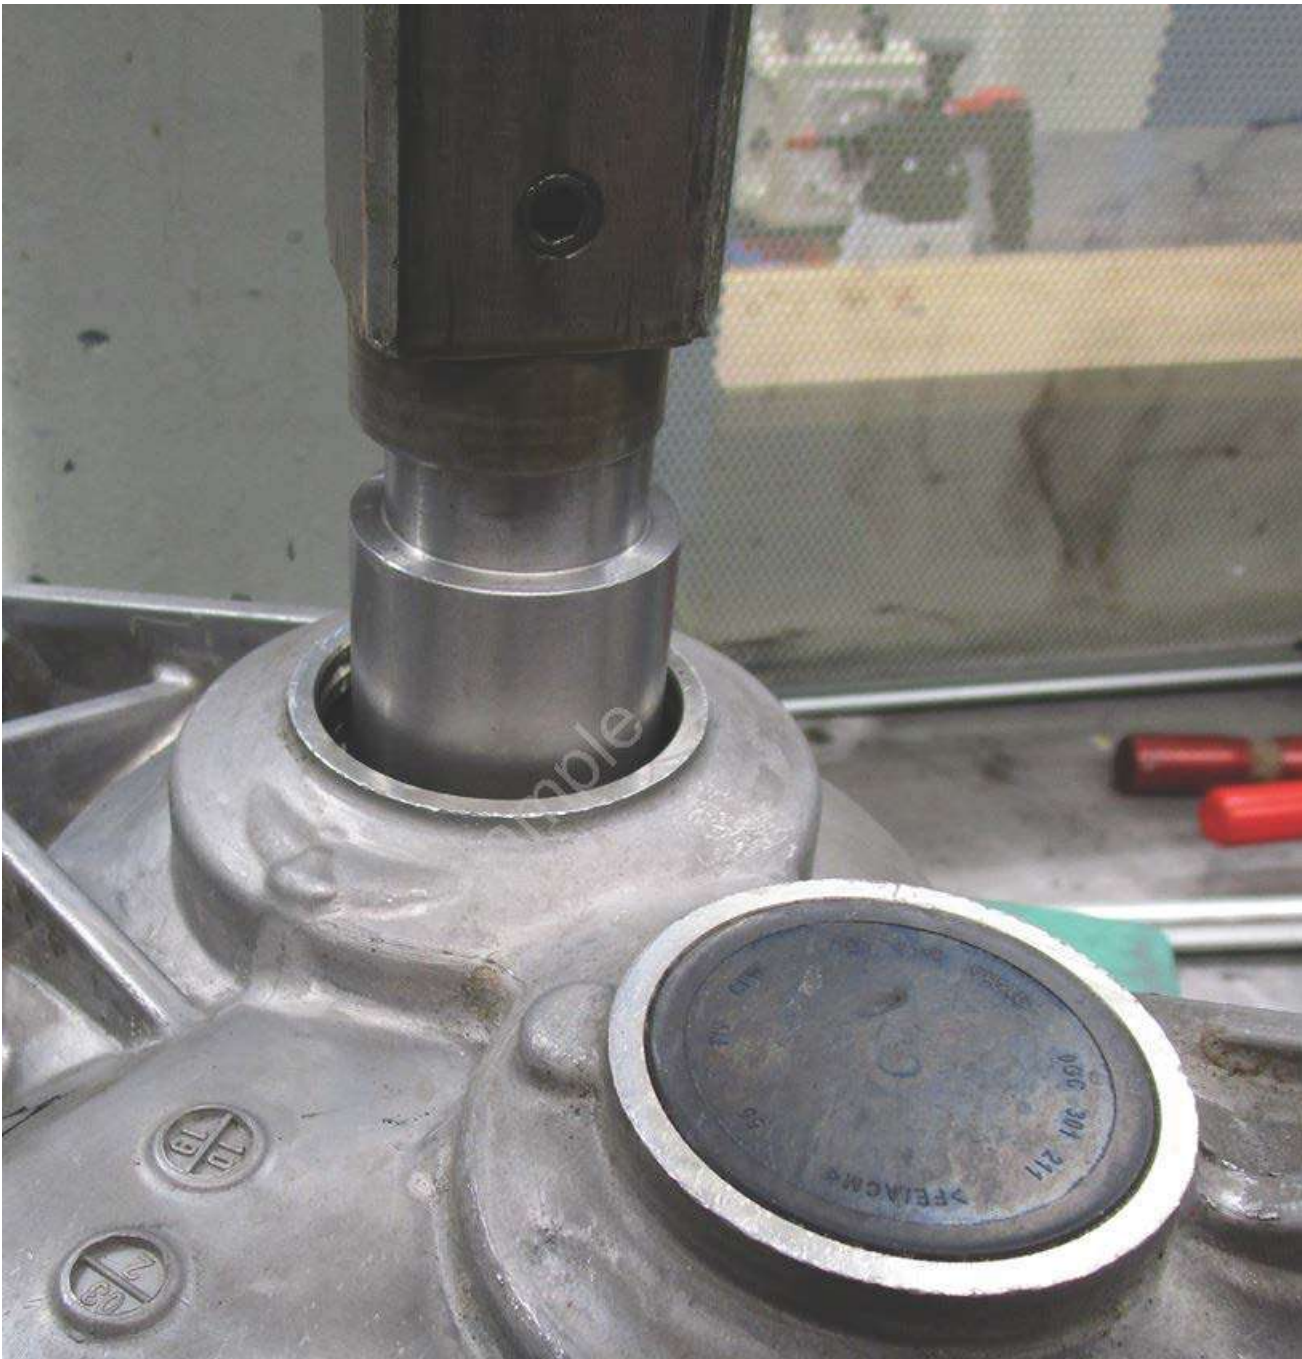
**Figure 10.** Pressing out the bearing for the intermediate shaft (example).

- Press the bearing for the intermediate shaft out, using the removing and installing tool -VW459/2- (refer to Figure 10).

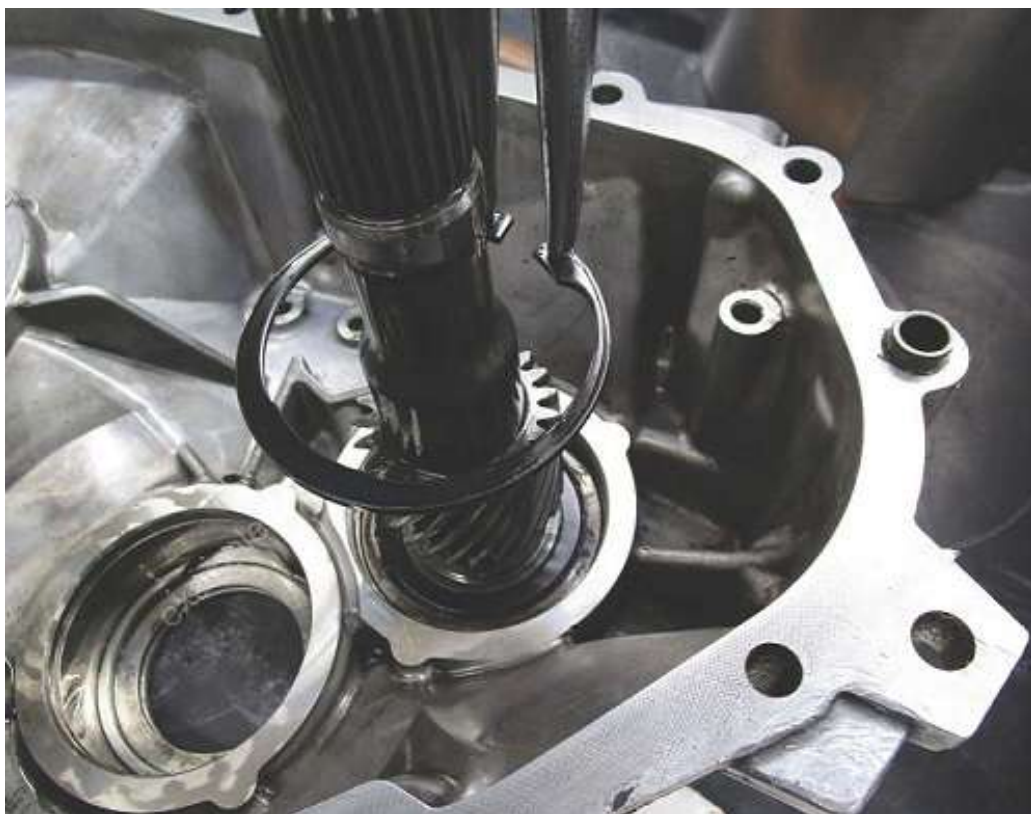
**Figure 11.** Removing the outer retaining ring for the drive shaft (example).

- Remove the outer retaining ring for the drive shaft (refer to Figure 11).

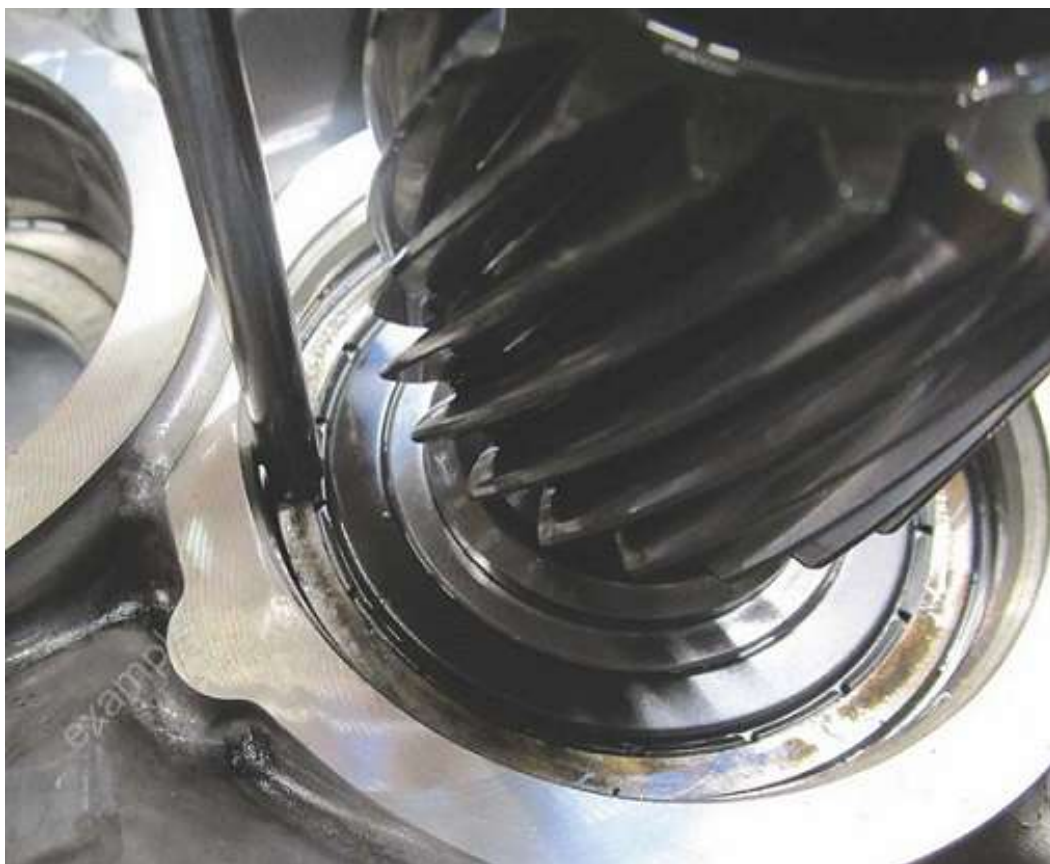
**Figure 12.** Driving the bearing for the drive shaft in deeper (example).

- Carefully drive the bearing for the drive shaft deeper into the gearbox housing using a commercially available drift and hammer at the outer ring of the bearing (refer to Figure 12).

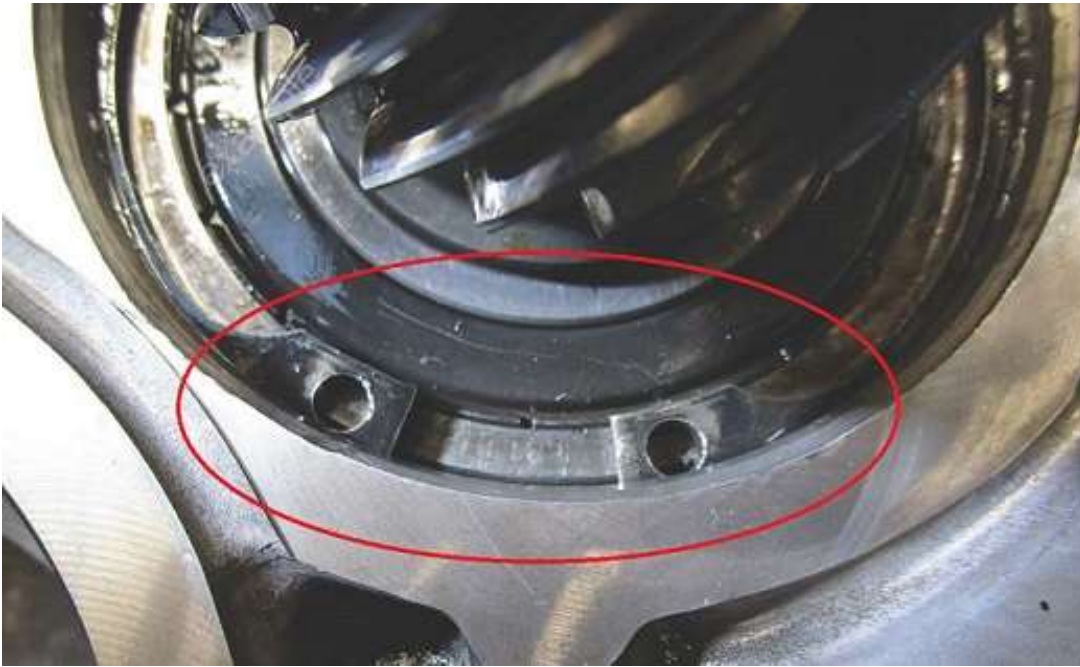
**Figure 13.** *The retaining ring has snapped fully into the groove (example).*

- Install the new retaining ring (with the maximum thickness/strength as described in parts information) as follows:
  - Install the new retaining ring (starting with the maximum thickness/strength). If the retaining ring does not fit in the groove, try to insert the next thinnest retaining ring.
  - Continue in this way as necessary until a retaining ring of the correct size can be installed.

**The new retaining ring must snap fully into the groove (refer to Figure 13, red oval).**

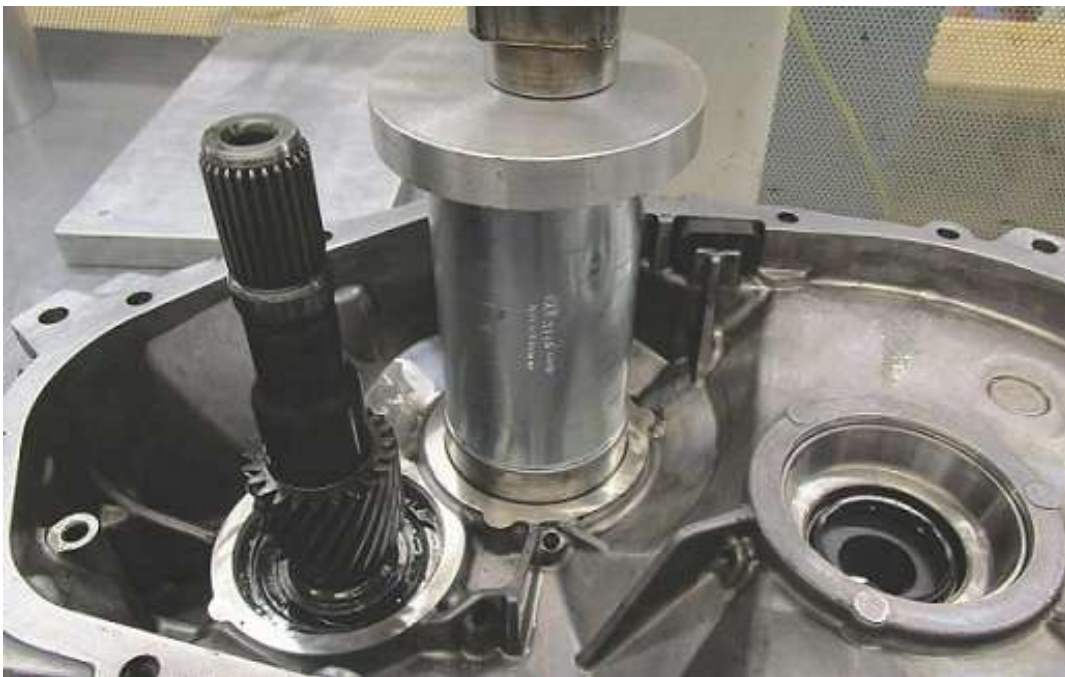
**Figure 14.** Pressing in the new bearing for the intermediate shaft with tube -3146-.

- Press the new bearing for the intermediate shaft (as described in parts information) into the gearbox housing with tube -3146- (refer to Figure 14).

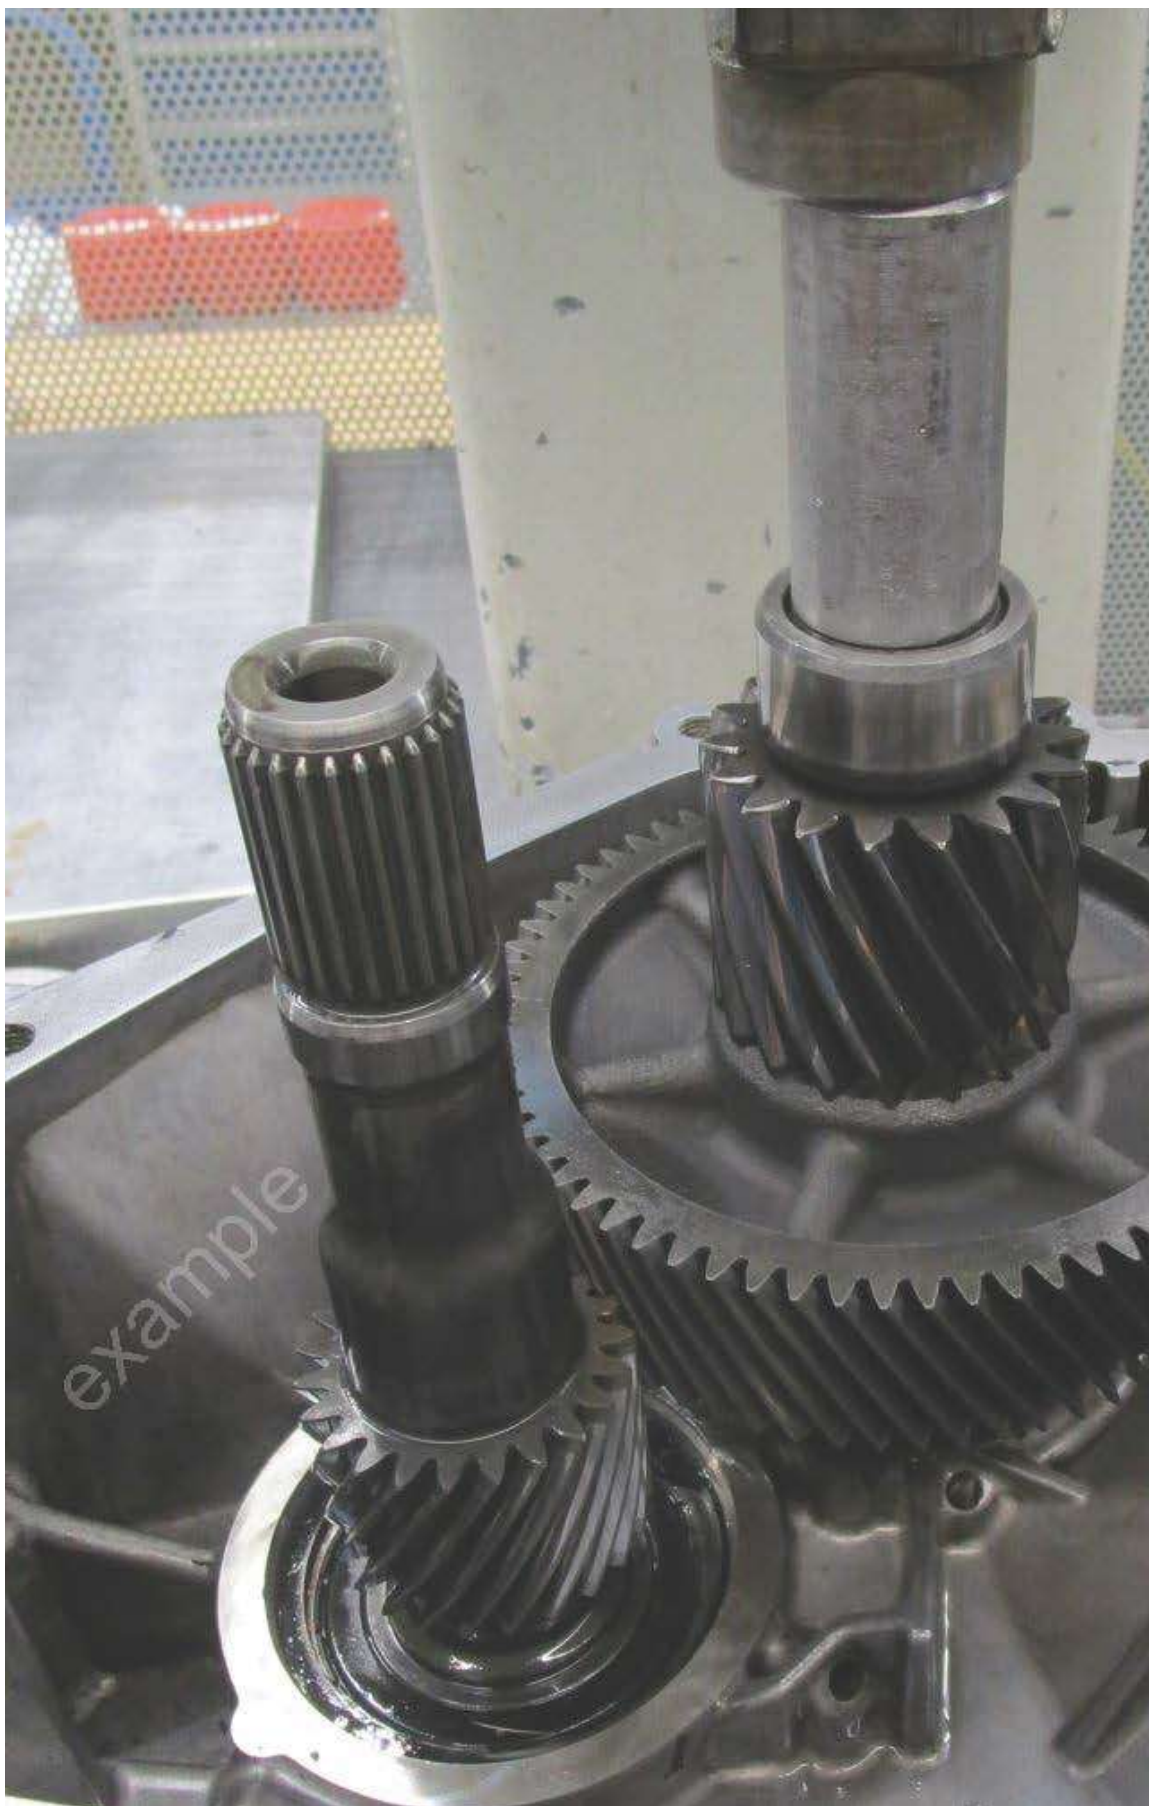
**Figure 15.** Pressing in the intermediate shaft with the removing and installing tool - VW459/2- (example).

- Re-install the retaining ring for the outer ring of the bearing for the intermediate shaft.
- Press the intermediate shaft in using the removing and installing tool -VW459/2- (refer to Figure 15); at the same time, support the inner ring with the thrust piece -VW454- (refer to Figure 16).

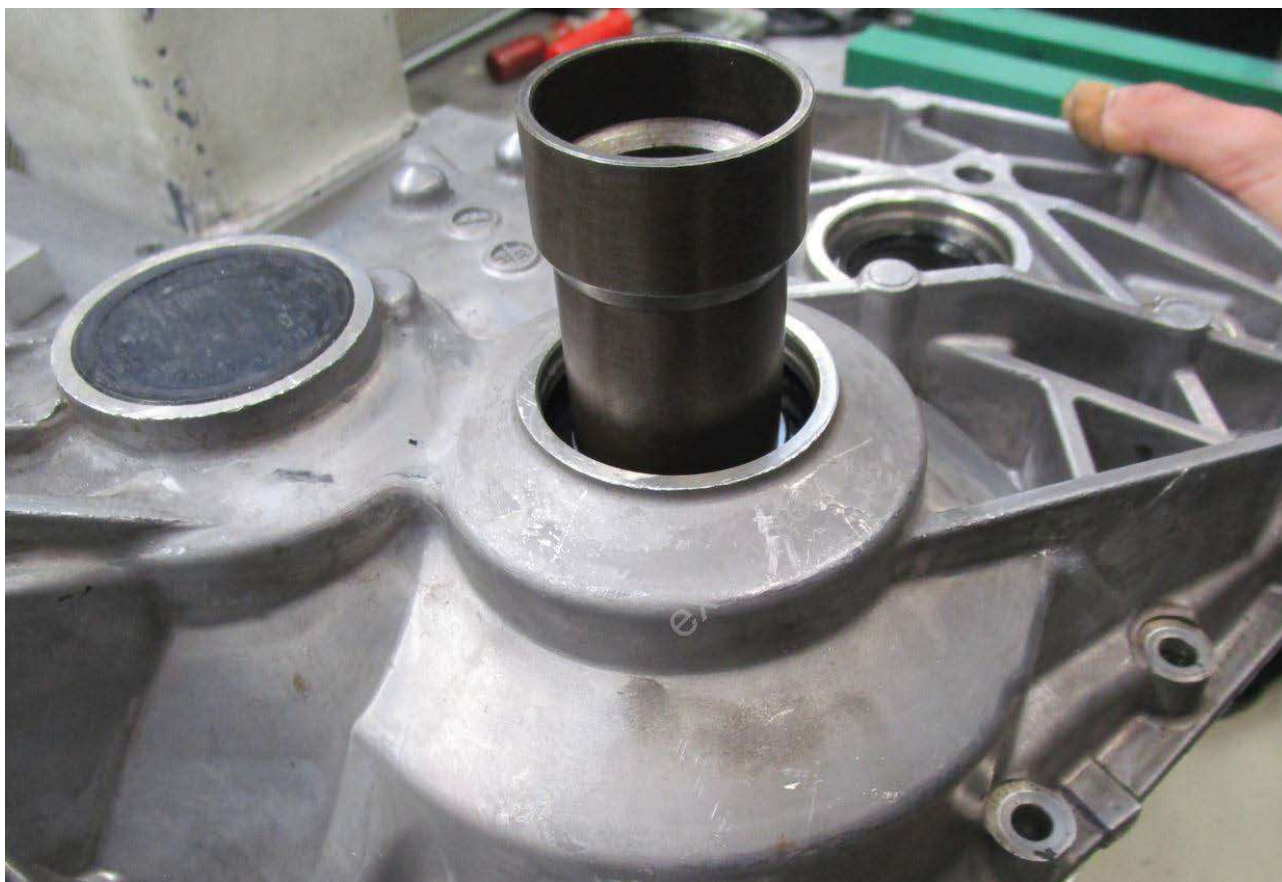
**Figure 16.** Supporting the inner ring with the thrust piece -VW454- (example).

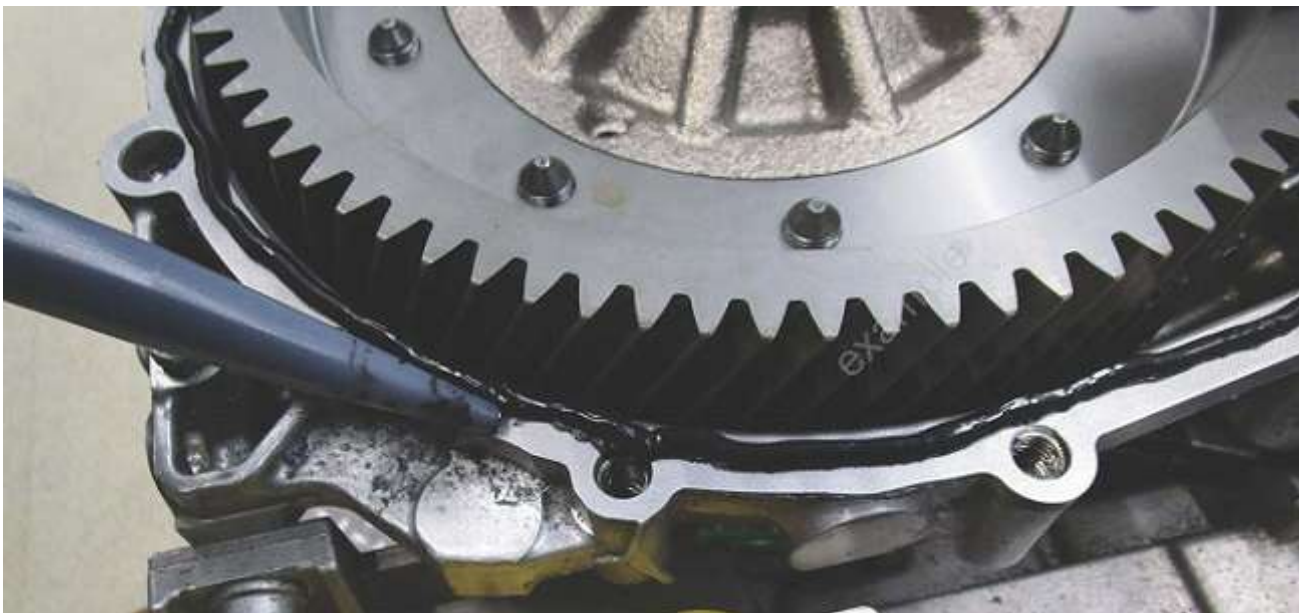
**Figure 17.** Applying silicone sealant all around the sealing surface of the intermediate housing (example).

- Allow flash-off time of 10 minutes for the sealing surfaces.
- Apply silicone sealant (part number: D 176 501 A1) all around the sealing surface of the intermediate housing (refer to Figure 17).

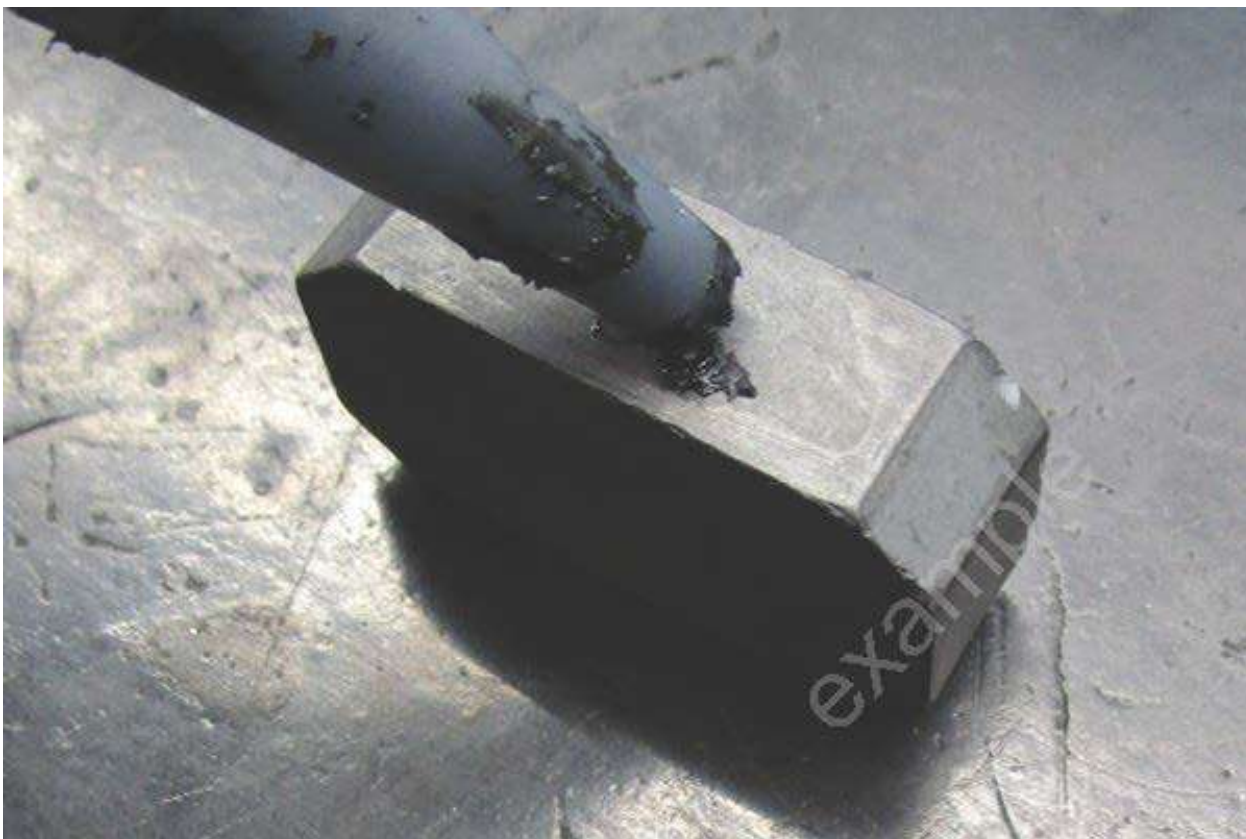
**Figure 18.** Magnet with silicone sealant (example).

- Bond the previously removed magnet (refer to Figure 18) into the gearbox housing using silicone sealant (part number: D 176 501 A1).

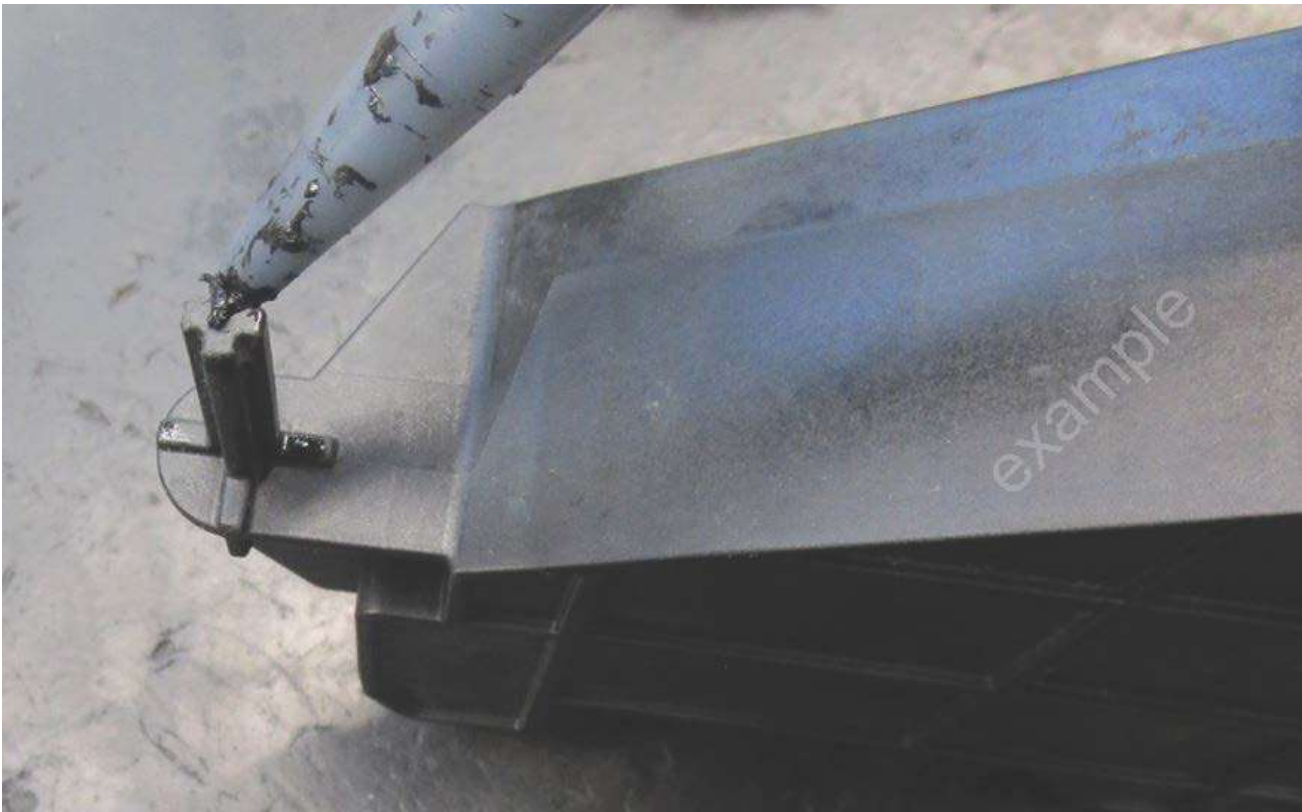
**Figure 19.** *Lightly applying silicone sealant to the attachment point (example).*

- Lightly apply silicone sealant (part number: D 176 501 A1) to the previously removed oil reservoir at 3 attachment points (refer to Figures 19 and 20).

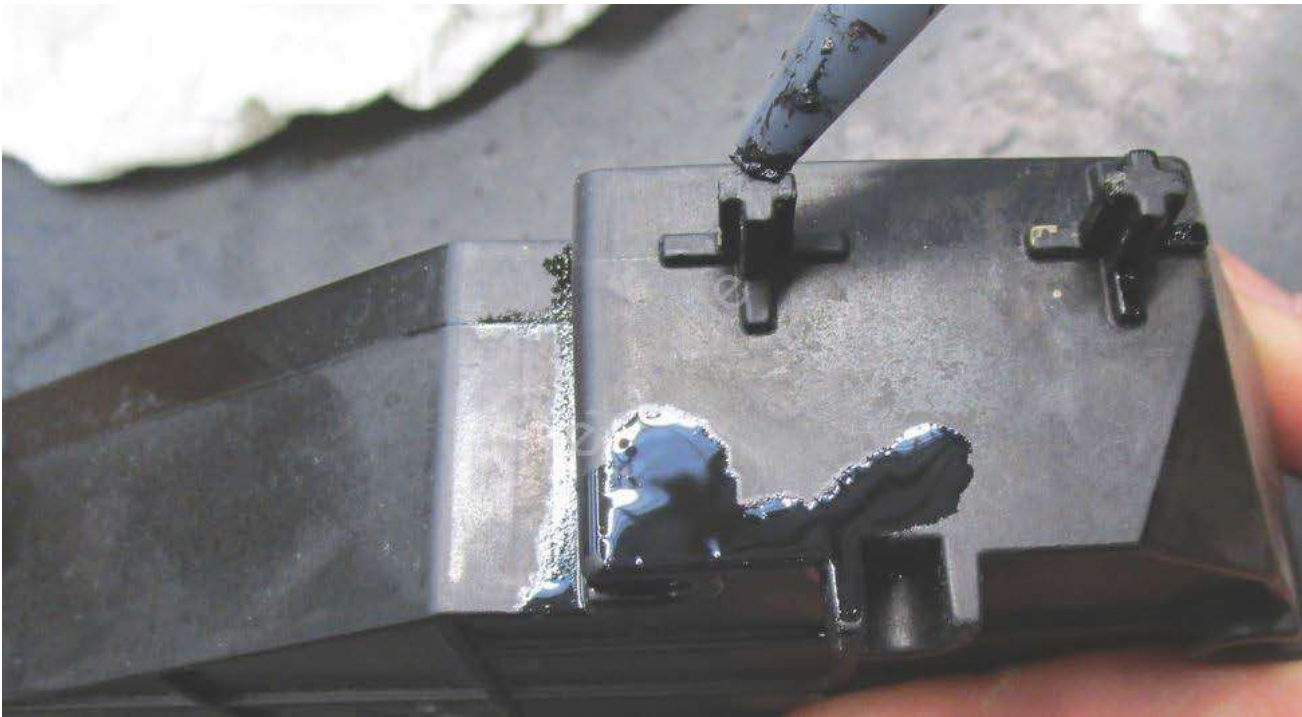
**Figure 20.** *Lightly applying silicone sealant to the attachment point (example).*

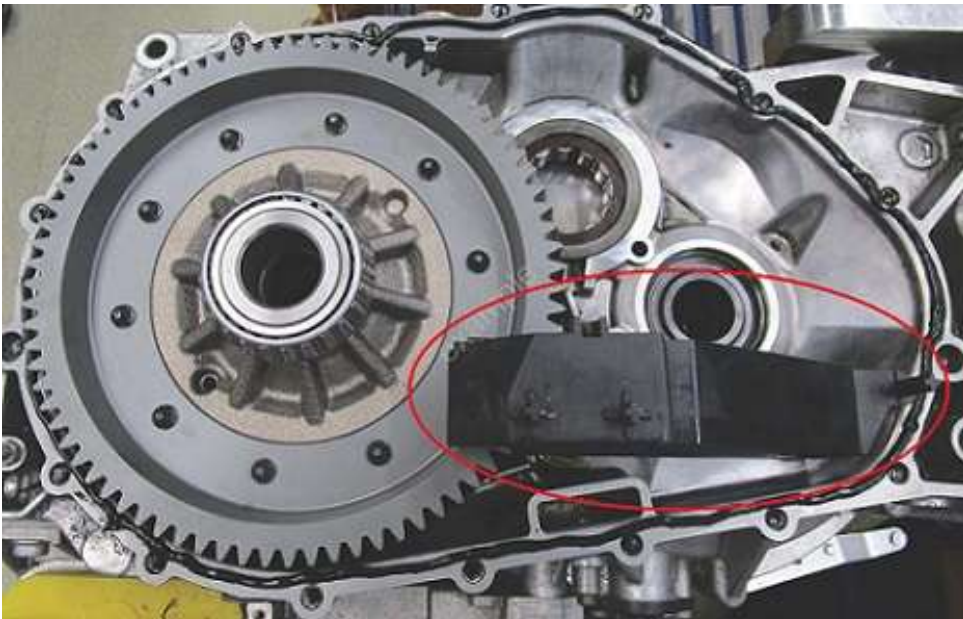
**Figure 21.** Oil reservoir fitted in the intermediate housing.

- Fit the oil reservoir (refer to Figure 21, red oval) in the intermediate housing.

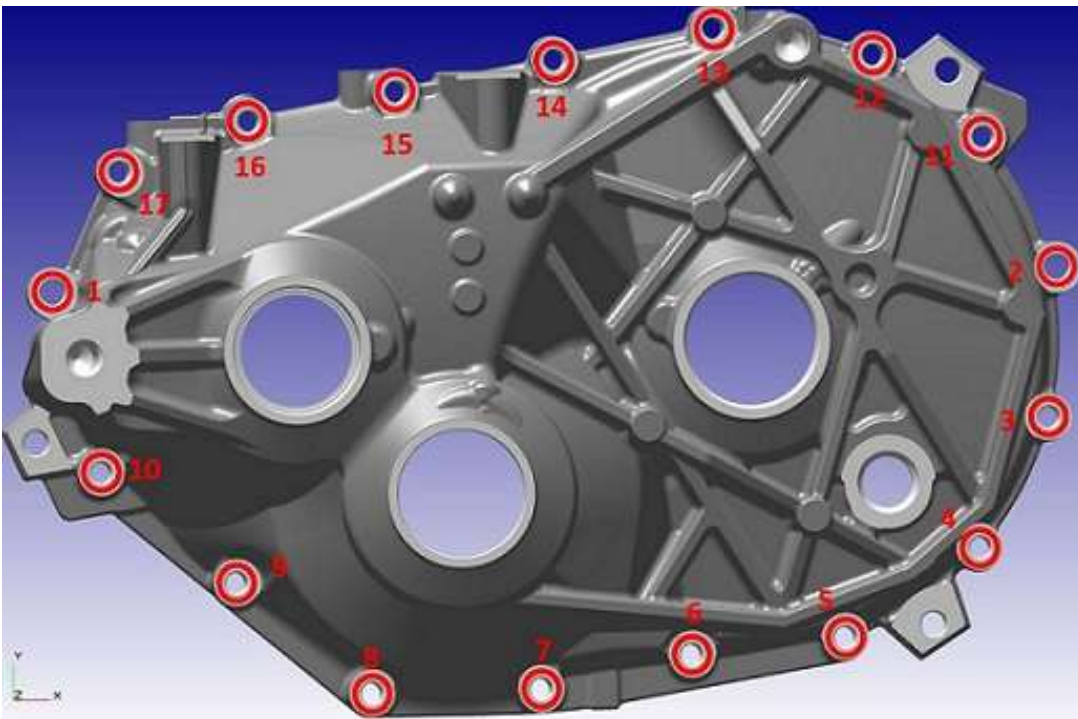
**Figure 22.** Installing the multi-point socket head bolts; tightening torque 20 Nm + 90°.

- Place the gearbox housing on the intermediate housing.
- Install the gearbox housing by screwing in the new multi-point socket head bolts in the sequence 1 to 17 (refer to Figure 22); **tightening torque: 20 Nm + 90°**.
