## Technical Service Bulletin

Transaction No.: **2078875/3**

27 Service info: A5/Q5/A6 - Charging system: fault! AC charging not possible -  
U01E400 / U011100 / C1249F5 in 0019

Release date: Aug 4, 2026

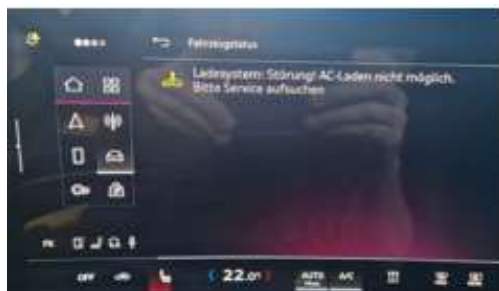
The message "Charging system: fault. AC charging not possible. Please contact workshop" is shown in the instrument cluster, although the vehicle has a combustion engine.

**Figure 1.** A message appears in the instrument cluster.

This is a software-related issue during the vehicle start-up phase which may cause the message described above to be displayed in the instrument cluster in rare cases. It has no effect on the normal operation of the vehicle, and the sporadic warning message usually does not appear after completely switching the ignition off and on again.

This complaint is solved in **VR target state 03.11.00/C**. Please check the column **VR target state 03.11.00/C** in the central service info **TSB 2081477**, *00 Service info: central overview of combined software updates for cluster 3, PPE/PPC*.

Please run the combined software update if available. Proceed according to the combined software update TSB which is specified for the vehicle in the central service info **TSB 2081477**.
