| Model(s) | Year(s) | VIN Range | Vehicle Specific Equipment |
|---|---|---|---|
| Q5, Q5 Sportback | 2025 - 2026 | All | DXCA engine code (2.0l) |

The air conditioning does not cool the interior.

On vehicles manufactured within a specific period, the wiring for N280 (brown connector for N25) (air conditioning system magnetic clutch) is too short.

| <b>Claim Comment:</b> | As per TSB 2079080/2 | | |

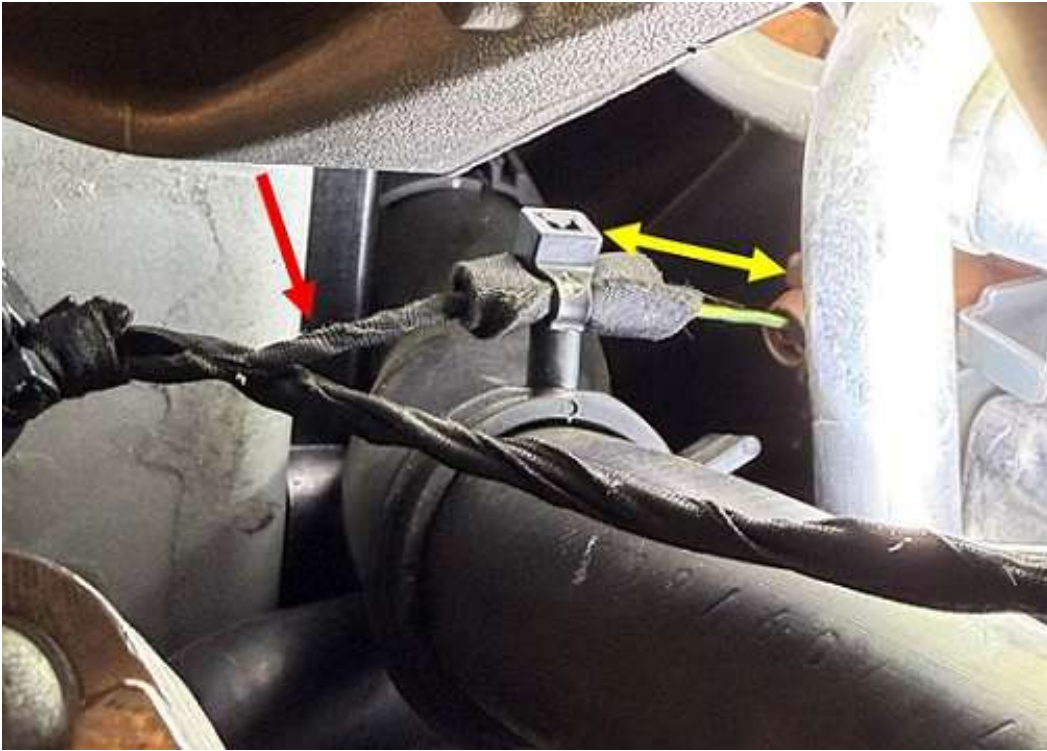
The complaint can be reproduced. A discrepancy is found at the wire leading to the brown connector (N25) on N280.

**Figure 1.** The position for the crimp connector is marked with the red arrow.

Repair the damaged wire using wiring harness repair set VAS 1978 B/C.

Place the crimp connector in the position marked with the red arrow (refer to Figure 1).

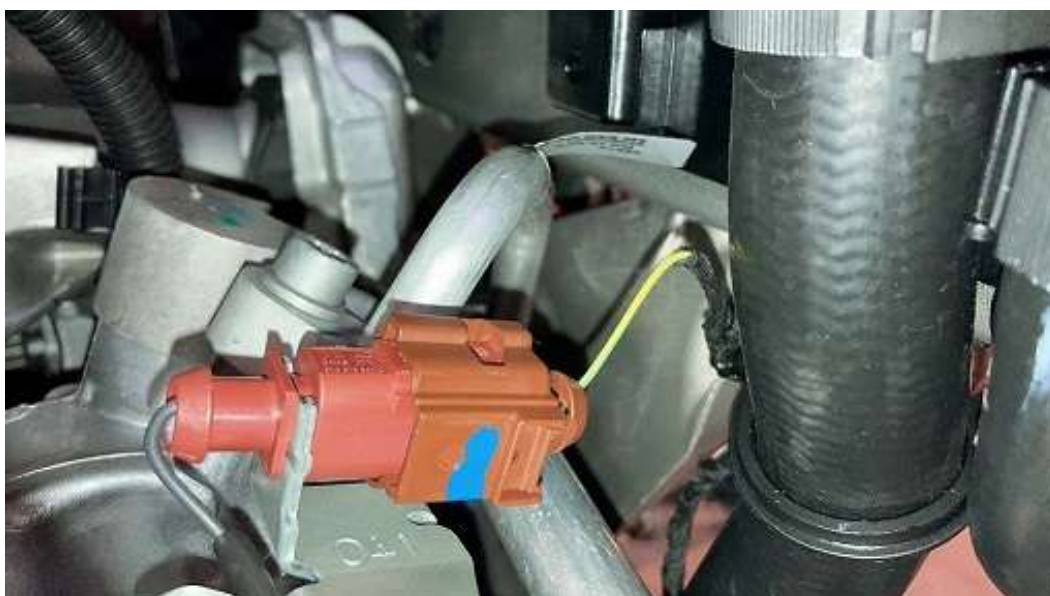
**Figure 2.** Connector in its repaired state.

The length of the wire between the cable tie and the brown connector (yellow arrow in Figure 1) **must be 60mm** (refer to Figure 2). This ensures that the wire is not too short again.

Wrap the repaired wire in fabric adhesive tape N10649702 almost as far as the connector so that it overlaps (refer to Figure 2).

Wrap the fabric adhesive tape at least 2.5 times underneath the area of the cable tie of the omega clip to ensure the wire can be secured in the cable tie.
