## Condition

| Model(s) | Year(s) | VIN Range | Vehicle Specific Equipment |
|---|---|---|---|
| A5, S5 (FU) | 2025 – 2026 | All | Not applicable |
| A6 Sedan (FN) | 2026 – 2027 | | |

## Technical Background

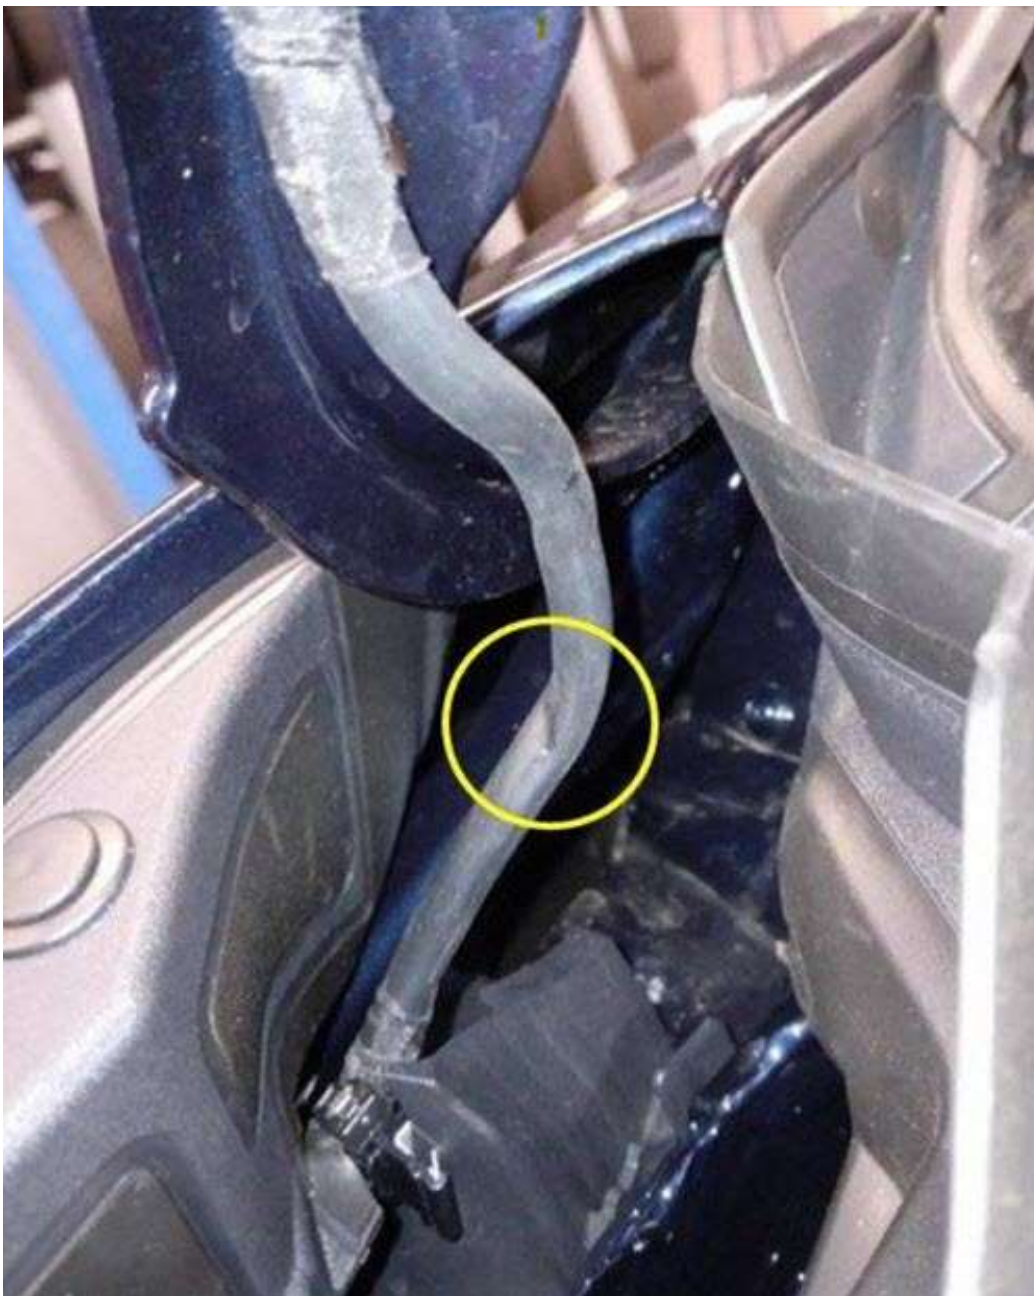
The windscreen washer system does not work because the hose is squashed/kinked at the hood hinge. Possible causes:

1. The claw clip has been tightened too much and is therefore blocking the washer fluid hose.
2. The clips have been positioned incorrectly at the factory.

Figure 1 shows the kink in the washer fluid hose.

**Figure 1.** Kink in washer fluid hose.

The kink in the EPDM hose can be “massaged” out using heat (hot air blower). It should then be possible to bend it through 180 degrees without kinking it.

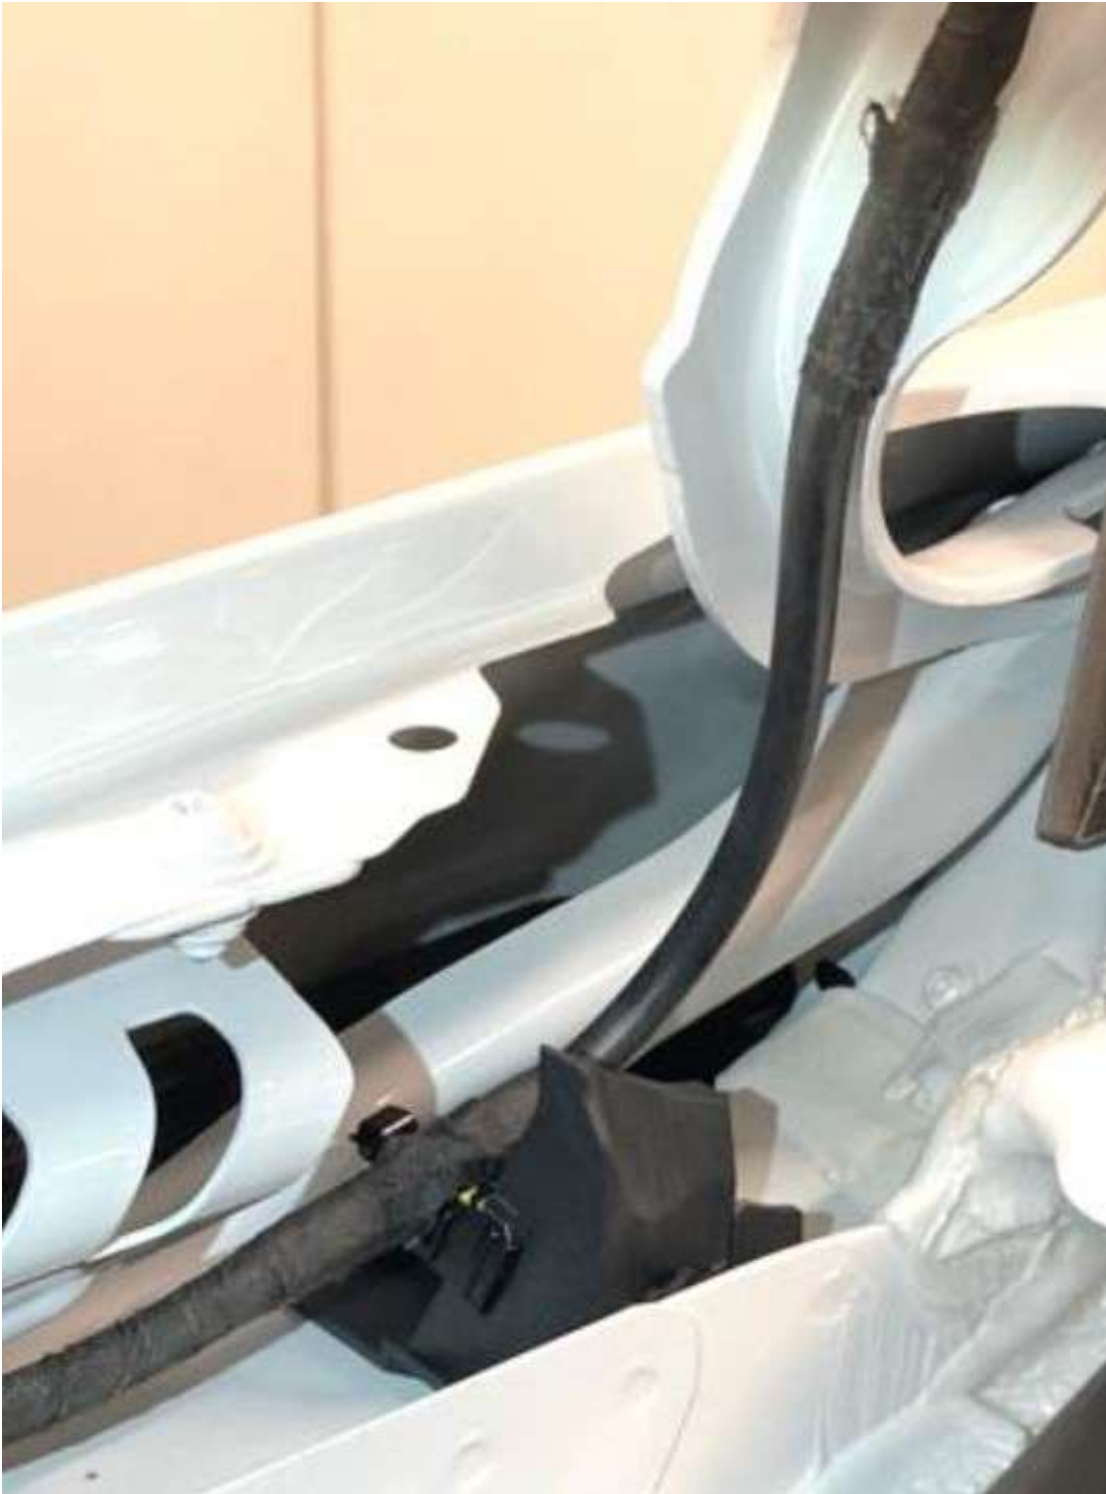
Figure 2 shows the correct routing of the washer fluid hose.

**Figure 2.** *Correct routing of washer fluid hose.*

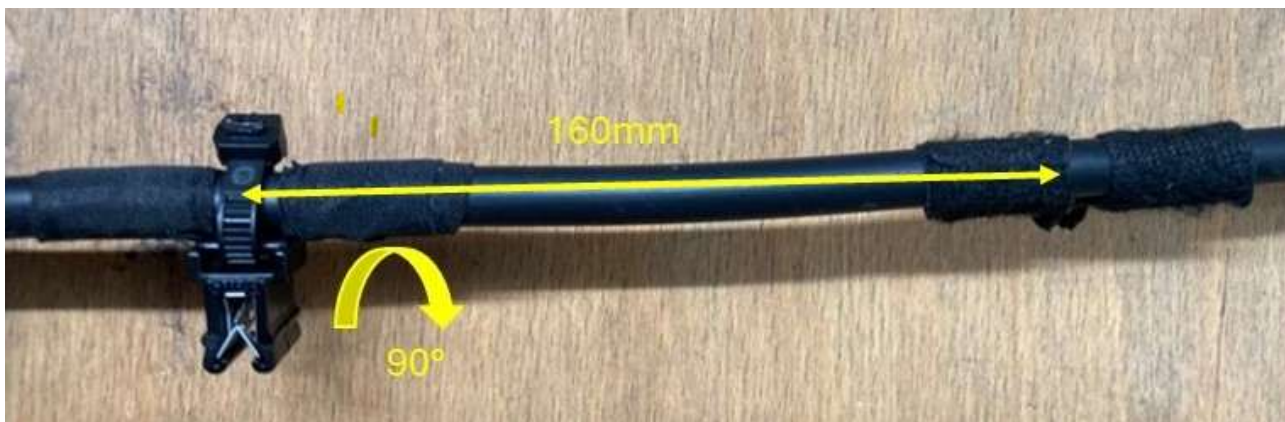
**Figure 3.** Clip position.

The distance between the claw clip and the pine-tree clip should be 160mm (+5mm maximum tolerance) (refer to Figure 3). The claw clip must be at 90 degrees to the pine-tree clip to ensure that the hose can be positioned in the correct location in the engine compartment and bonnet without being twisted (refer to Figure 3). Check the extrusion line on the hose to determine whether it is twisted. To do this, release both clips. It is then possible to check whether the clips are oriented correctly without tension.
